UQ Materials Performance

D04489-001

**Assessing the Risk of Operating Mining Equipment
During Lightning Storms**

6 September 2022

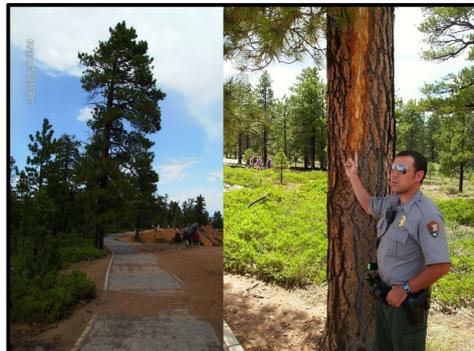
Figure 1 Example of a side flash fatality site near a tall tree [3]

In 2011, a man took shelter under this tall tree. When lightning struck the tree, the man was killed by a side flash.

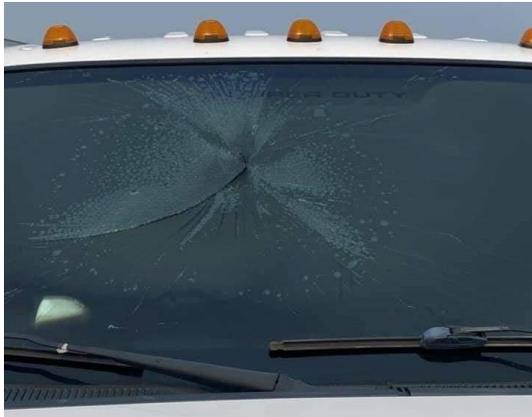
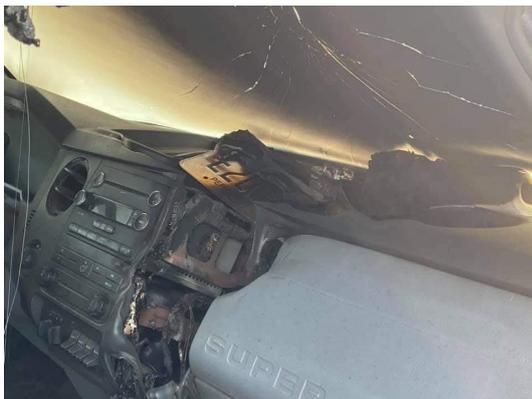
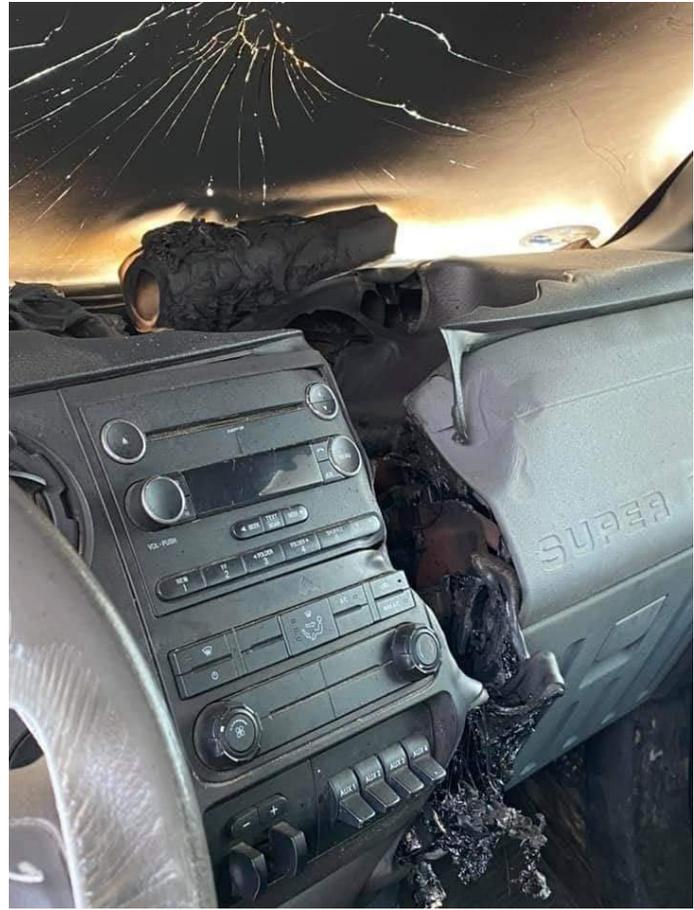
Figure 4 Photographs of an apparent direct lightning strike to the windshield of a stationary utility vehicle, Ford Super Duty [22].

An example of a lightning strike occurring through the windshield has been documented in the public domain [22]. According to the report, the unoccupied car (Ford Super Duty) was struck while parked at a dealership in Michigan, USA. The lightning strike appears to have first struck the windshield before passing through into the dashboard below the windshield where gross localised melting of plastic was observed.

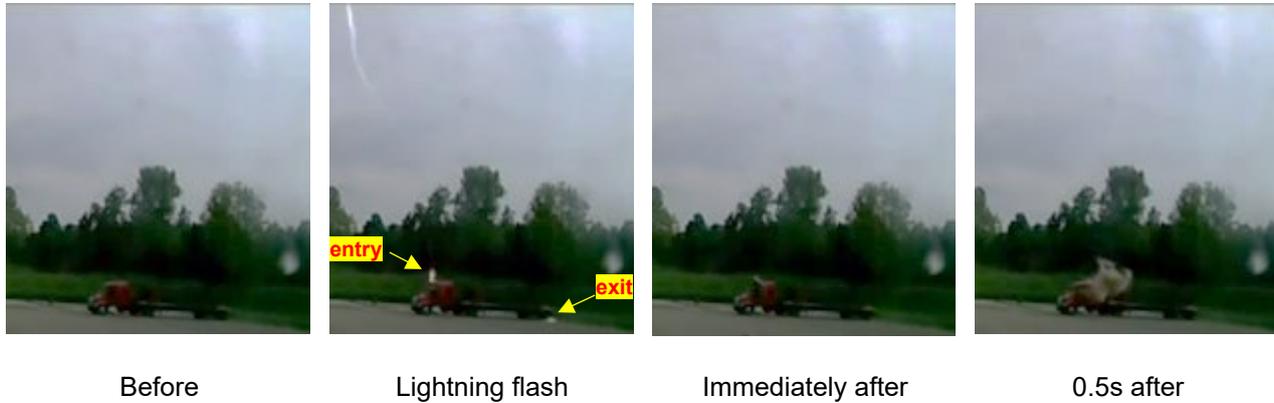
Figure 5 Frame captures of a lightning strike to a truck, taken from Ref. [26].

Lightning strikes to the antenna are the most common type of damage to non-mining vehicles from lightning (see Figure 15, page 40). Further examples of lightning strike to non-mining vehicles have been reported in the public domain. This includes a video of a truck that was struck by lightning while parked at a truck stop [26]. The incident occurred in South Carolina, USA on 1 August 2012 and was captured by another truck's dashcam. The lightning is believed to have struck the trucks front antenna and then travelled through the driver's shoulder, out the back of his left arm and then grounded at the back of the trailer (see Figure 5). The driver survived with some minor burns. The truck would not start and almost all internal electronics were burnt out.

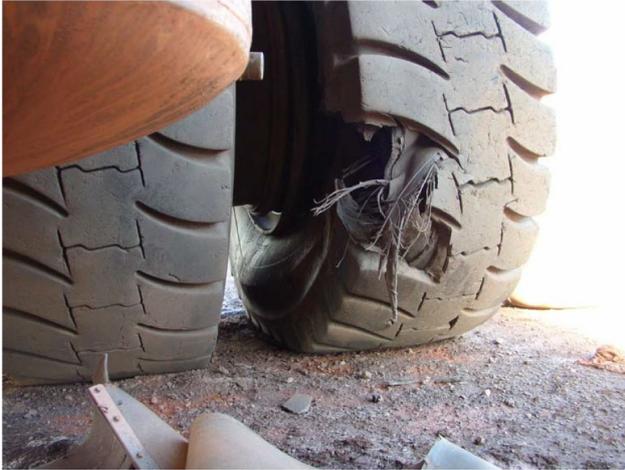
Figure 11 Photographs of tyre explosion after lightning strike in Pilbara, WA in 2004 [15].

Exploded position 3, left outside rear tyre (note torn mud-flap in foreground)

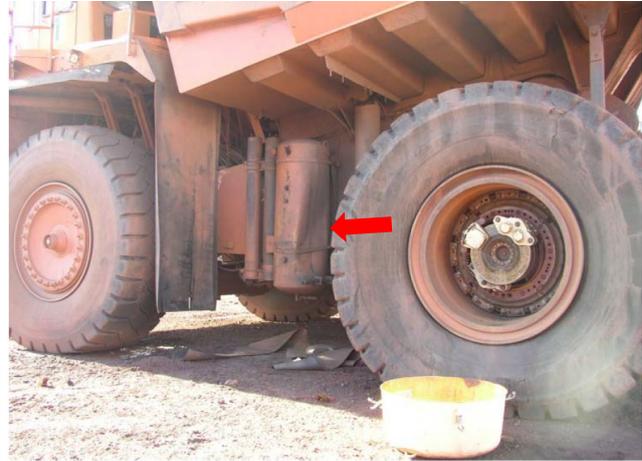
Damaged hydraulic tank & blown-off left wheel cover (the right side wheel cover was also blown off)

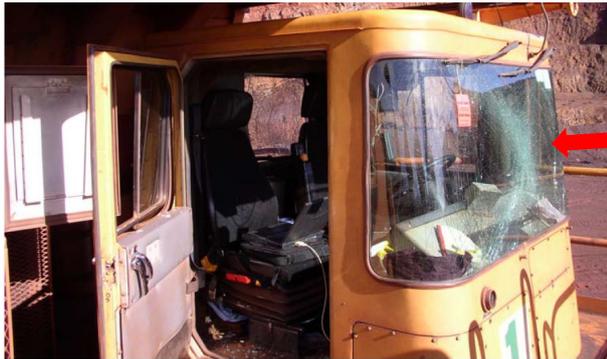
Damaged driver's cabin (note outwardly deformed windscreen & rear window)

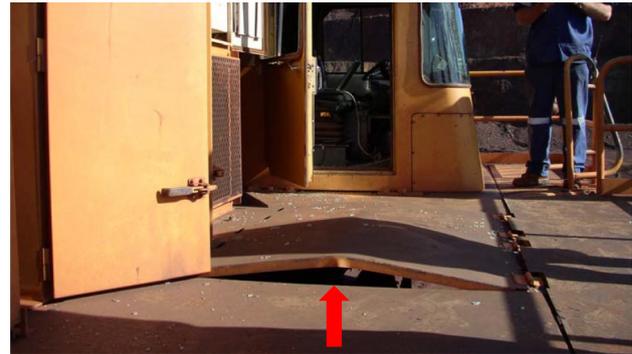
Buckled walk-platform (note blown-open doors on electrical cabinet)

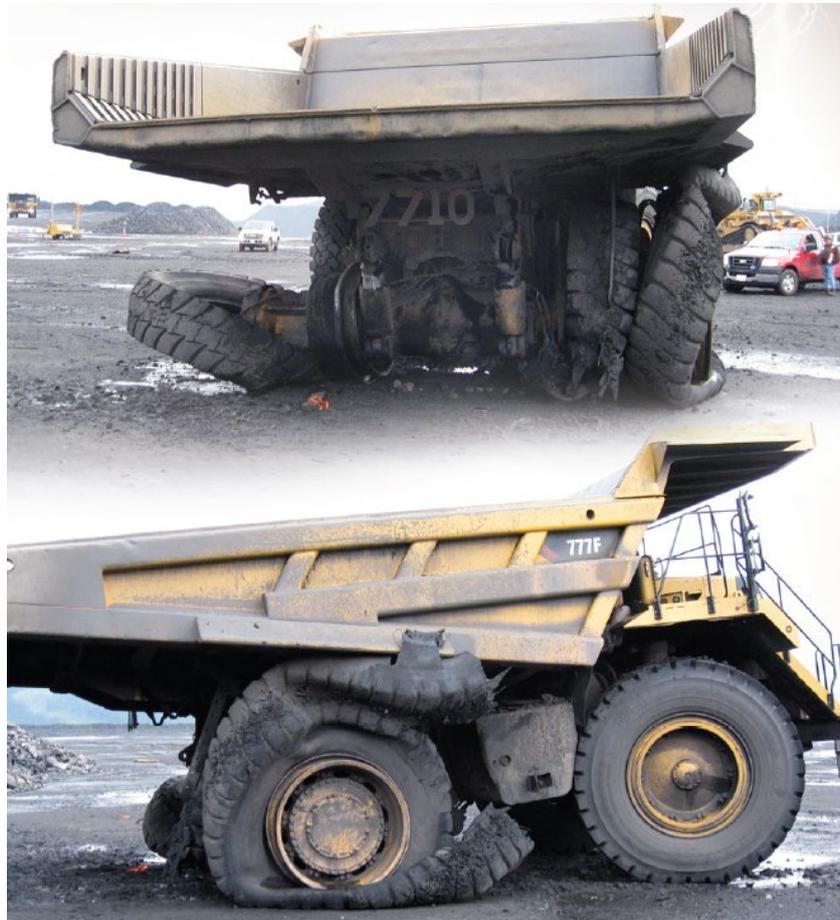
Figure 12 Photographs of tyre explosion after lightning strike [34]. Unknown incident date and location.

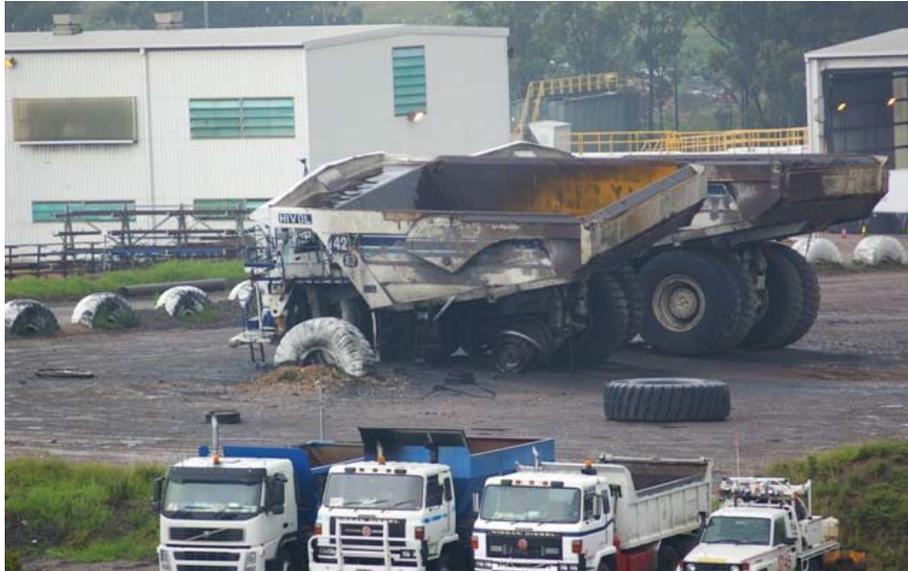
Figure 13 Photographs of tyre explosion after lightning strike in NSW in 2008 [35].

(a) Incident truck

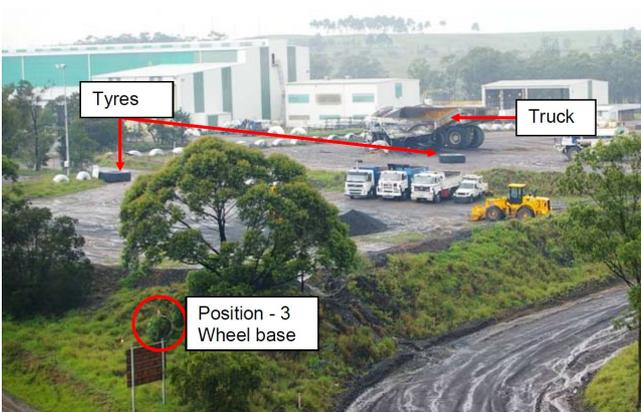
(b) Truck and debris

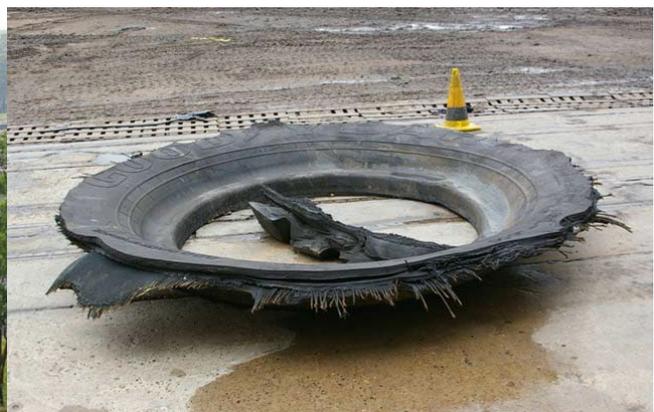
(c) Tyre side wall from position number 1

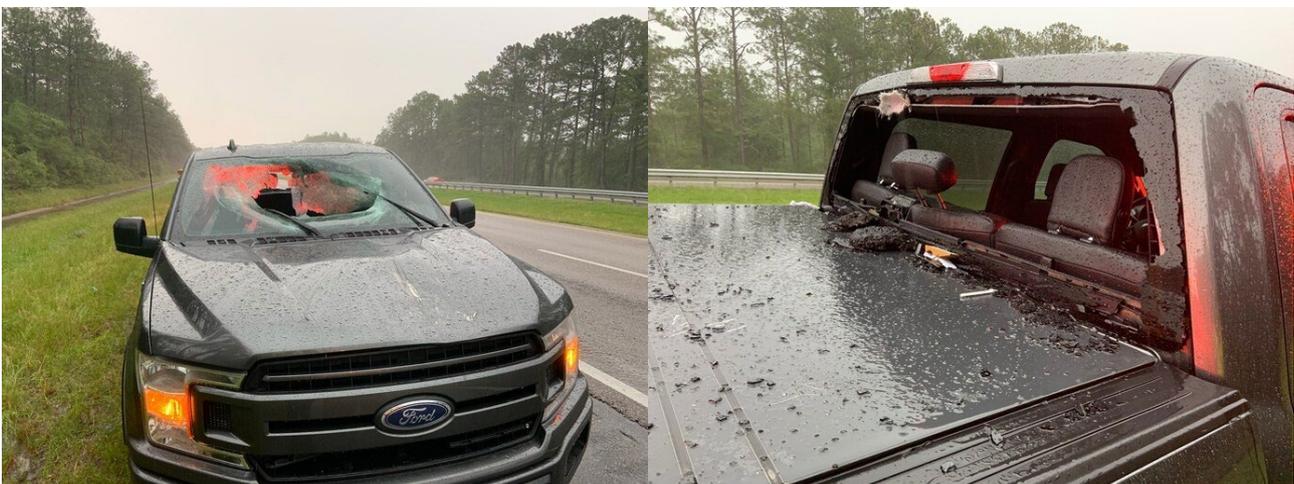
In addition to fallen trees and branches, it has also been reported that lightning strikes have thrown up ground debris and heavy fragments of pavement [40]. These projectiles have hit fast moving cars and windshields and caused significant injury to the occupants. Figure 16 shows the damage caused by a fragment of pavement thrown up by a lightning strike. The fragment broke both the front and back windshield. The rear middle seat was also damaged – the headrest bent back more than six inches. No passengers were seated there at the time. It is thought that the lightning may have instantaneously vaporised water trapped within or beneath the surface of the roadway.

Figure 15 Photos of a ute in Florida damaged after pavement was thrown by a lightning strike through the front and back windshield before coming to rest atop of the covered tray [40]
