July 2022 Incident periodical

Recent High Potential Incidents**
Learnings and Recommendations
Communications and Safety Notices
Queensland Coal Mines Inspectorate

Coal Inspectorate

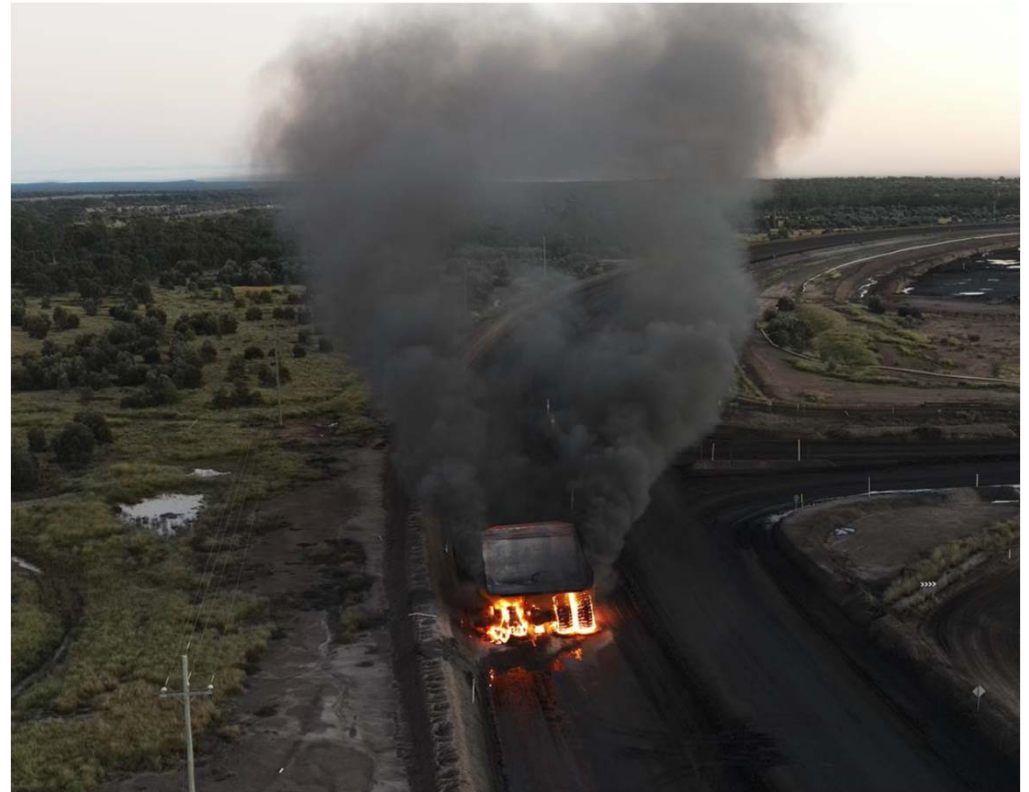
1. Incident – tyre fire

- A rear dump truck was totally destroyed by fire
- The truck was being escorted to a hot tyre bay when a CMW noticed flames coming from Pos 4 wheel and called the emergency
- The operator safely exited the truck
- Investigations identified likely tyre damage (cuts & tread separation) due to poor road conditions, potentially exacerbated by wet weather
- Prior to the incident two other trucks had been stood down for suspected hot tyres
- Travel speed and distance to a hot tyre bay were not considered when relocating the truck
- Internal tyre temp & pressure sensors did not indicate the likelihood of an external tyre tread fire

- Review mine road design and operating standards. Including location of “hot tyre” bays.
- Confirm vehicle tyre selection is appropriate
- Review “hot tyre” response procedures including defect identification, use of thermal imaging, proximity to “hot tyre” areas and relocation requirements
- Review emergency response capability for dealing with “hot tyres”

- Make sure road standards and conditions meet or exceed the site standards
- Understand and communicate to CMWs current site procedures for dealing with “hot tyres” including emergency response procedures

- Understand and comply with site roadway operating standards
- Understand and follow site procedures for dealing with “hot tyres”, including emergency response requirements

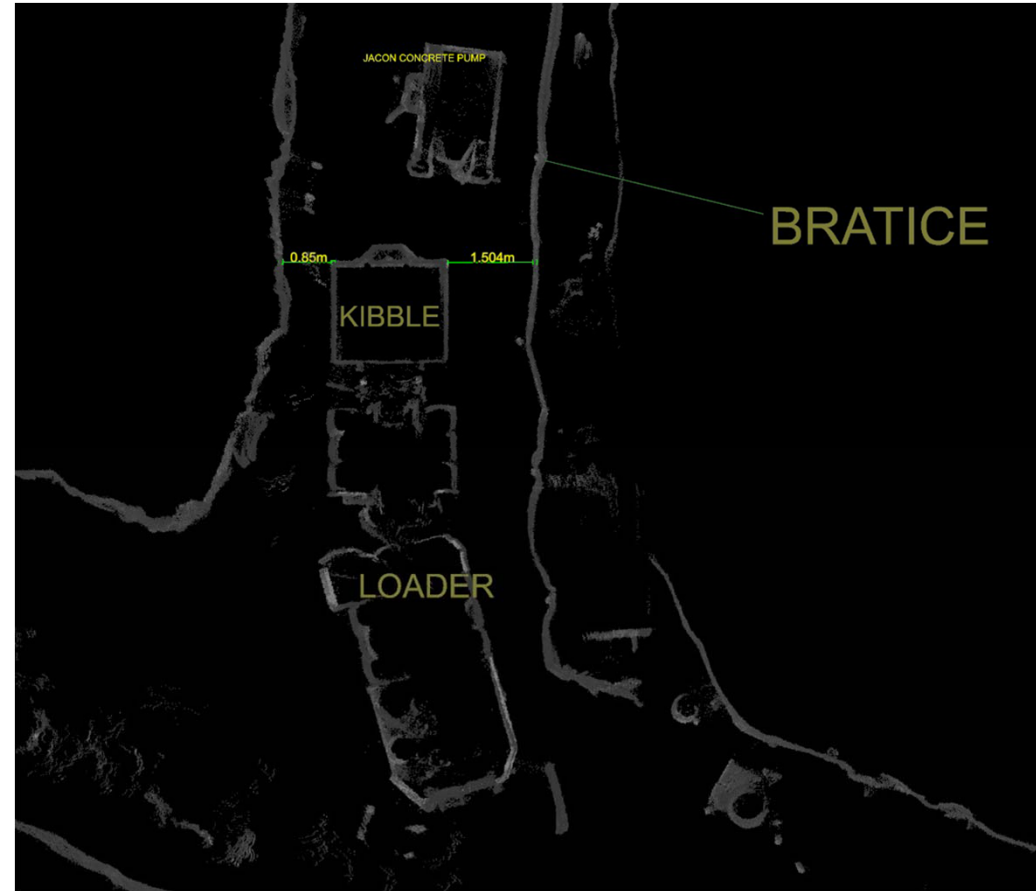
2. Incident – CMW crush injury

- A CMW suffered serious crush injuries to their right leg and hip when pinned between a Load Haul Dump (LHD)/ concrete kibble and a Jacon concrete pump.
- CMWs were constructing a Longwall goaf seal. A load of concrete had been delivered by the LHD/kibble and pumping of the load had been completed.
- The LHD/kibble backed out from pump and on re-entry the LHD/kibble operator heard the injured person shout out.
- The injured CMW was found trapped between the kibble and the Jacon concrete pump.

- Ensure work tasks are properly planned, prepared and risk assessed prior to being undertaken.
- Make sure that tasks are properly resourced and competently supervised
- To have systems in place that ensure requirements for spotters and "no-go" zones are implemented and enforced.
- Consider higher order controls which eliminate people/machine interface such as collision avoidance or pumping concrete from the surface

- To ensure tasks are not allocated or proceed unless they have been properly planned, prepared and risk assessed.
- To make sure CMWs understand systems and procedures including site requirements for spotters and "No-go" zones when working around machinery
- Enforce compliance with critical controls identified that would prevent injury

- Must follow site procedures and work instructions
- Carry out their activities and work in a way that does not expose themselves or someone else to an unacceptable level of risk

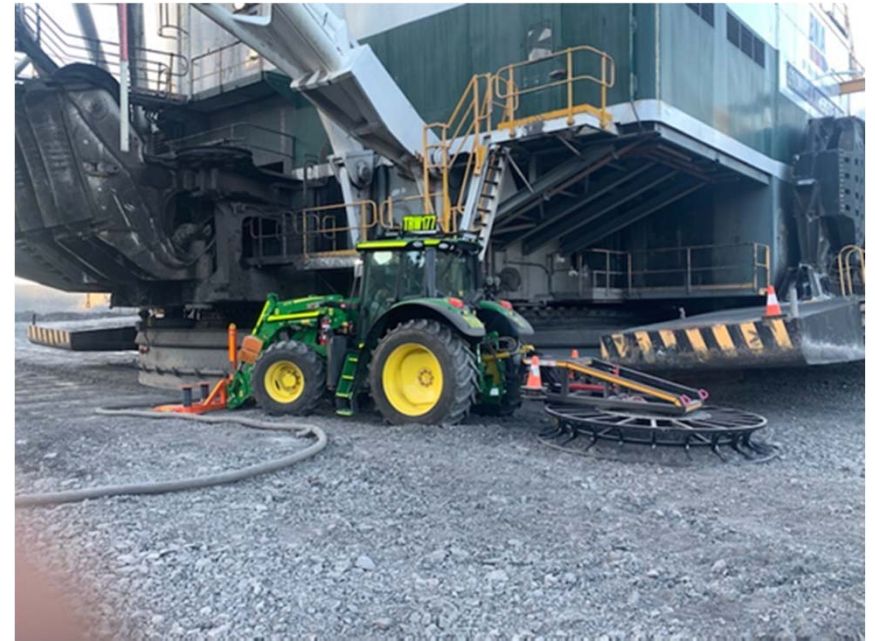
4. Incident – Dragline contacting tractor

- CMWs were using a cable tractor to position cable
- The cable tractor moved a loop of cable and was repositioned to move another cable loop.
- The dragline operator assumed the tractor to be clear of the “no-go” zone and started to swing the dragline at slow speed.
- The dragline contacted the cable tractor reeler and cab mirror
- The cable tractor operator has then called on the 2 way twice to stop the dragline, however the dragline operator could not hear him clearly.
- The cable tractor operator exited the tractor and waved at the dragline operator to get his attention.
- At this point the dragline operator has stopped the dragline from swinging.

There have been 22 reported HPis between 2017 and 2021 involving interactions between draglines and vehicles / machinery. A further two incidents have been reported in June and July 2022

- Implement higher level controls, over and above positive communications, that ensure inadvertent contact between draglines and machinery, and / or personnel does not occur.
- Ensure “No Go Zones” are defined and clearly delineated.
- Ensure compliance with procedures regarding personnel and equipment entering areas where they may be struck by operating equipment are adequate and effective.

- Should ensure compliance with procedures and processes. This includes conducting behavioural observations during dragline operations.

- Carry out their activities and work in a way that does not expose themselves or someone else to an unacceptable level of risk.
- Must follow site procedures and work instructions.
- If in doubt “STOP” outside of the “No Go Zone”

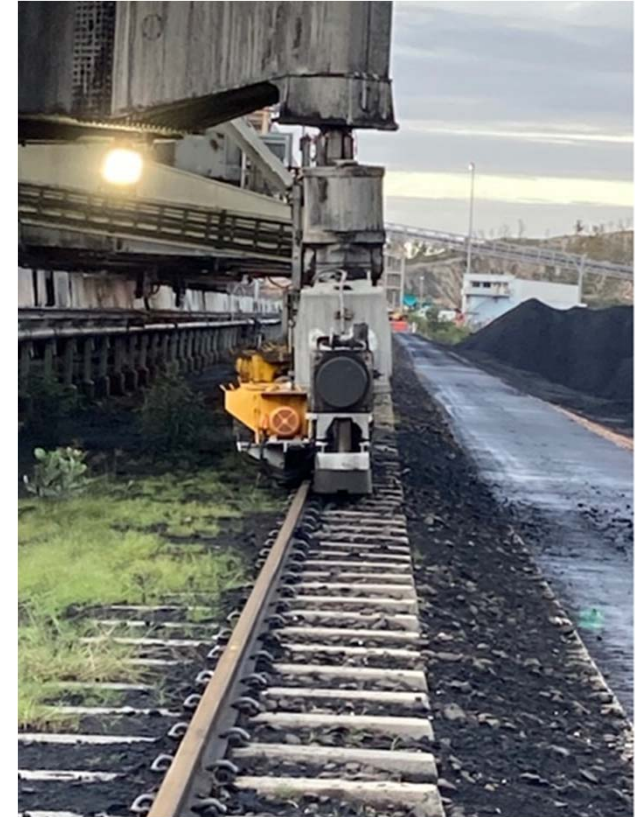
5. Incident – Bucketwheel stacker/reclaimer derailment

- A bucket wheel reclaimer/stacker derailed whilst the machine was being repositioned to begin stacking.
- The stacker boom was slewed and lowered contacting the stockpile. During this action, bogie wheels were partially derailed and the machine power tripped.
- The front bogie came off the rail and moved about 250 mm sideways when machine power was reset and the stacker boom slewed back into the park position.
- The control room operator was undertaking other production tasks at the time of the incident and did not stop the machine prior to the derailment occurring.
- Investigation identified PLC control system design defects.

- Ensure plant and equipment is fit for purpose.
- Initiate safety reviews of automated or semi-automated control systems with the aim of identifying and controlling foreseeable errors.
- Consider collision avoidance detection, code error checking, ground force protection systems

- Communicate with CMWs the importance of monitoring remote operations
- Undertake periodic functional safety audits of PLC codes

- Don't multi-task when critical tasks are being undertaken
