# MMQ Quarterly Report

High Potential Incidents and Serious Accident Summary  
Queensland Mineral Mines and Quarries Inspectorate  
*January- March 2022 quarter*

**Resources Safety & Health**  
Queensland

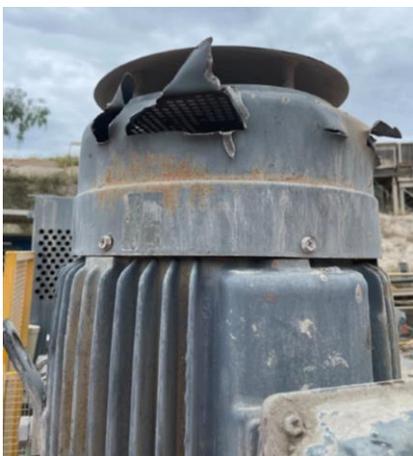
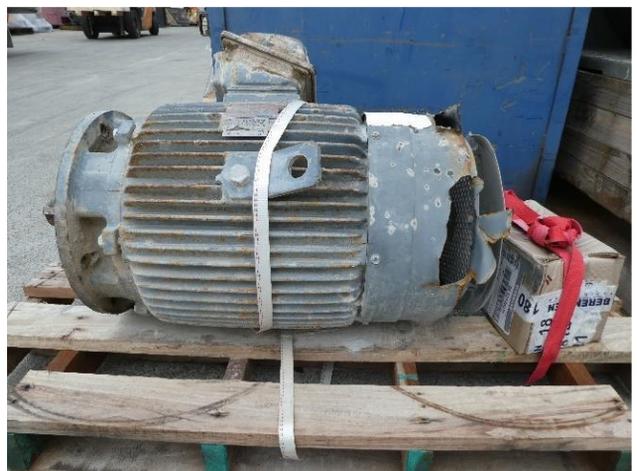
During a mill inching task to reposition mill and balancing mill charge, the motor fan of the inching drive disintegrated, ejecting fragments of the fan into the immediate area.

**Familiarity with task** - Frequent exposure breeding familiarity with the task resulting in a failure to recognise potential hazards.

**Reliance on undocumented knowledge** - There is no risk-based documented standard work process or instruction to inform workers of the safest method of performing the task or to identify potential energy sources

**Hazard identification** - “nothing bad has happened before during the tasks” resulting in a failure to identify and control the dormant hazard.

**Change management** - initial management of change when motor was first changed out failed to identify and introduce compatible equipment

Photos showing fan fragment ejection damage

This hazard has been present for a period, thought to be longer than a decade. Engineering a solution that removes the excessive energy being directed through the inching drive motor and ensuring effective change management will prevent such future incidents. To assist hazard perception and recognition we need to challenge the status quo and acknowledge we are all influenced by our biases - what are the potential hidden hazards and what could go wrong?

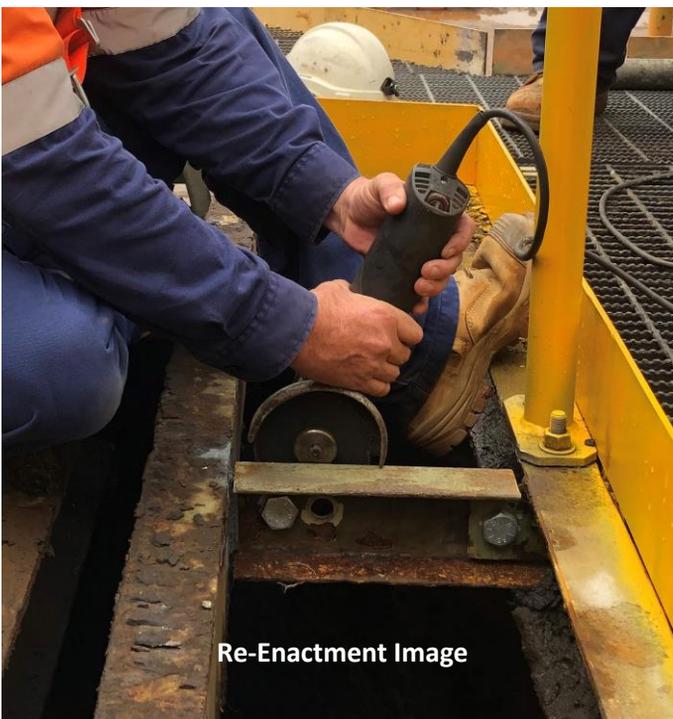
Re-Enactment Image

A worker was using a 5" angle grinder to cut off bolts from a platform. The angle grinder has 'bit into' the bolt being cut, then kicked back into the workers abdomen causing a 20cm laceration.

- The SHMS didn't include procedures for outlining the requirements for small powered hand tools.
- The Standard Work Instruction (SWI) did not identify correct body position or safe operation requirements for the grinder.
- Training records management for the worker did not include training in the relevant SWI.
- The worker did not identify hazards associated with their body position or incorrect operation of the angle grinder.

- Workers must not be positioned in a hazards 'line of fire'.
- Angle grinders should be fitted with dead-man switches, guards and handles (OEM).
- Ensure that workers are trained and assessed as competent to perform tasks.
- Procedures should be sufficiently detailed to manage all hazards associated with the task.
