March 2021 Incident periodical

Recent High Potential Incidents
Learnings and Recommendations
Queensland Coal Mines Inspectorate

Coal Inspectorate

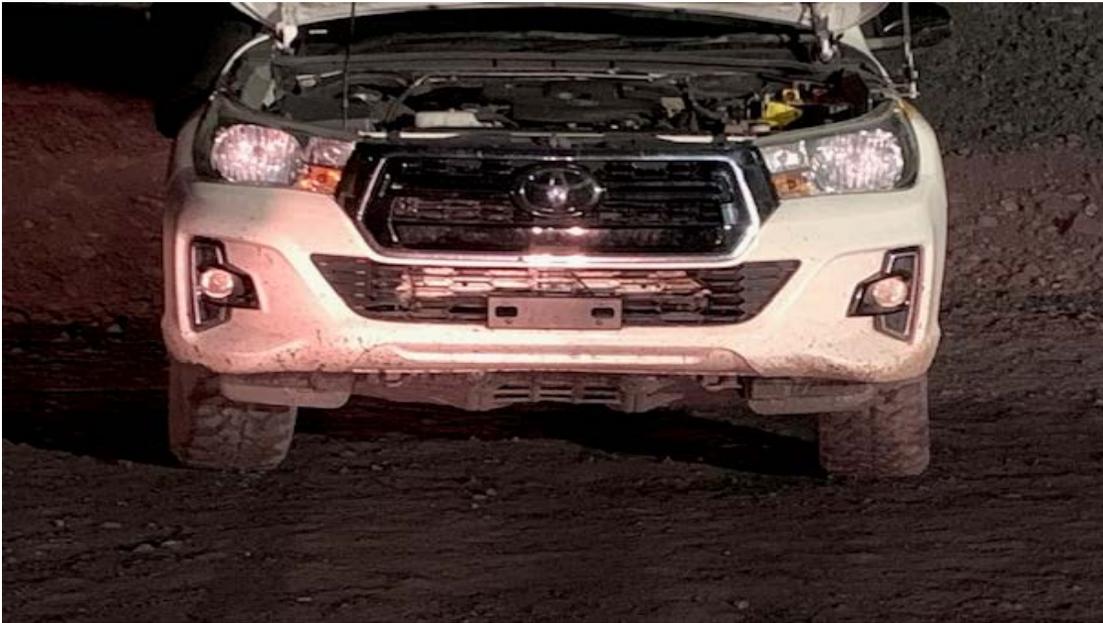
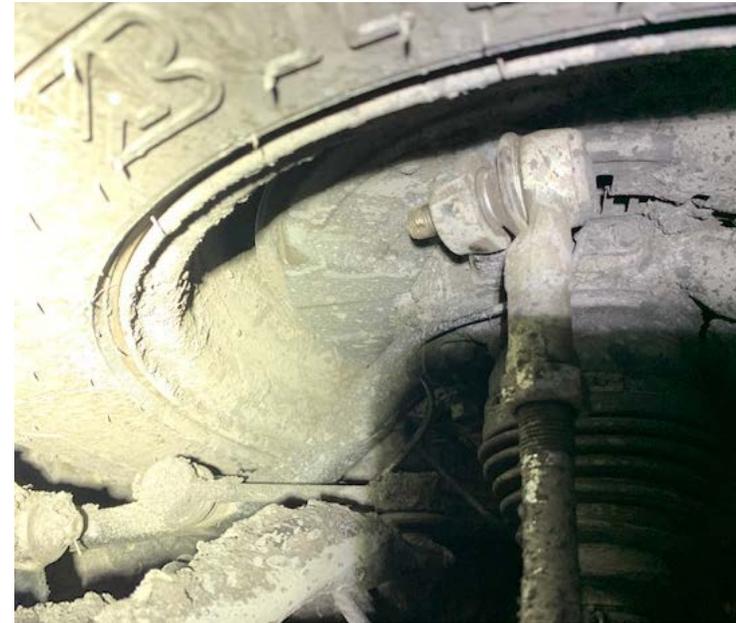
1. Incident – Steering joint failure – Surface Mine

1. Whilst travelling a light vehicle lost steering when the right hand side tie rod end nuts came off.
2. The light vehicle had the steering rack and pinion replaced on the shift prior to the incident occurring.

- Ensure the SHMS contains an effective maintenance strategy and plans for maintaining mobile plant.
- Ensure the persons carrying out maintenance on mobile plant are competent to perform the work.

- Ensure mobile equipment componentry is maintained and replaced as per the OEM's specifications and recommendations.
- Check that critical maintenance steps have been completed as required.

- Must maintain mobile plant as per the requirements of their mine's SHMS and the relevant OEM.

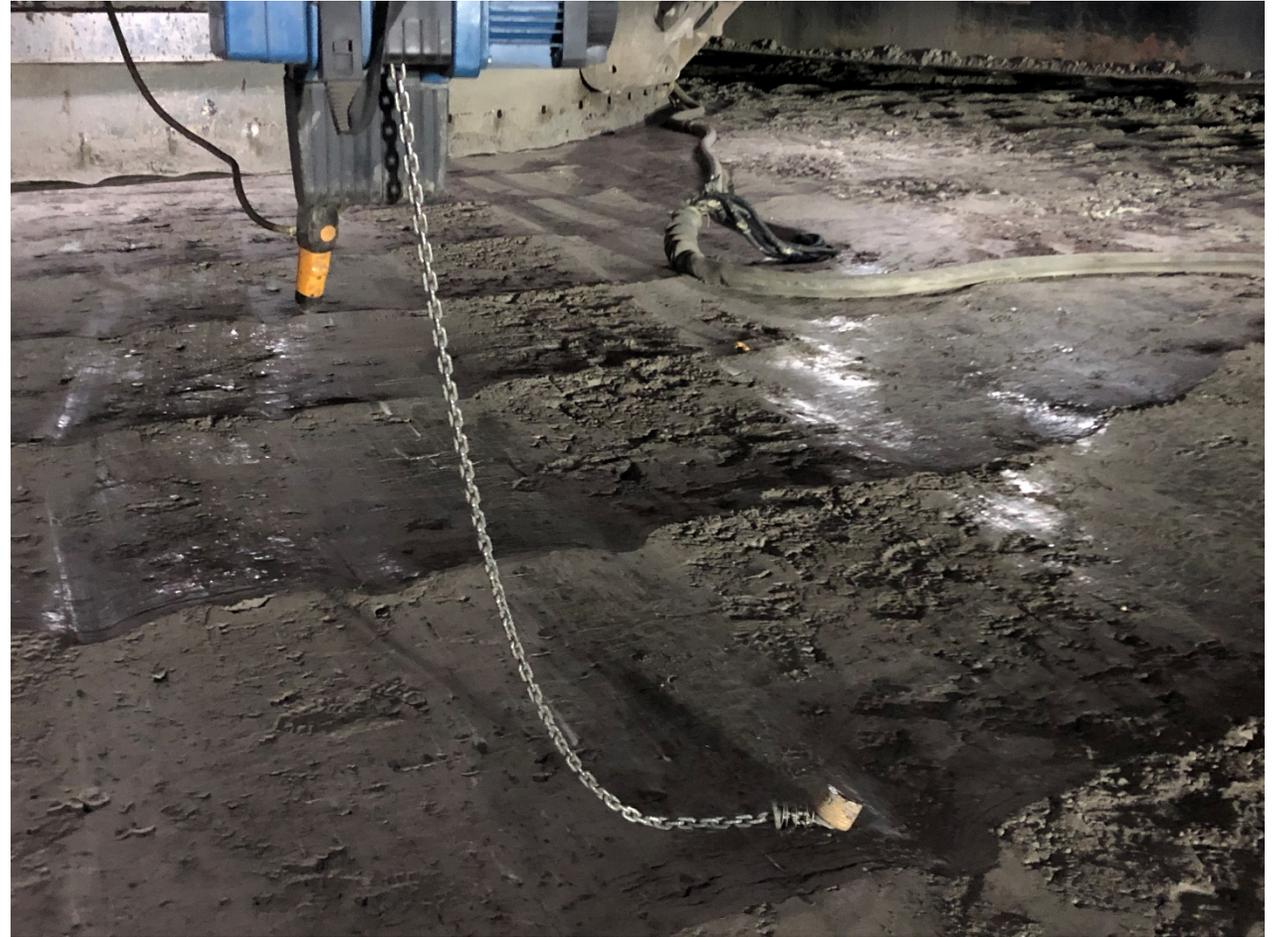
2. Incident – HV Cable damaged – Surface Mine

1. A dragline was repositioning due to sinking in soft ground.
2. A worker on the ground at the front of the dragline directed the operator to swing to the right. The cable winch under the house was still attached to the cable, and this resulted in significant cable damage when the dragline swung.

- Ensure the mine's safety and health management system contains an effective procedure for handling high voltage trailing cables.
- Ensure that all coal mine workers handling high voltage trailing cables are competent to perform the task.

- Should be checking that workers handling high voltage trailing cables are complying with the requirements of their mine's SHMS.

- Always ensure high voltage trailing cable are handled as per the requirements of their mine's SHMS.

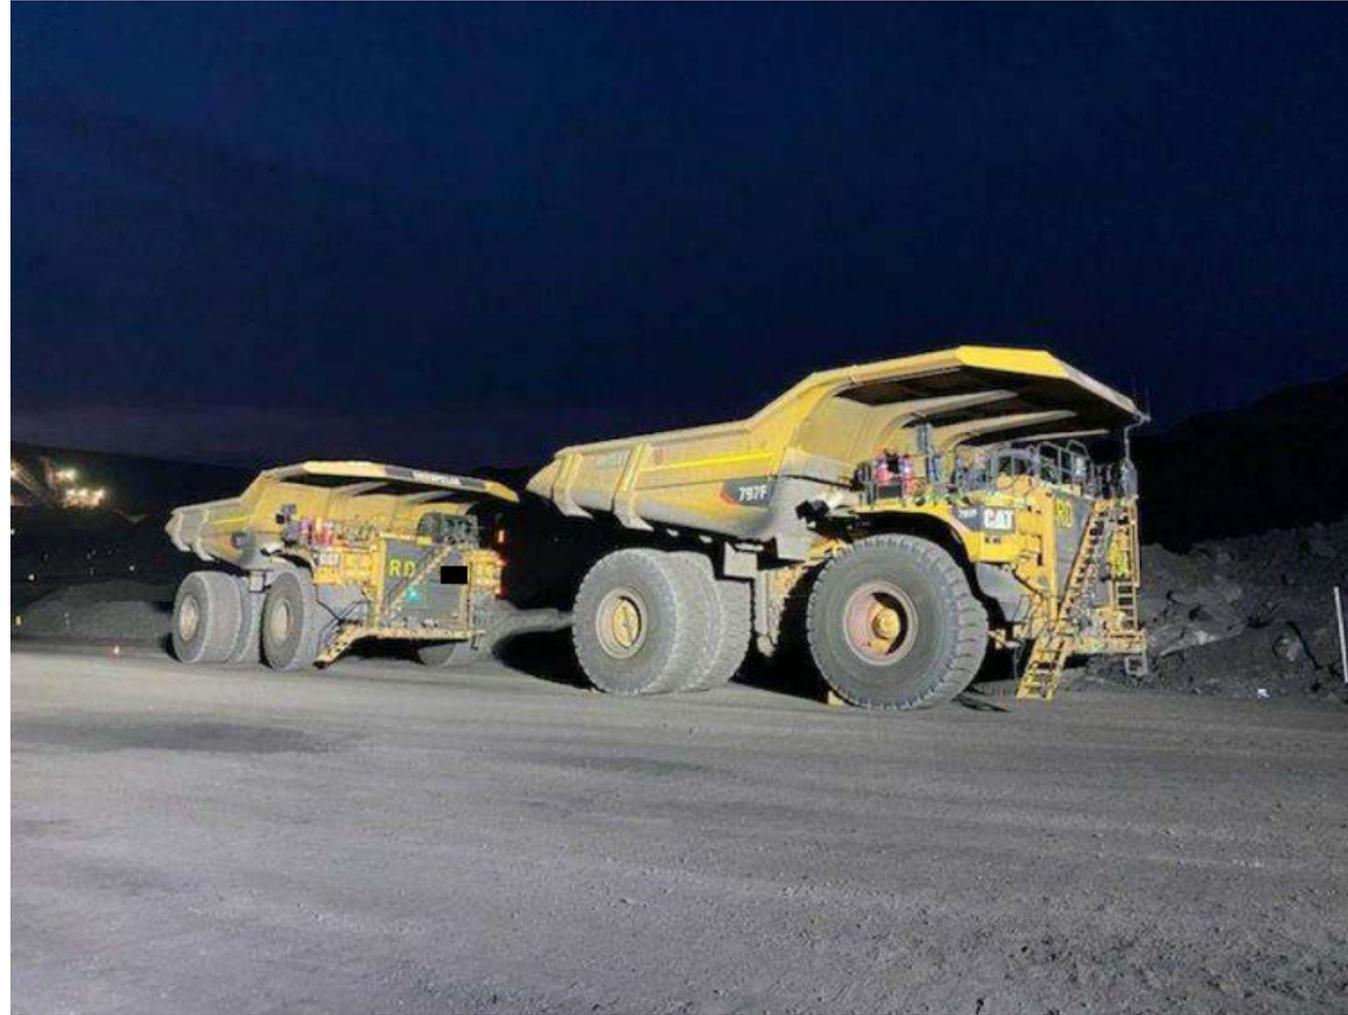
4. Incident – Equipment Collision – Surface Mine

- The operator of a large rear dump truck parked in a queue at a dig face with the truck left in gear and only the retarder brake applied.
- The operator has then fell asleep.
- The retarder brake released after a period of time, and the truck then idled forward and run into the tail of another truck that was parked in front of it.
- No injuries, but damaged handrailing resulted.

- Ensure the standard operating procedure for using mobile plant contains effective ways of minimising the risks associated with the parking of mobile equipment.

- Ensure the parking of mobile equipment is monitored and audited for compliance with the mine's procedure, and this may be done by periodically checking the vehicle's Vital Information Monitoring System (VIMS) data.

- Must always park mobile equipment as per the requirements of the mine's standard operating procedure for using mobile plant.

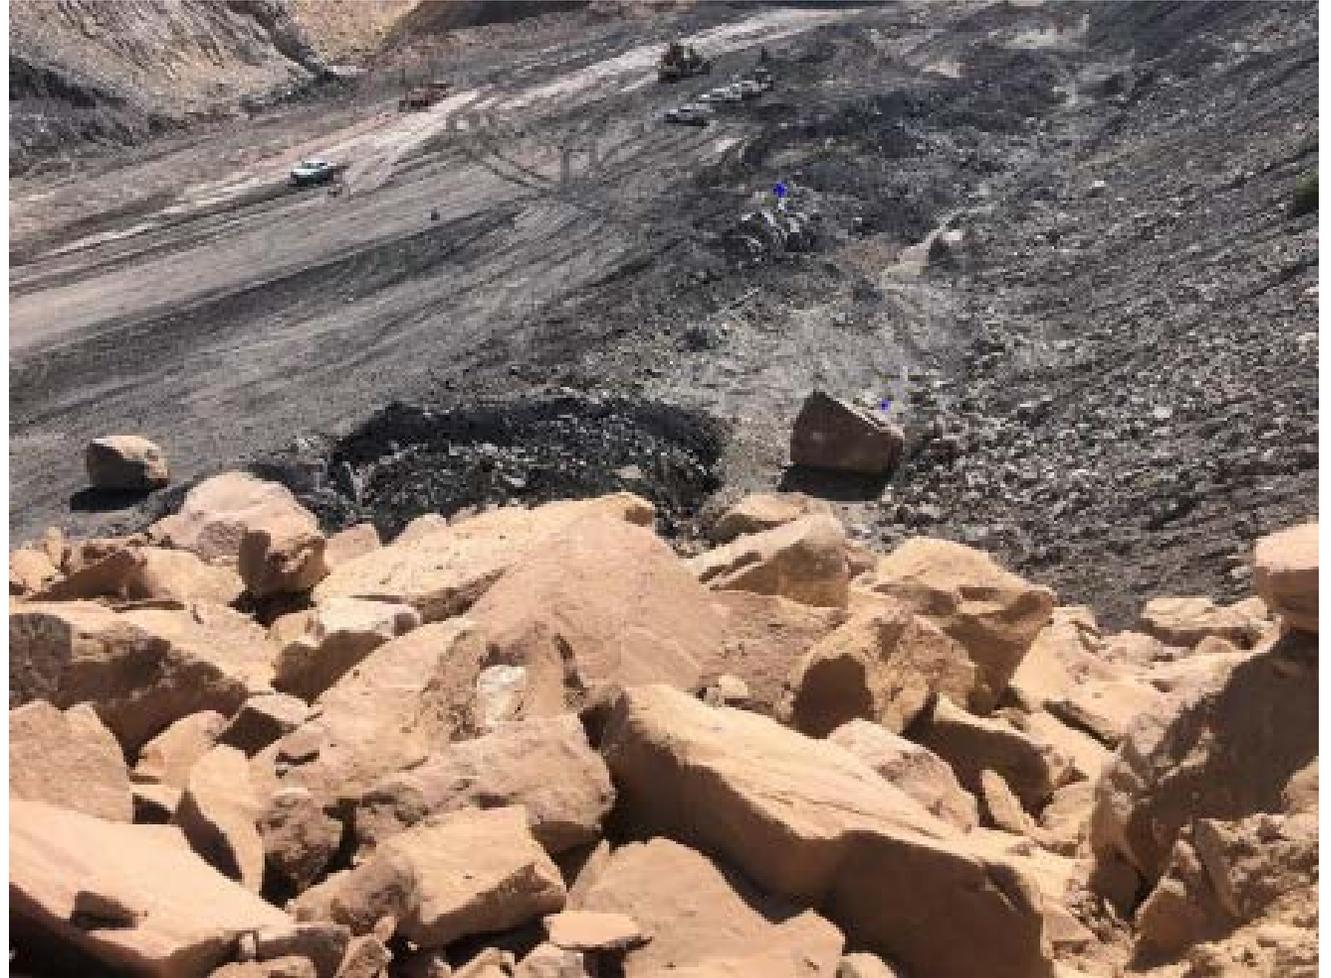
5. Incident – Failure of Strata Control – Surface Mine

- A dozer operator maintaining an active dump noticed a large rock had rolled down from the tip-head and breached the catch rill below the dump.
- The large rock ended up on the active access leading into an operating dragline's work area.

- Must ensure the mine's principal hazard management plan for ground / strata control has identified all potential risks and contains effective controls.

- Conduct shiftly inspections of active work areas checking that all of the required controls are implemented for managing strata, and the effectiveness of these controls is verified.
- Must ensure a check and examination of each coal mine worker's specific work area is carried out by the coal mine worker.

- To carry out their activities / work in a way that does not expose themselves or someone else to an unacceptable level of risk.
- Must check the condition of their work area before commencing the activity.

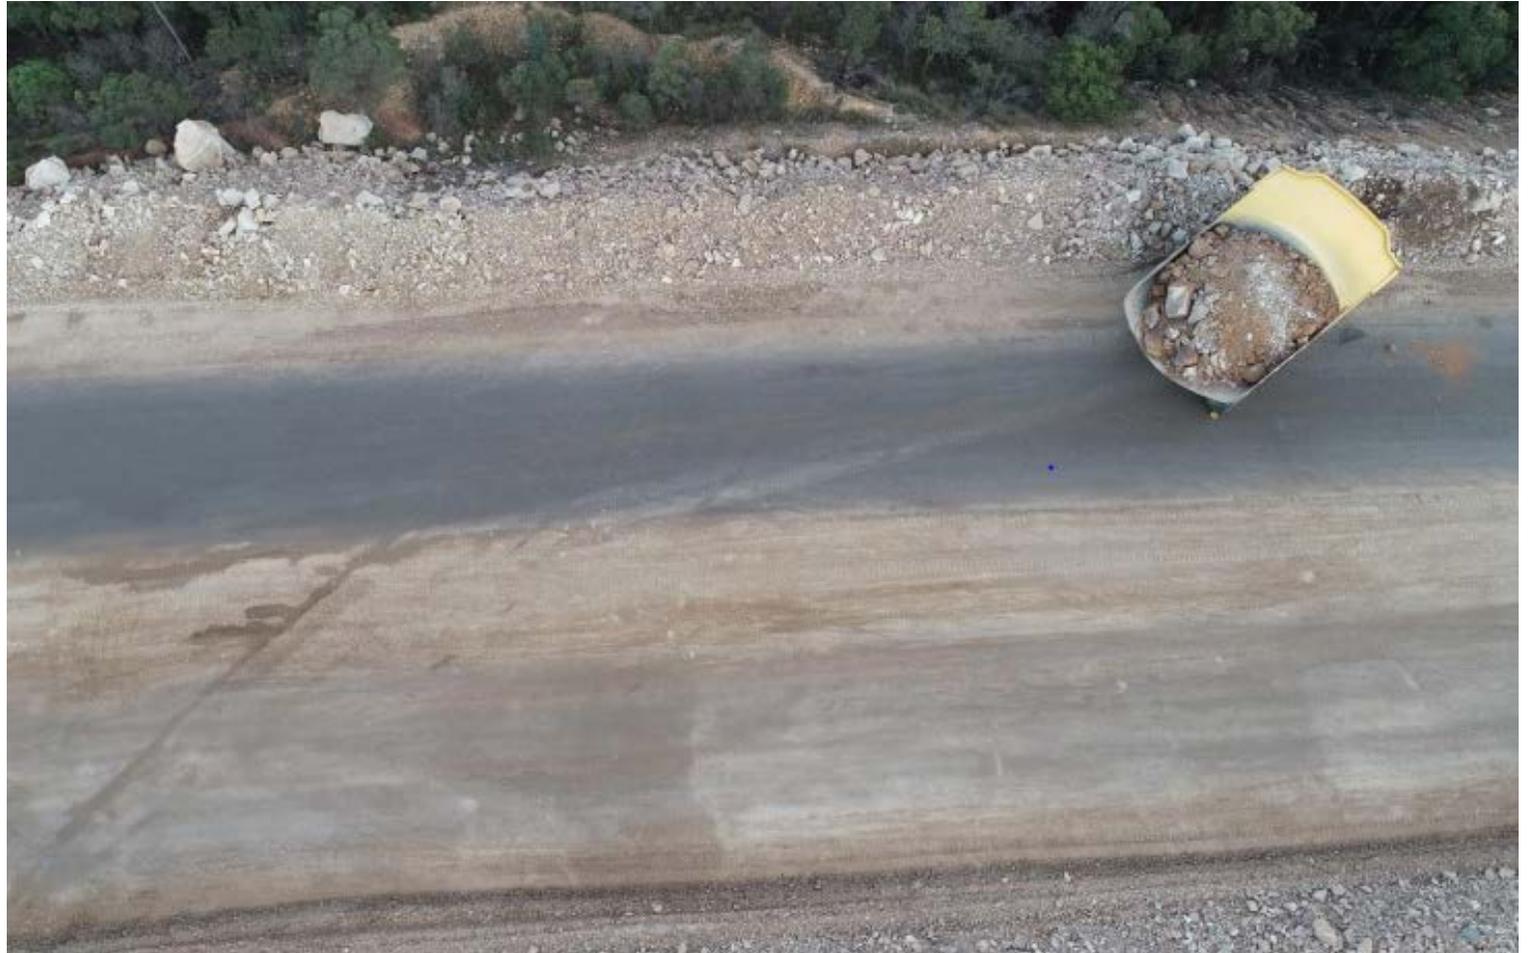
6. Incident – Microsleep – Surface Mine

- At approximately 5:00am an operator of a loaded rear dump truck travelling along a haulroad experienced a microsleep.
- This resulted in the truck contacting the haulroad's left hand side safety berm.

- Must ensure the coal mine's safety and health management system provides for controlling risks at the mine associated with the personal fatigue.

- Periodically monitor and check on the fatigue level of workers.
- Encourage workers to report any fatigue related issues.
- Adopt methods that may reduce the likelihood of fatigue, for example job rotation.

- Ensure they make the necessary pre-shift preparation required for managing fatigue.
- To stop and report any fatigue related issues that they may be experiencing.

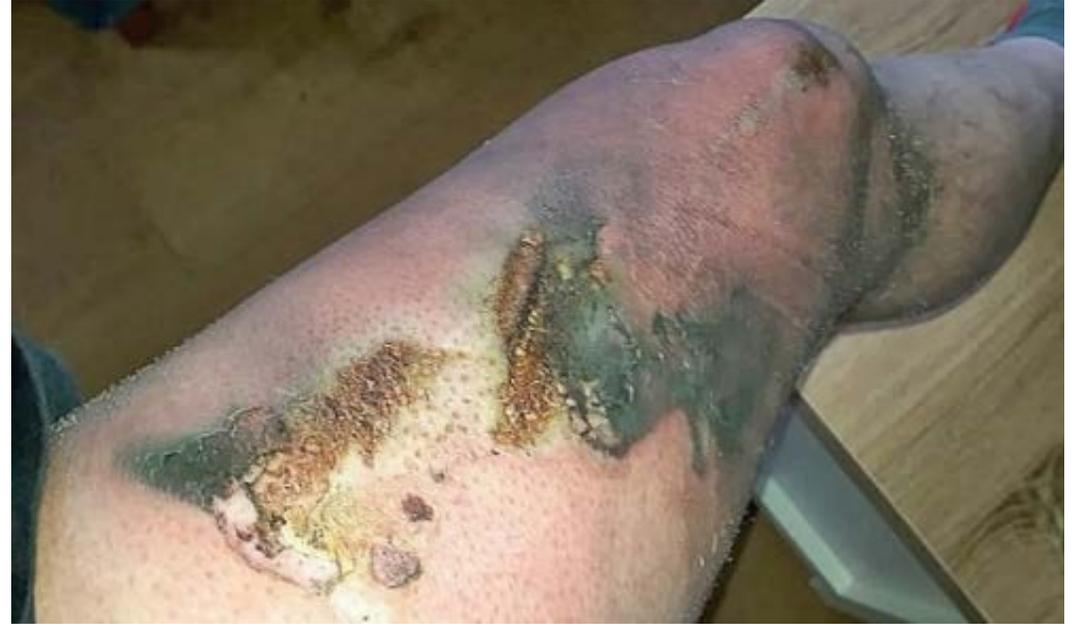
7. Hazards associated with the use of e-cigarette devices.

- In January 2021 the WA Dept of Mines received a report of an incident at a mine site where an electronic cigarette (vape) battery spontaneously ignited in a worker's pocket whilst he was travelling in a utility with two other workers. Statements described it as a combustion event not unlike fireworks going off and flying around inside the vehicle that they were travelling in. The worker received serious burns to his leg.

E-cigarettes contain interchangeable parts, often including extra-low voltage lithium batteries. Failure of these parts has been linked to ignition of E-cigarettes, with a number of incidences of burn injuries reported overseas. Many have been linked to overcharging and overheating of the batteries, causing the device to ignite or explode in close proximity to the user.

- Given the foreseeability of these occurrences and their potential consequences, the risks associated with carrying electronic cigarette devices (i.e. vaping equipment) on persons on site, particularly in hazardous areas, should be reviewed and preventative and control measures developed and implemented.
- Refer to “[Mines Safety Bulletin No. 181](#)” issued by WA Department of Mines, Industry Regulation and Safety.
