December 2023 Incident periodical

Recent High Potential Incidents
Risk Controls identified by mine-site investigations
Communications

Queensland Coal Mines Inspectorate

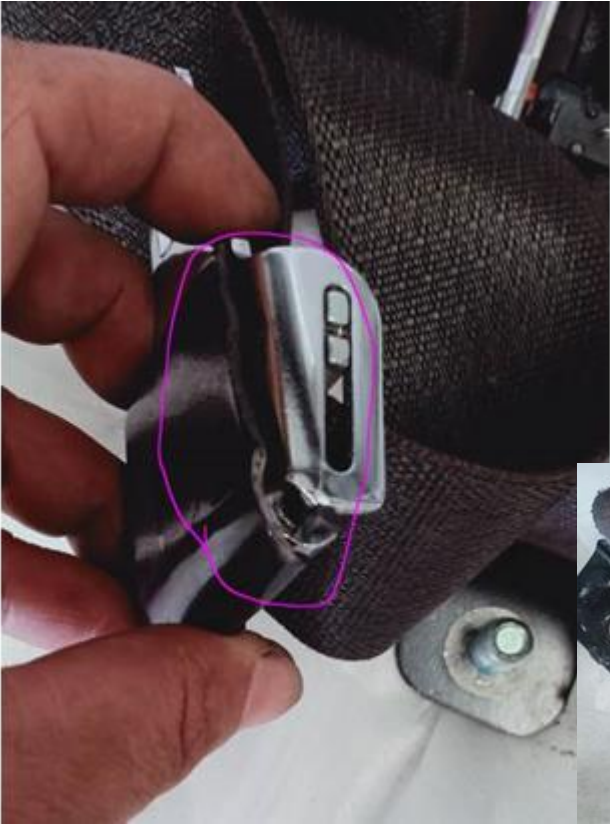
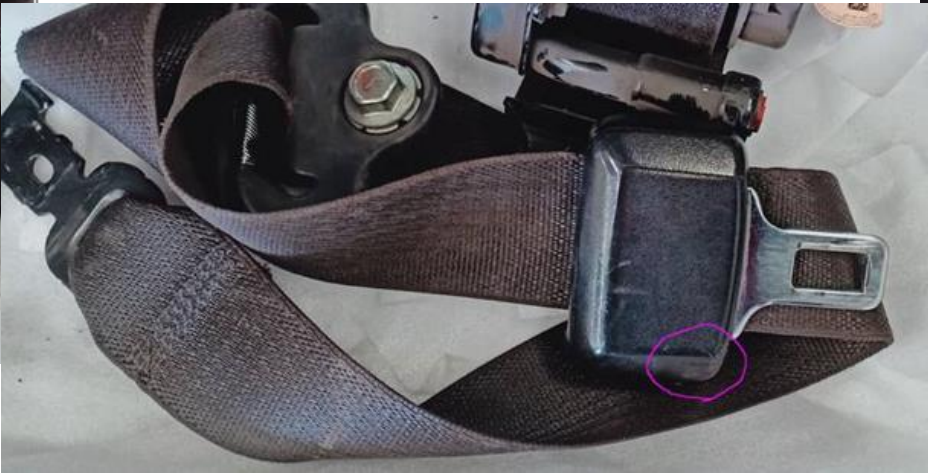
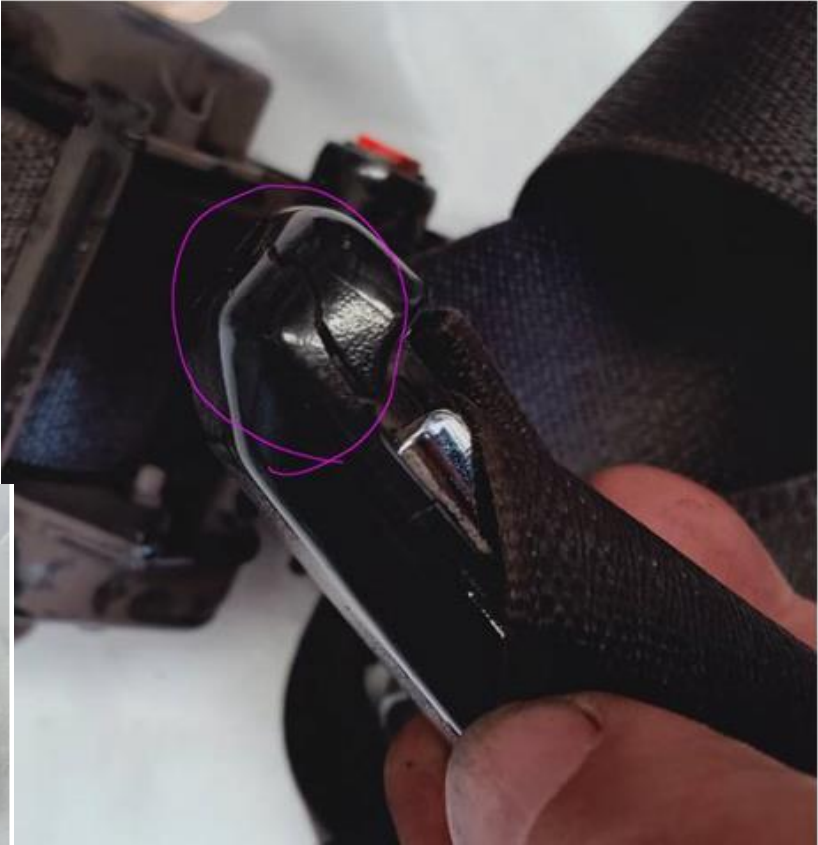
Ineffective seat belts

- A coal mine recently found several vehicles (all Utes) had defective seat belts.
- The seat belts were reported to unlatch while the vehicle was in motion.
- 101 vehicles were inspected at the mine; 6 were identified as having defects with seat belts.
- Seat belts had cracked plastics around the tongue and/or failing tongue integrity.
- Seat belts had latch assembly failures where the seat belt pulled out of the latch when tested.
- The cause of the “unlatching” failures has not been categorically confirmed however evidence suggests dust ingress is a potential contributor.

- Why are the mine's prestart checks not adequately covering the inspection and function checks of seat belts?
- Why are the field task observations / safety interactions not ensuring compliance to your SHMS, every day on every shift?
- Should site vehicles be audited every day/week/month/ year for seat belt integrity and functionality?
- Who checks the effectiveness of your site maintenance systems for seat belt inspections, on both light and heavy mobile plant?

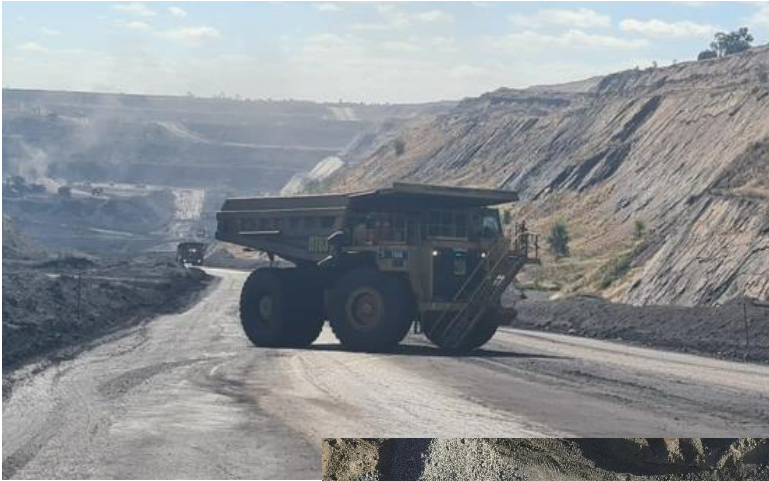
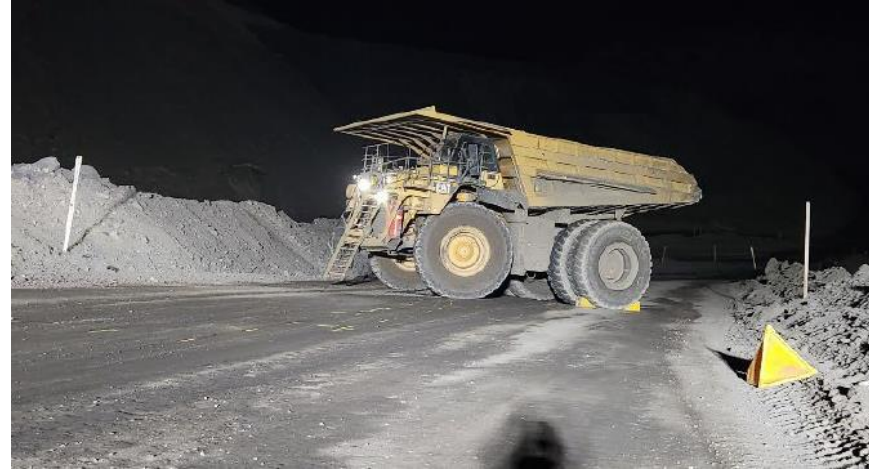
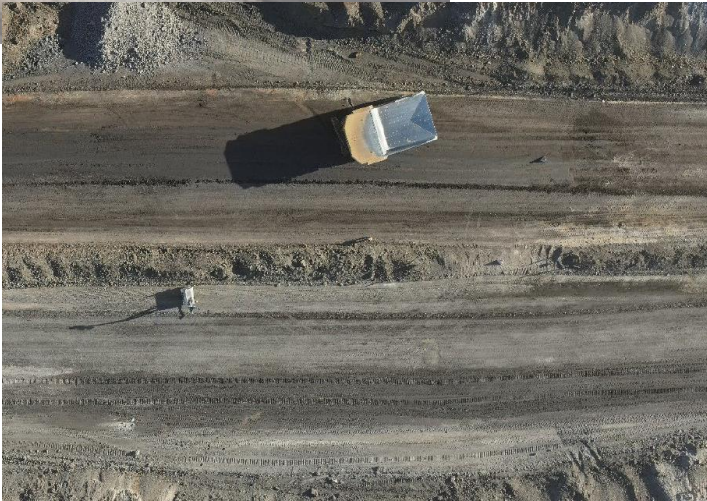
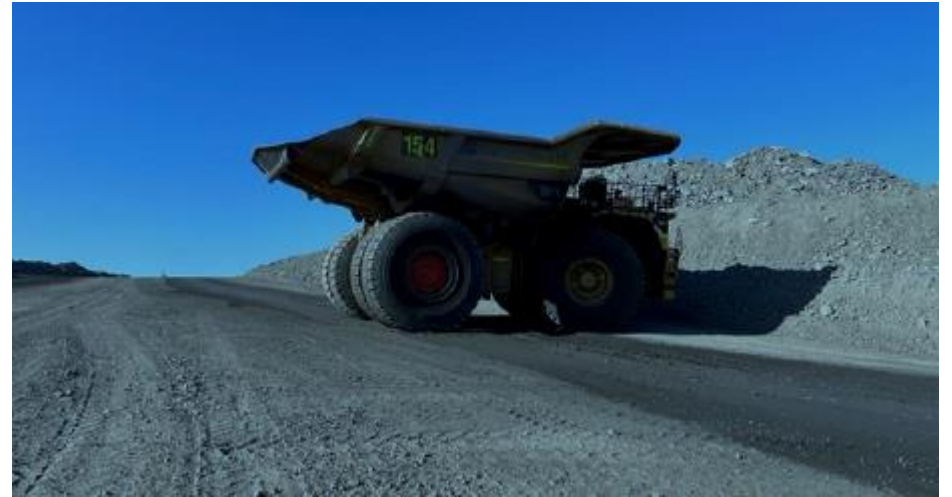
Loss of control of dump trucks

- 11 notifications in September reported that coal mine workers had lost control of a dump truck.
- Multiple events occurred at three mines.
- Single events occurred at four mines.
- Every event occurred when the dump truck was travelling downhill.
- Fortunately, all the trucks stayed on their wheels.
- Some trucks did cross into the uphill lane during the loss of control event.

- Daily inspection sheets to be completed by supervisors/OCE.
- Appropriate actions to be taken at time of inspection.
- Educate CMW's through toolbox talk.
- Conduct a spot spray trial for down ramps only.
- Reminder to truck operators for first load down a ramp to take it easy on gear selection.
- Retrain truck operator and retest in wet conditions.
- Add in the SOP packs to the new starter training packs so truck operators can read between sessions.
- Create SWI outlining the requirements and responsibilities involved in watering circuits with all water carts.
- Retrain truck operator on low traction training.

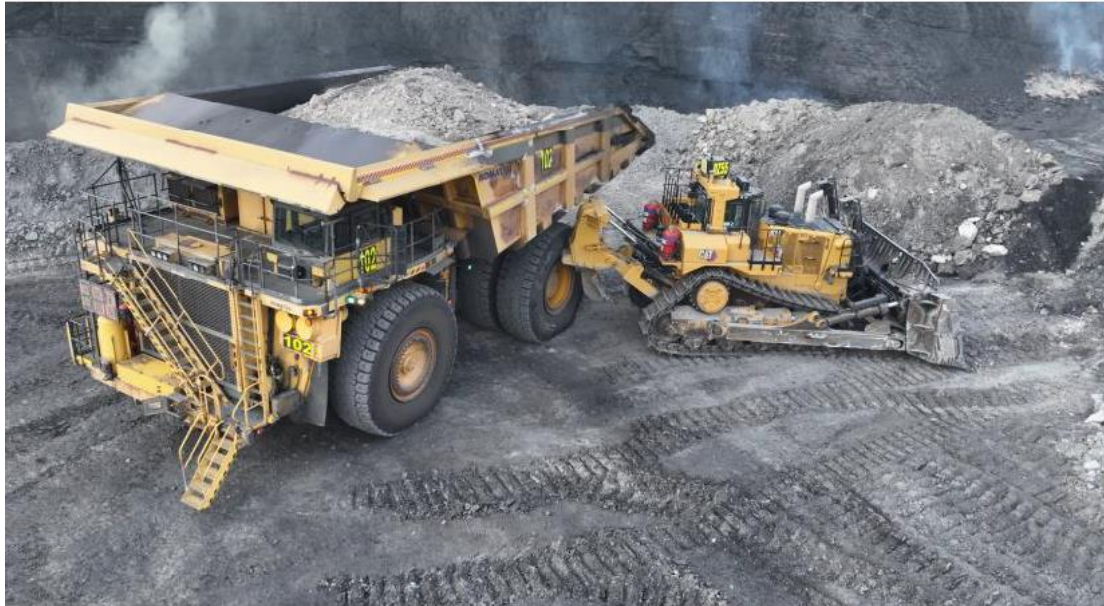
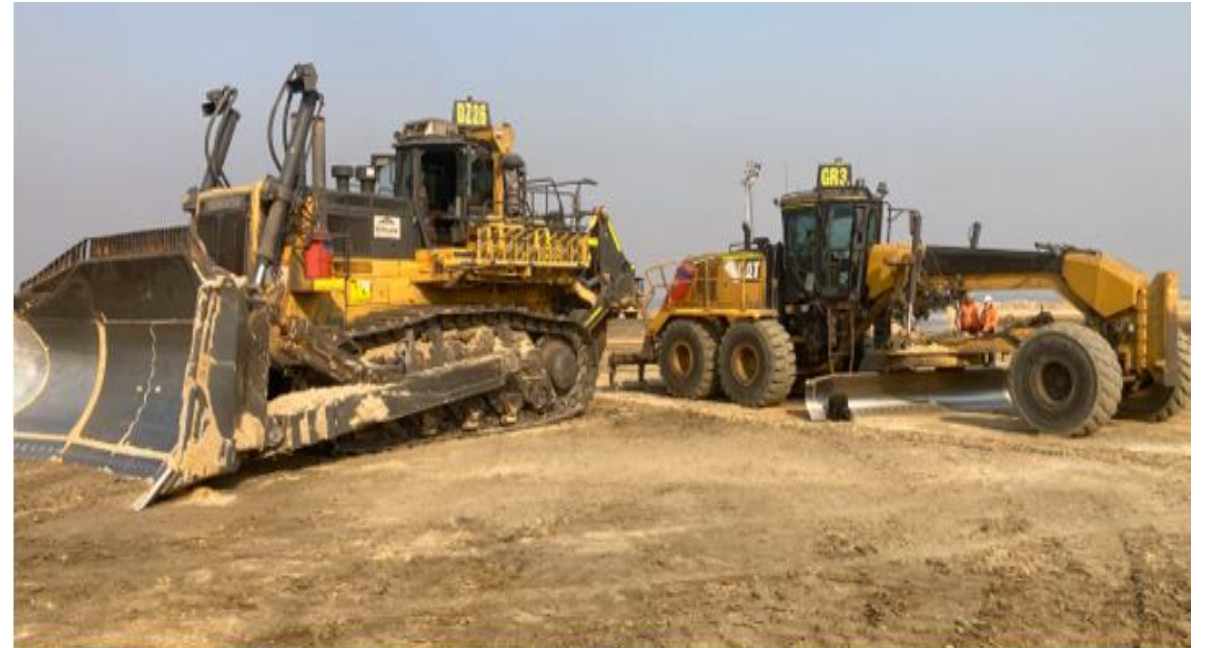
Collisions at dumps and dig faces

- 11 collisions were reported during September.
- Most collisions happened on dumps or at dig faces.
- One coal mine worker reported an injury.
- Positive communication between equipment operators was made before some of the collisions occurred and did not prevent it.

- Positive Communications between the vehicle operators.
- Share DZXX and RDYYY incident and learning with mining teams.
- Follow safety compliance protocol with operators involved in DZXX and RDYYY incident.
- Mining equipment to keep headlights on at all times, even while queuing.
- Toolbox on positive communication and site SOP refresher.
- Review truck and dozer operations training package and remove any reference to switching headlights off while waiting in a queue.
