# June 2020 Incident periodical

Recent High Potential Incidents  
Learnings and Recommendations  
Queensland Coal Mines Inspectorate

Coal Inspectorate

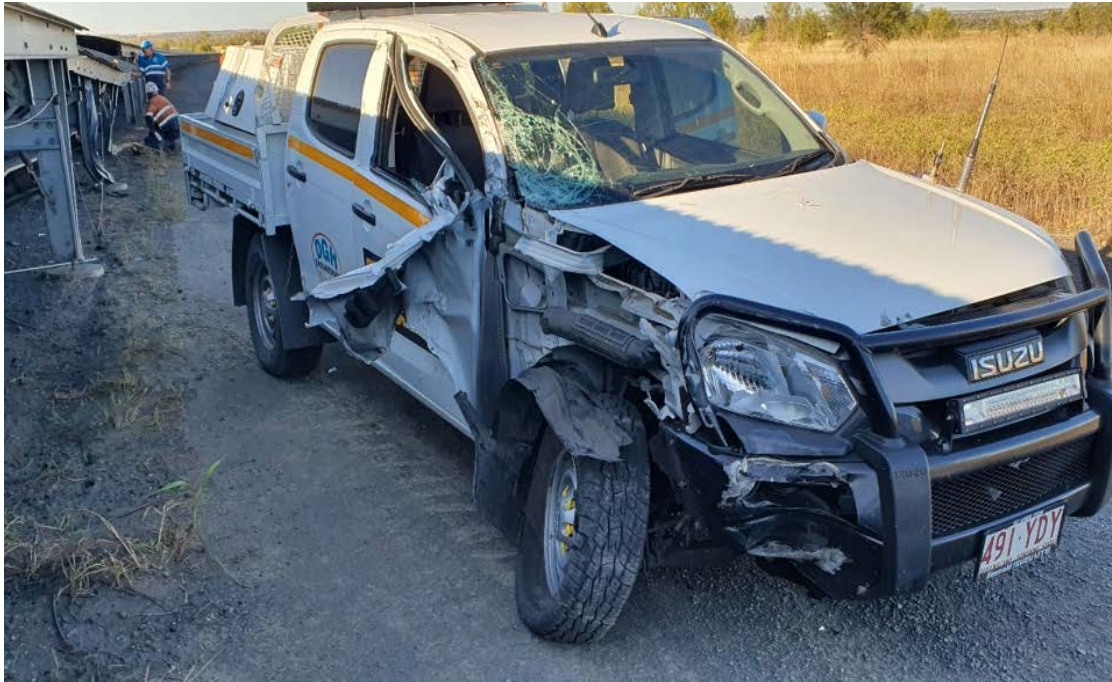
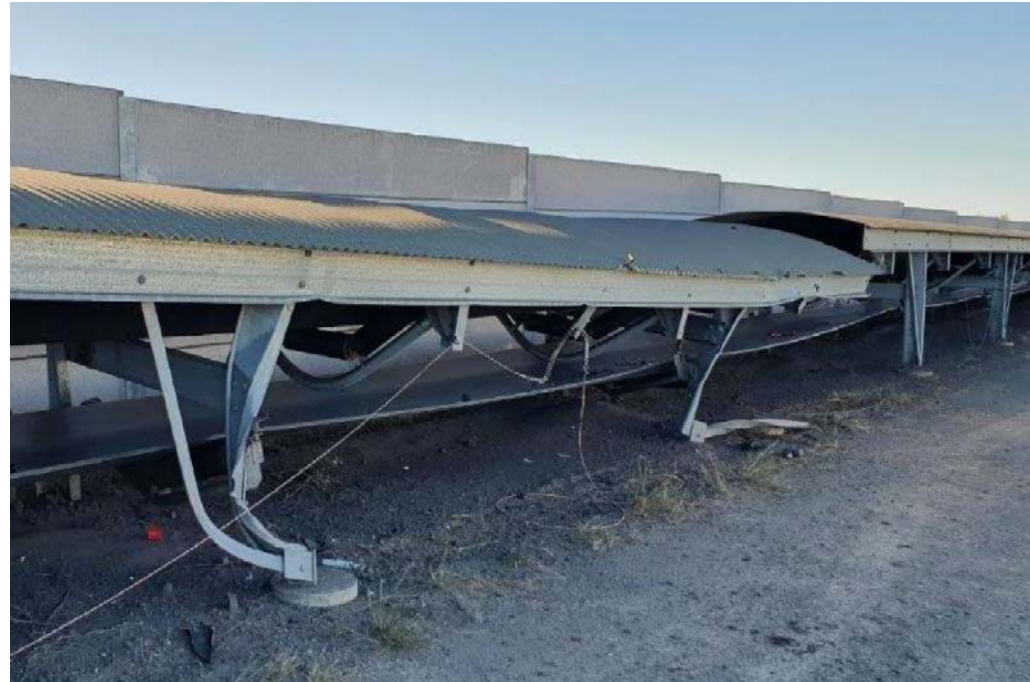
# Incident - Light vehicle collides with Conveyor

1. A light vehicle with four occupants collided with a conveyor structure.
2. There were no injuries, however significant damage occurred to the vehicle and conveyor system.

- Ensure mine specification for the design and construction of mine roads has been mapped against the requirements Recognised Standard #19.

- Ensure all mine roads, including the surface area of underground mines, are audited for compliance to the mine's specification for the design and construction of mine roads.

- Ensure they abide with the mine's traffic rules and fitness for work provisions.
- Be acutely aware of the dangers associated with driver distraction

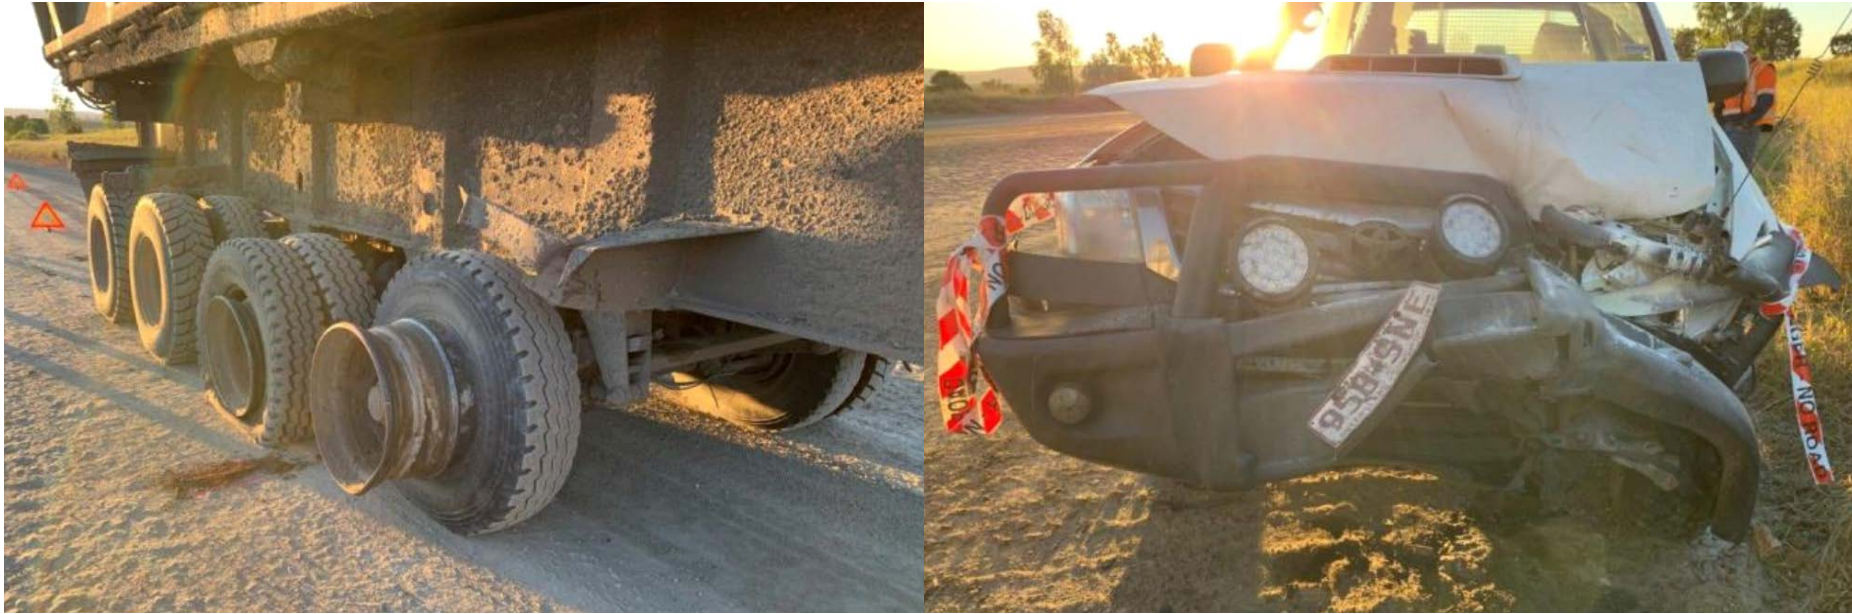
# Incident - Light vehicle collides with road train

- A light vehicle collided with the rear trailer on a dual powered road train pulling 5 trailers.
- The LV driver claimed to have been changing mine radio channels when he looked up and was approaching the rear of the road train at speed.
- The LV driver took evasive action to prevent a collision with the rear of the truck, but over-corrected the steering which then caused the light vehicle to swerve into the first and second tyre of the 5th trailer.
- The LV was travelling at approximately 60 kph and the road train was travelling at 18 kph going uphill.

- Ensure their safety and health management system and the actual mine roads have been mapped against the requirements of Recognised Standard #19 “Design & Construction of Mine Roads”.

- Ensure their mine’s procedures for operating mobile equipment are followed and complied with to achieve an acceptable level of risk.

- Must be acutely aware of the dangers associated with driver distraction, and in cases like this pull off the road and stop before attempting to change mine radio channels.

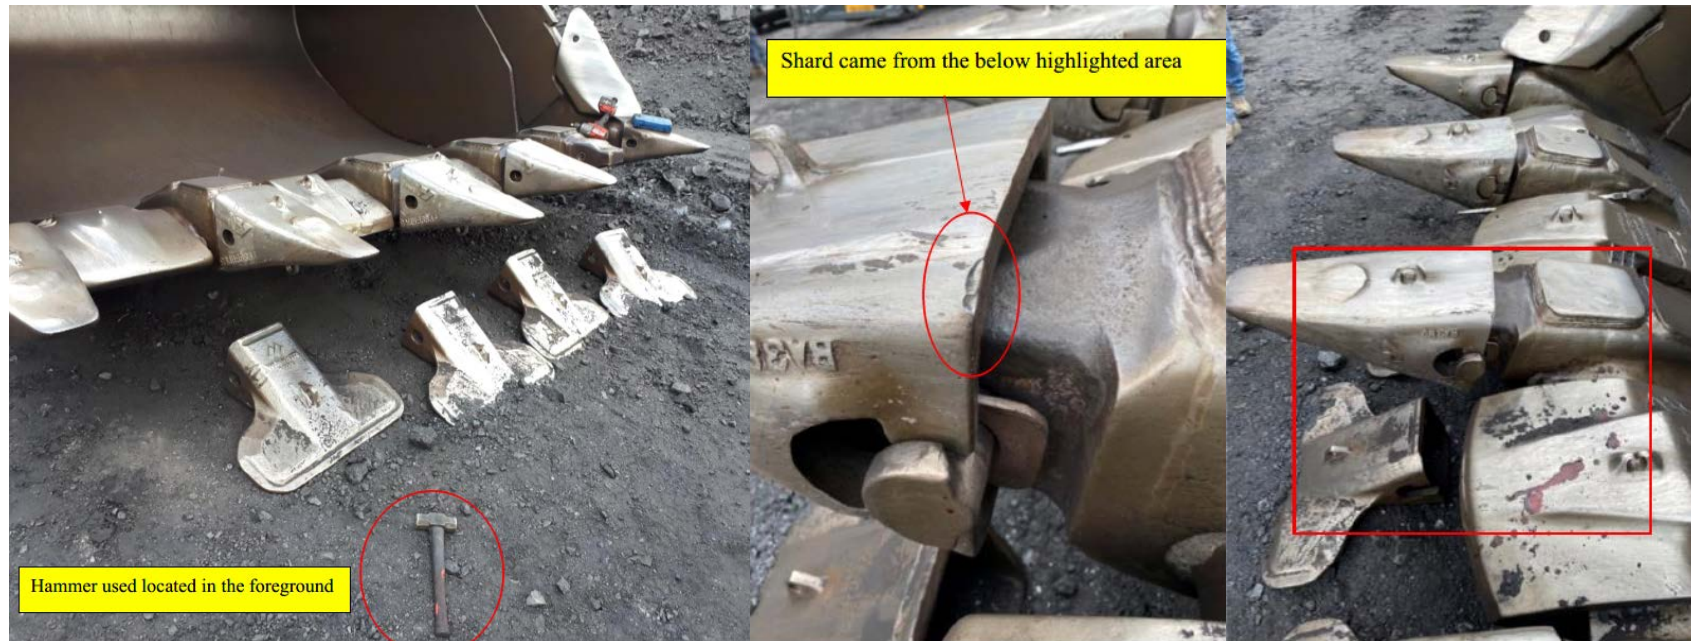
# Incident – Metal Shard Injury

- A coal mine worker (CMW) replacing GET on an excavator bucket, when the tooth being fitted became jammed in wrong position to allow fitment of the retaining lock. The piece of GET was required to be relocated back off the bucket adaptor to expose the locating hole in which the retaining lock was to be fitted.
- The CMW chose to use a hard face hammer to try and knock the GET back off the adapter when a piece of hardened shard was chipped off the tooth projecting it in to the CMW's L/H forearm resulting in a deep laceration. The CMW was then transported to a hospital for further treatment

- Ensure their procedures / safe work instructions for conducting this type of work state ways of controlling all potential hazards associated with the task so an acceptable level of risk is achieved

- Ensure adequate resources are provided (in this case soft face hammers).

- Ensure check for potential hazards prior to commencing a task.

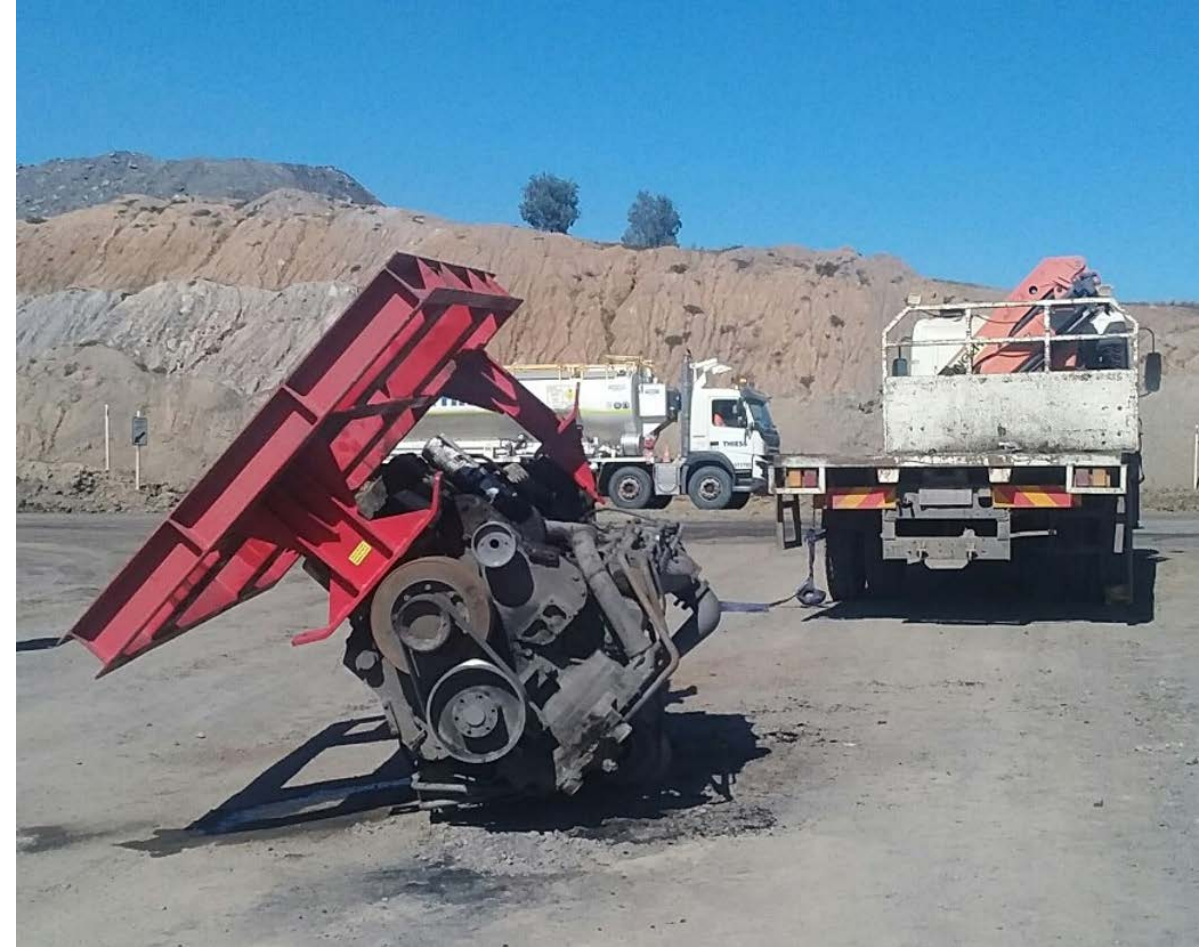
# Incident – Loss of load

- An engine mounted on a stand has fallen from a truck onto a haul road during transit.
- The engine and stand weighed approximately 6 tonne, and was secured on the truck by two ratchet straps. There was no dunnage or non-slip matting present between the cradle and the truck bed.
- Upon moving off from a stop sign on the ascent from the pit, the cradle and motor moved towards the rear of the truck bed snapping the restraints.
- No persons were in the vicinity at the time.

- Ensure the relevant coal mine workers are trained in the appropriate methods to secure loads being transported (Load restraint limits and ratings).

- Ensure that persons under their supervision are trained, competent, and understand the risk and controls required to undertake the task they have been allocated

- Ensure appropriate measures are in place to prevent any uncontrolled movement of loads being transported.

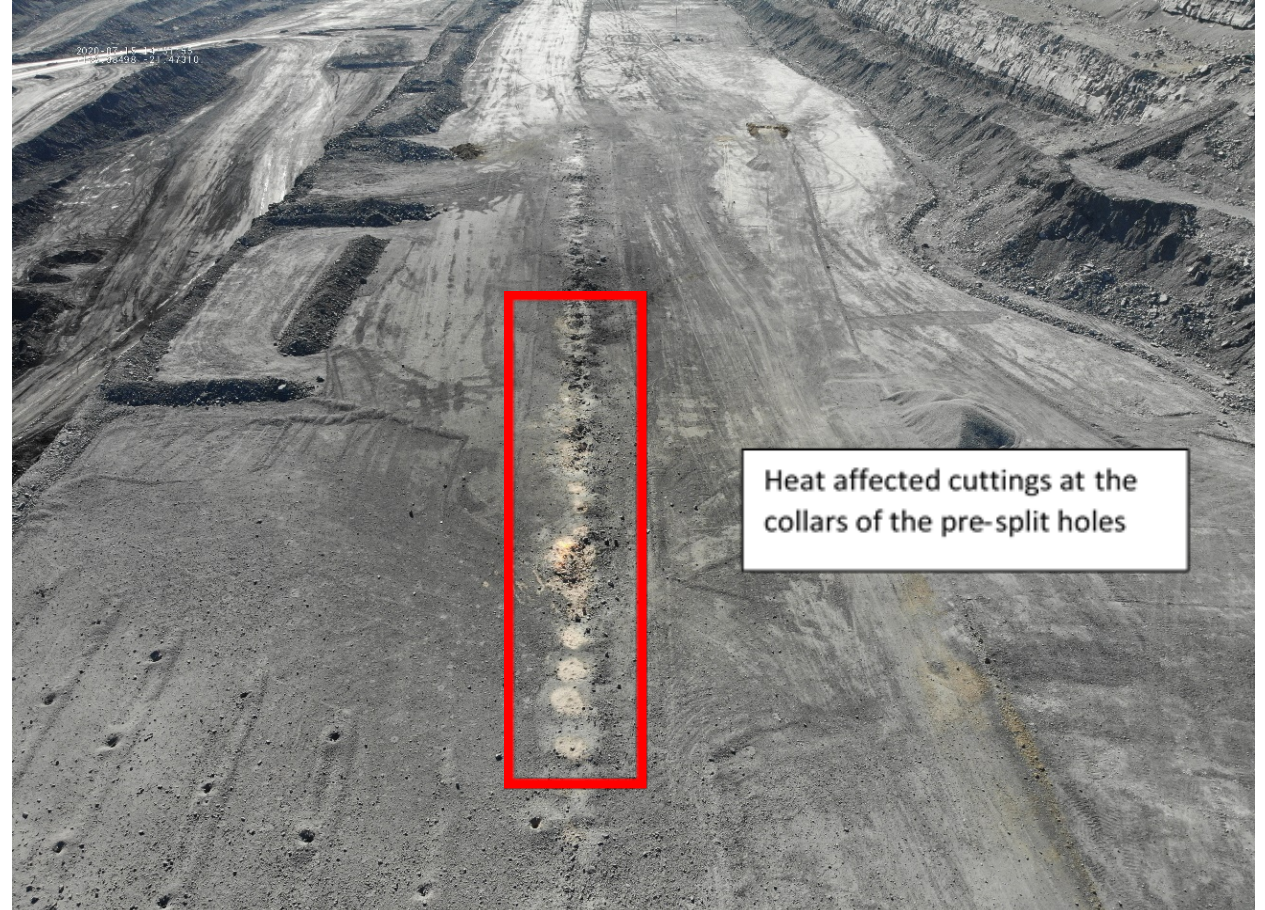
# Incident – Ignition of Gas – Surface Mine

1. A pre-split blast was fired at the same time as a production blast
2. During the post blast inspection, flame was observed along the pre-split line
3. Gas contained in the strata had been ignited by the blast.
4. The working area was quarantined and a plan to extinguish the flames prepared, risk assessed and implemented.

- Ensure the management of gas is considered in all aspects of the operation and appropriate management plans are developed to control the risk

- Identify the hazard or the presence of flammable gas in the mine so as appropriate risk mitigation strategies are implemented.
- Consider undertaking gas content and emission monitoring during exploration and blasthole drilling to identify the hazard prior to the loading design phase.

- Gas monitoring equipment used by coal mine workers to be suitable to detect the presence of flammable gas, including the availability of equipment to take gas samples from below the collar level of the blastholes.

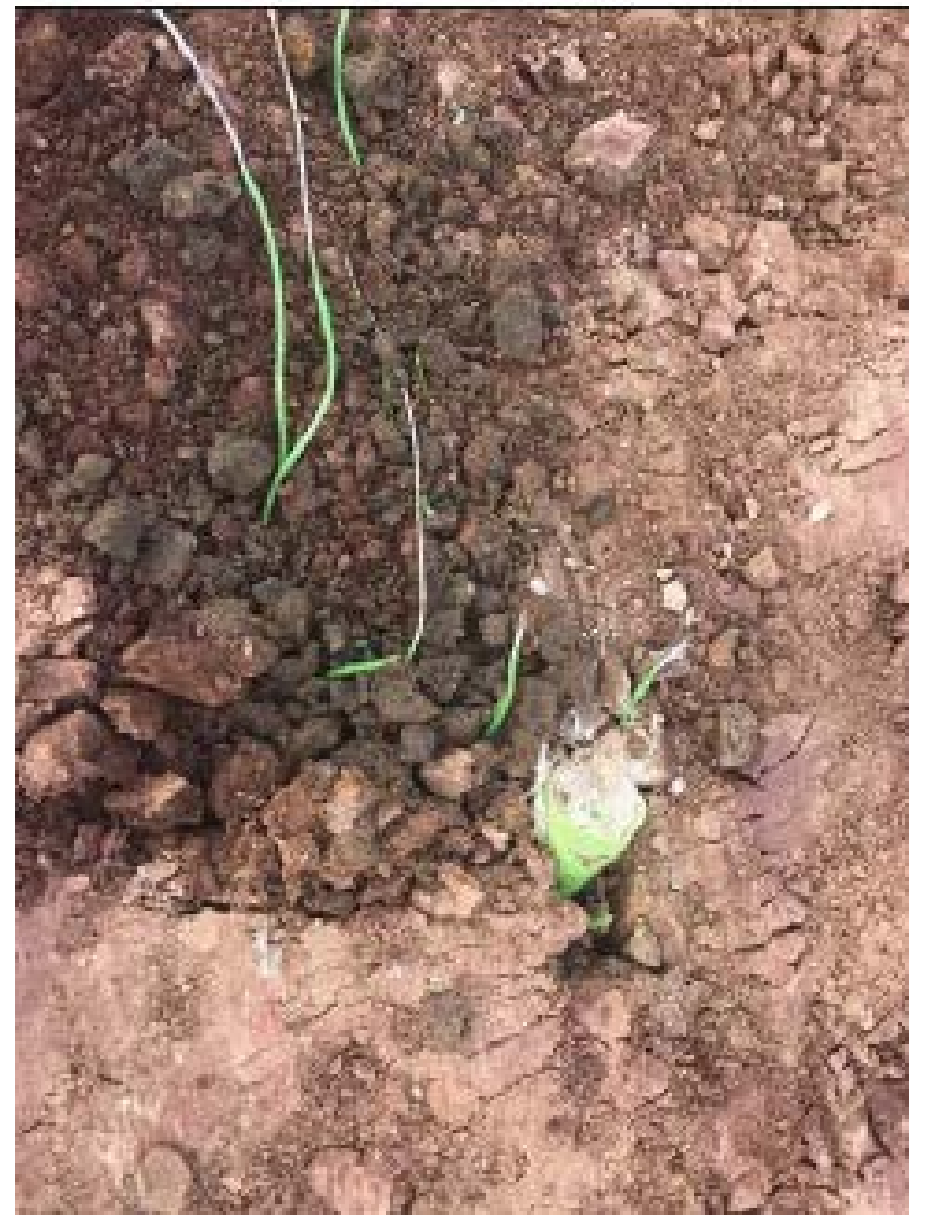
# Incident – Undetonated Primer

1. An undetonated primer was uncovered by a grader operator working on a pit bench 6 months after the blast.
2. The nonel signal tube had been pulled out of the detonator crimp, removing the firing signal.
3. Wet weather during the loading process may have affected the bulk explosive product and allowed hole slumping to occur.

- Ensure the management misfires is considered in all aspects of the operation and appropriate management plans are developed to control the risk

- Ensure blast designs and blast scheduling include reviews of weather forecasts, prior to explosives loading activities taking place, and subsequent appropriate product selection
- Ensure video reviews of blasts are used for detecting anomalies in the blast.

- Blastholes not expected to fire as per the design, such as known slumped holes, or electronic “no reads”, which the shotfirer has been unable to remediate prior to firing, should be considered a misfire hazard until the entire blast area has been excavated.

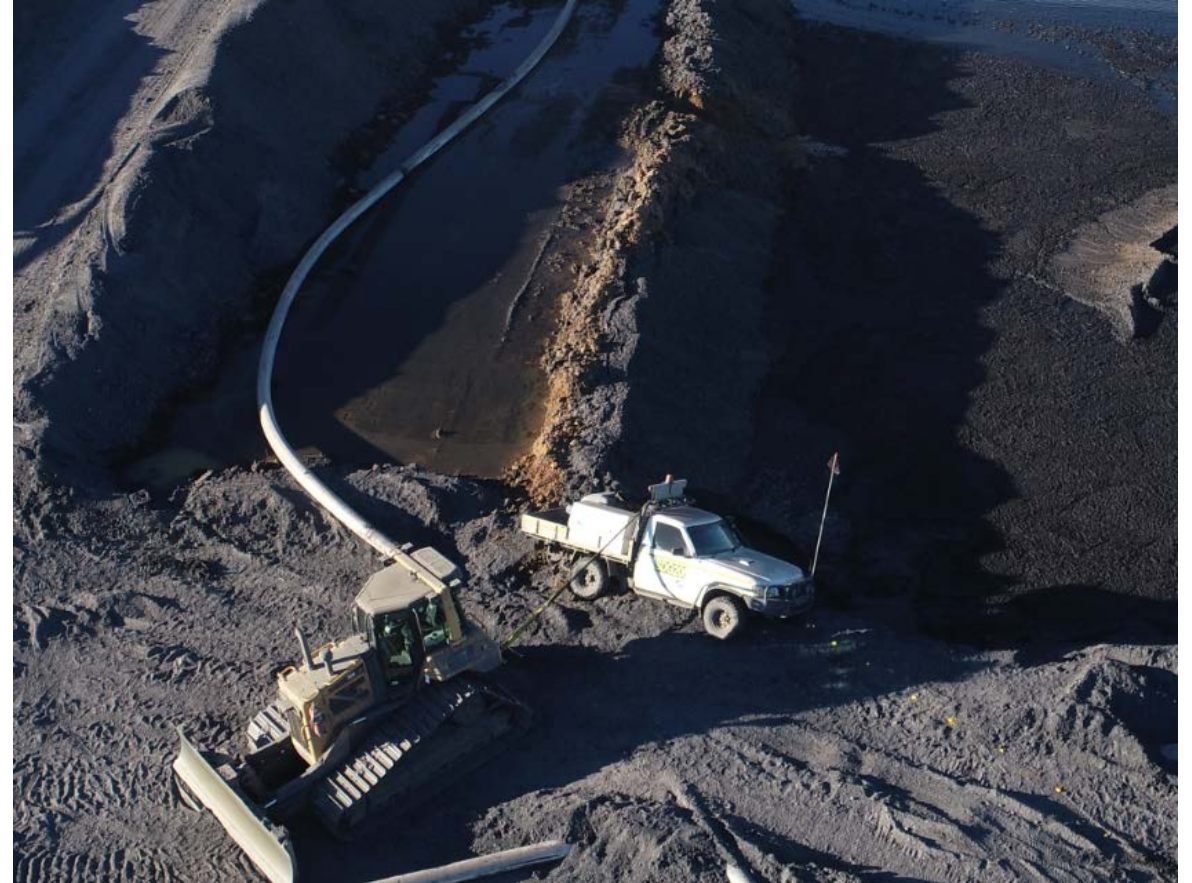
# Incident – Bund protection near water bodies

1. A coal mine worker had a near miss when operating a light vehicle next to a water body
2. The coal mine worker made an error while reversing the light vehicle, which led to an emergency recovery operation
3. The incident occurred during the hours of darkness.
4. Insufficient bunding contributed to the incident

- Ensure mine specification for the design and construction of mine roads has been mapped against the requirements Recognised Standard #19 with special attention to access around bodies of water

- Familiarise yourself with the standards for bunding around water bodies and ensure work areas are safe for coal mine workers and that access to areas requiring to be brought up to standard is prevented.

- Coal mine workers must inspect each work area for safety before commencing work and unless the work area is safe, not commence work .

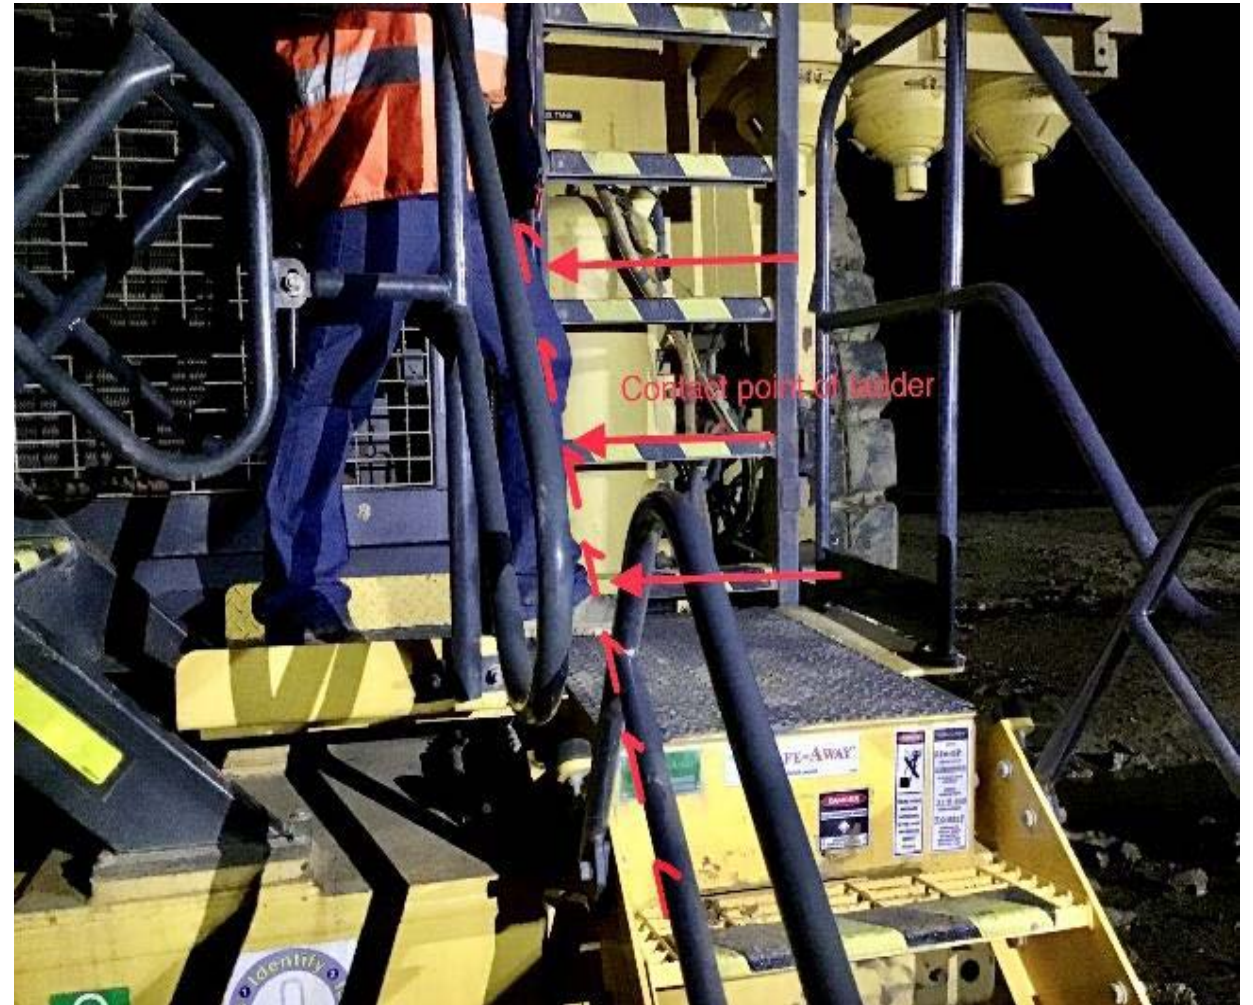
# Incident – Mobile equipment access

1. A coal mine worker was struck by a moving stairway on a truck.
2. The worker has responded to an alarm that the stairs had failed to raise.
3. The worker placed one leg into the space when the stairs raised and struck the worker on the leg.

- Consider the establishment of “No Go” zones, or restricting access where a retractable ladder has the potential to move into a space that a coal mine worker might occupy.

- Design of retractable ladders should be reviewed and modifications identified that ensure workers cannot be caught between stationary and moving parts, with reference to lessons from Safety Bulletin 185 being applied to all mining mobile equipment on site.

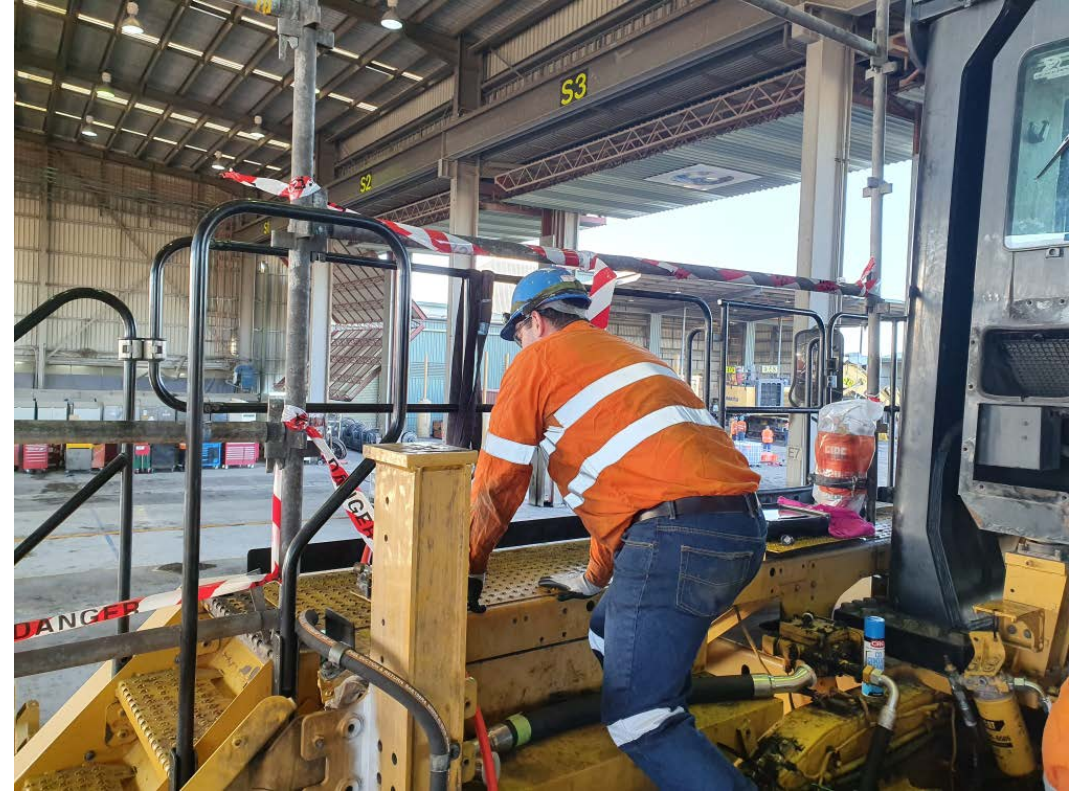
1. A coal mine worker received an injury to their head/neck when climbing out of the engine bay of a machine.
2. The worker hit their helmet on the fall protection scaffolding that had been installed on the walkway beside the engine bay.
3. The worker suffered some persistent adverse effects for a period following the knock to the head.

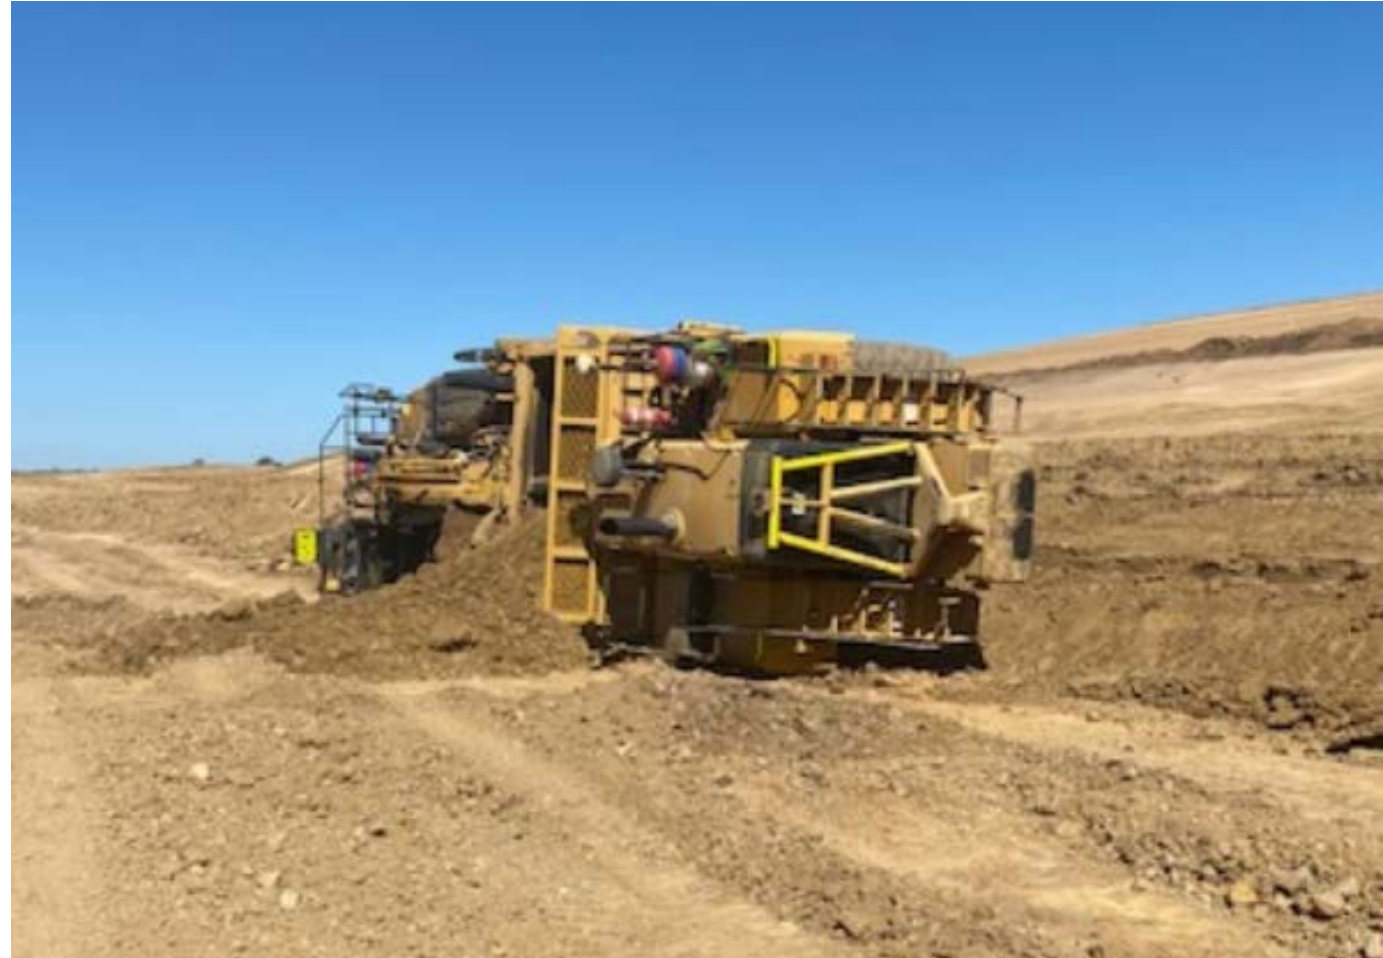
1. A loaded scraper has rolled onto its side when endeavouring to traverse from a lower level bench up onto a higher level bench.
2. The operator was not injured in this incident.

- Work area inspections checking for hazards must be conducted by supervisors, open cut examiners and coal mine workers prior to work commencing.

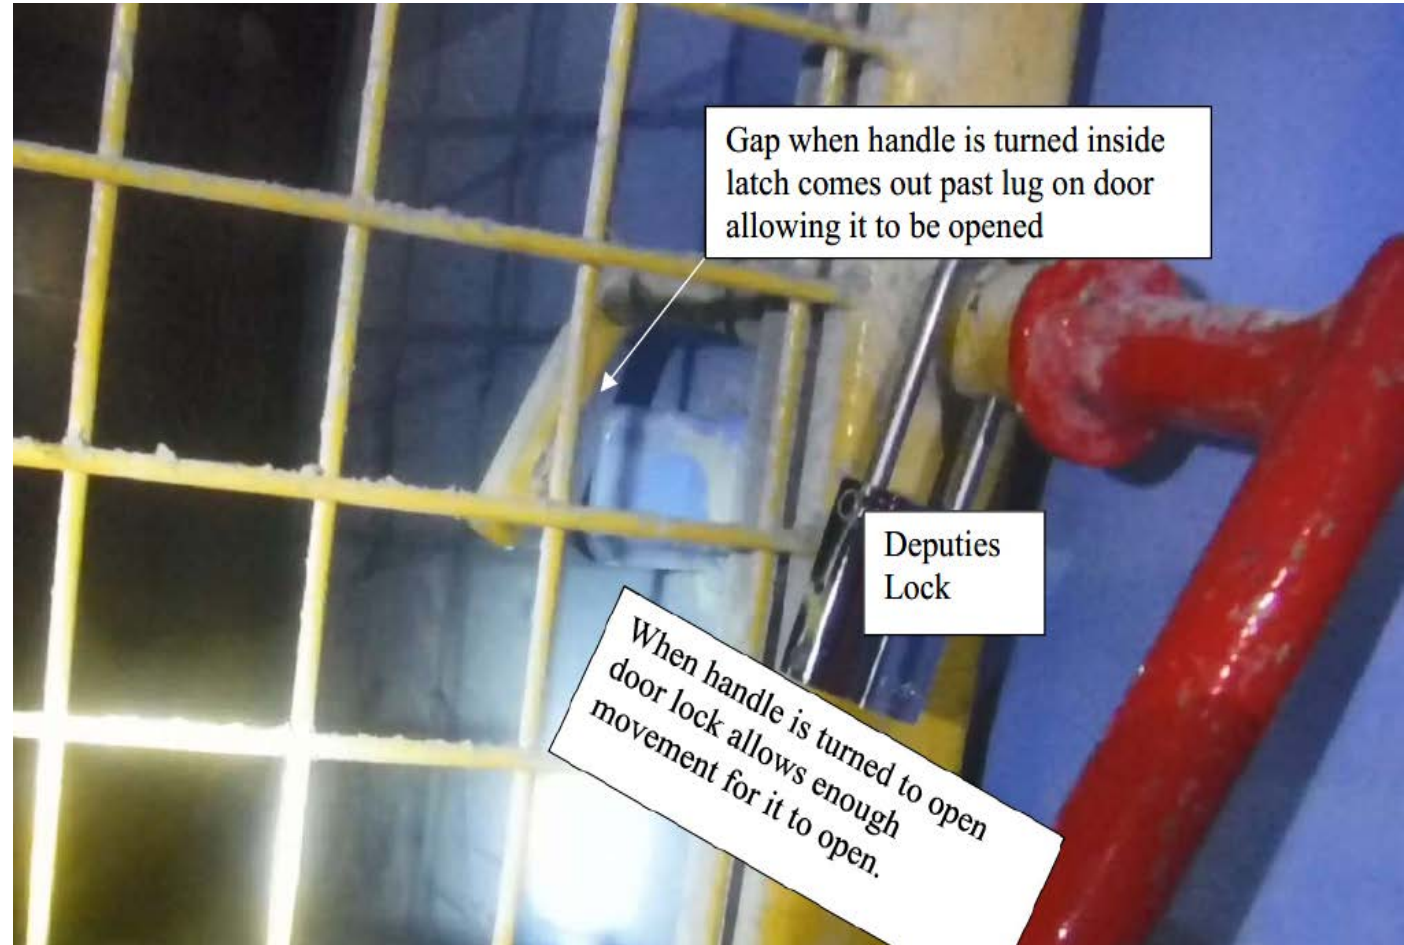
1. When testing the locking mechanism on a newly installed final Seal Hatch door as part of the seal up it was found that the locked mesh hatch door could be opened with minimal amount of force.

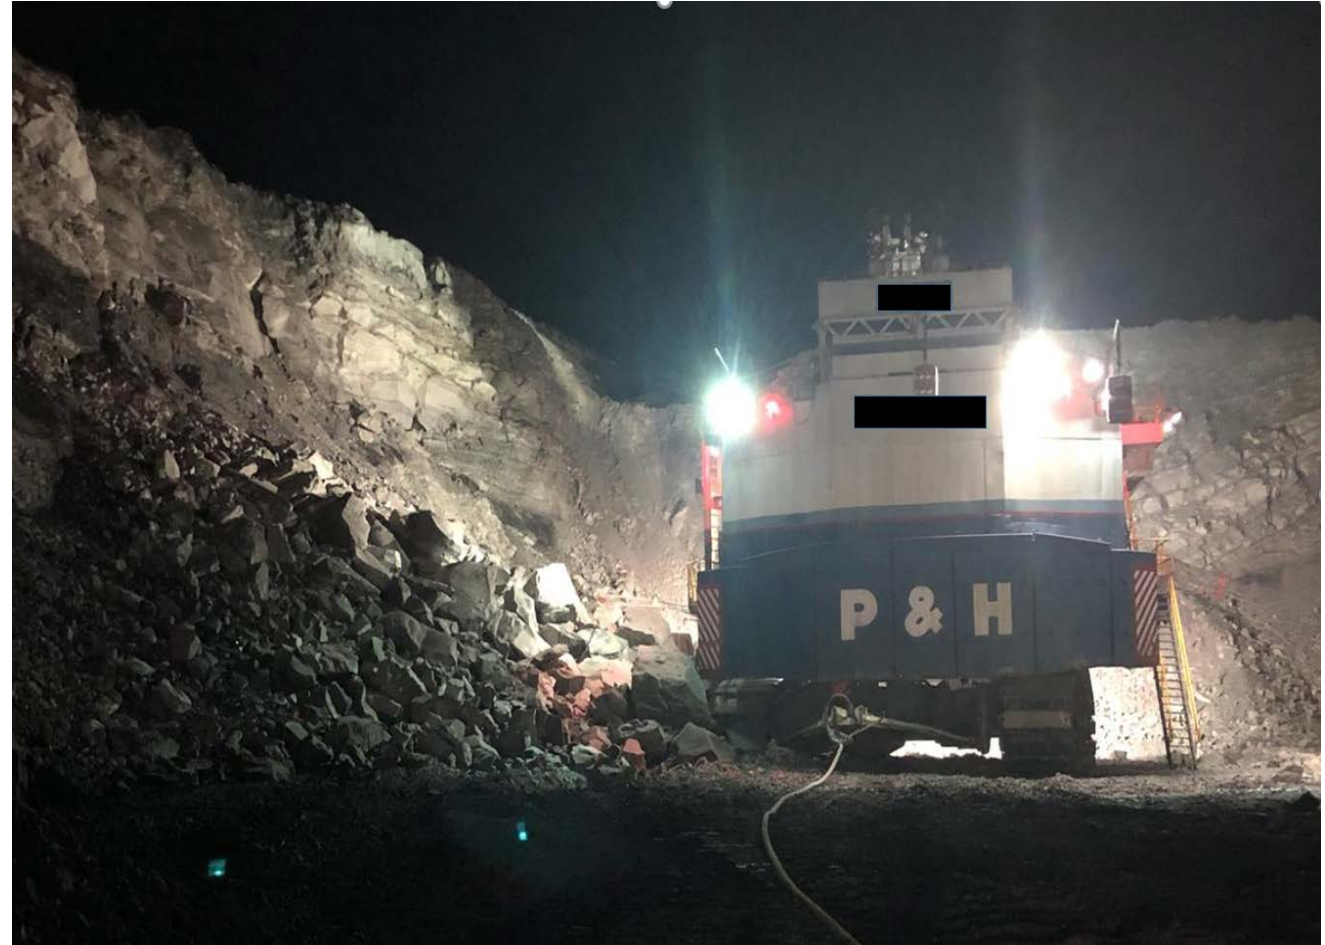
# Incident – Highwall failure – Surface Mine

1. During pre-strip operations a section of highwall failed resulting in fallen material impacting the undercarriage and counterweight on an electric shovel.

- Must carry out thorough inspections of pit walls looking for signs of potential strata failures.

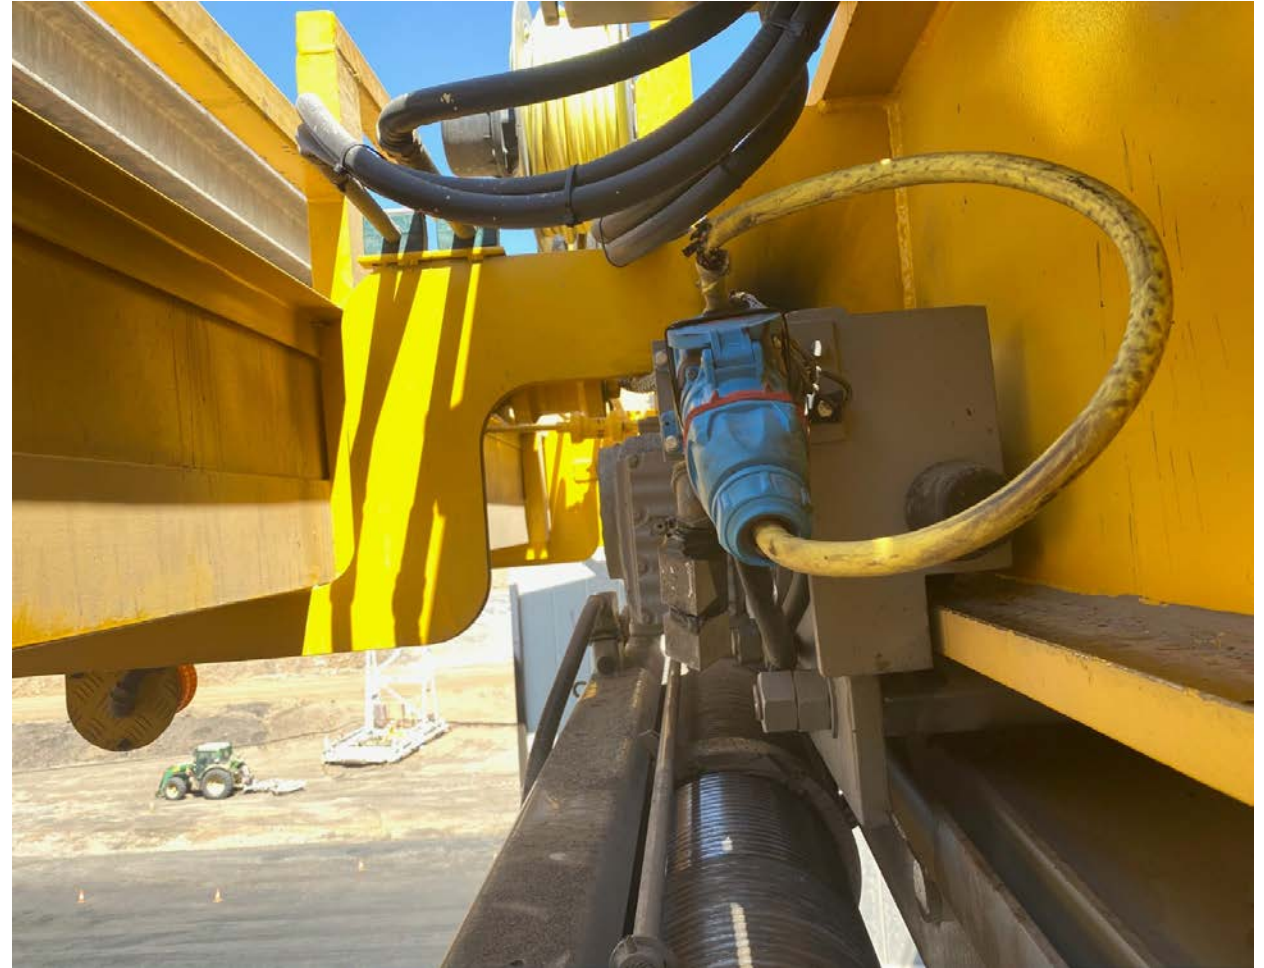
# Incident – Cable damage on an overhead crane – Surface Mine

1. Whilst relocating an overhead crane in the house of a dragline an electrical cable has become caught on structure.
2. The cable was damaged causing a release of energy.
3. The earth leakage protection tripped as per design.
4. The cable had been incorrectly reinstalled after a recent service.

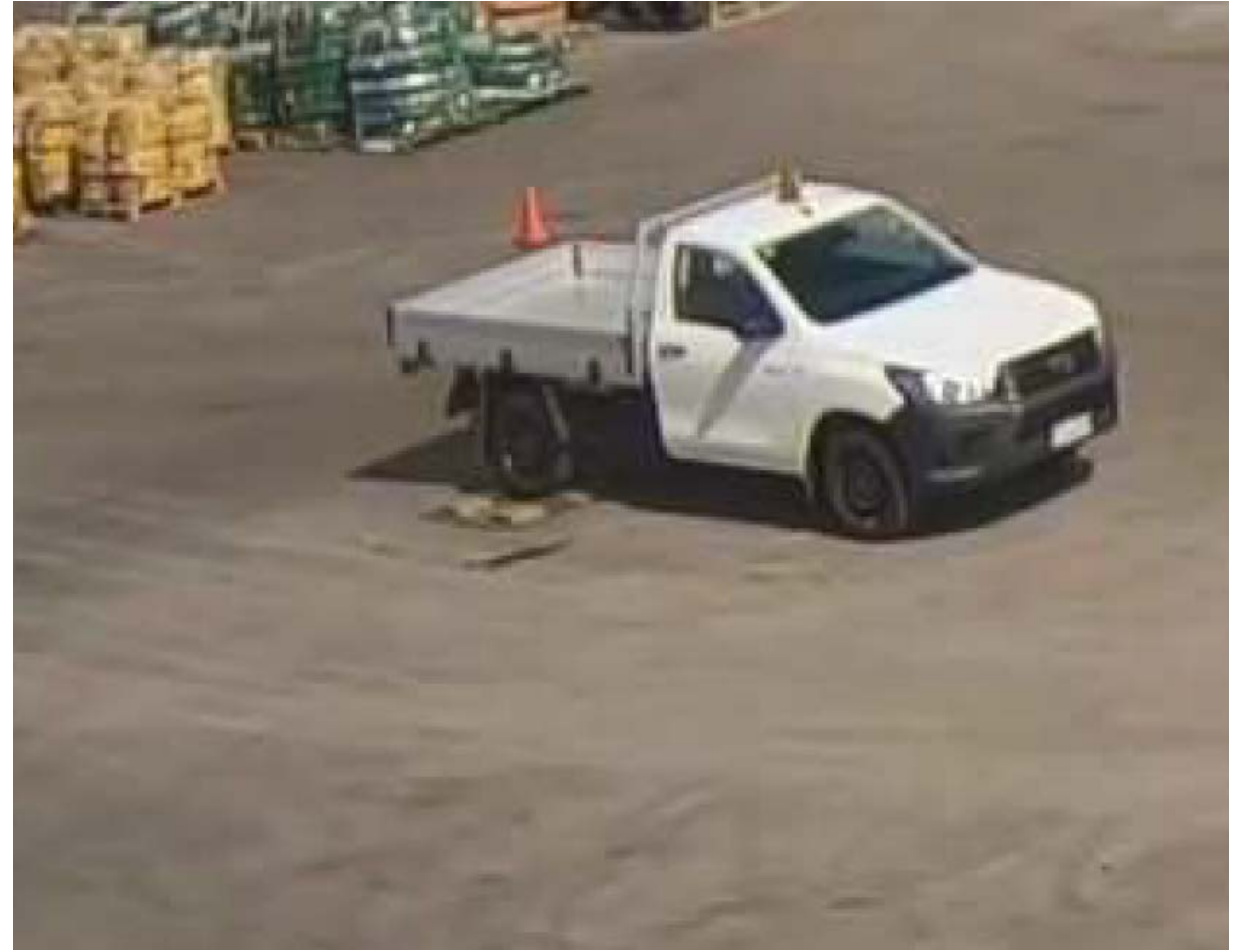
1. A light vehicle was left unattended in a store yard, still running and in gear (drive) with the park brake on.
2. The vehicle moved slowly down the yard until it reached a storage area, where it bumped into some pallets and equipment before coming to a stop.

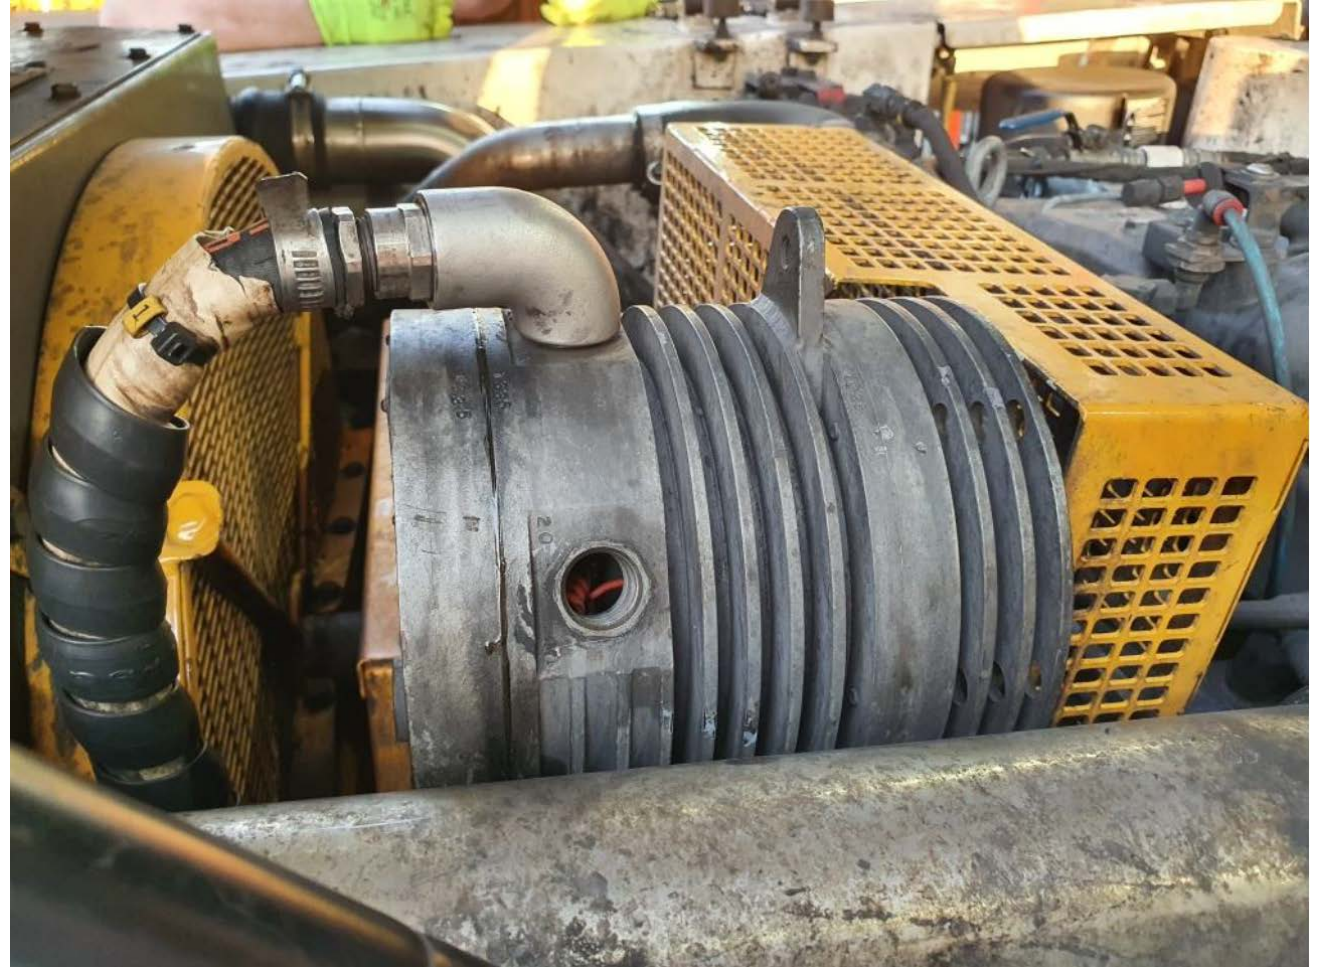
1. A daily vehicle pre-start inspection on an underground man carrier revealed that a Flameproof Exd 20mm bung was missing from the flameproof alternator.

- Ensure bungs and other devices are installed and maintained so as to prevent inadvertent failure of the bungs and/or devices.

- Ensure all defects are recorded and reported during pre start inspections of equipment

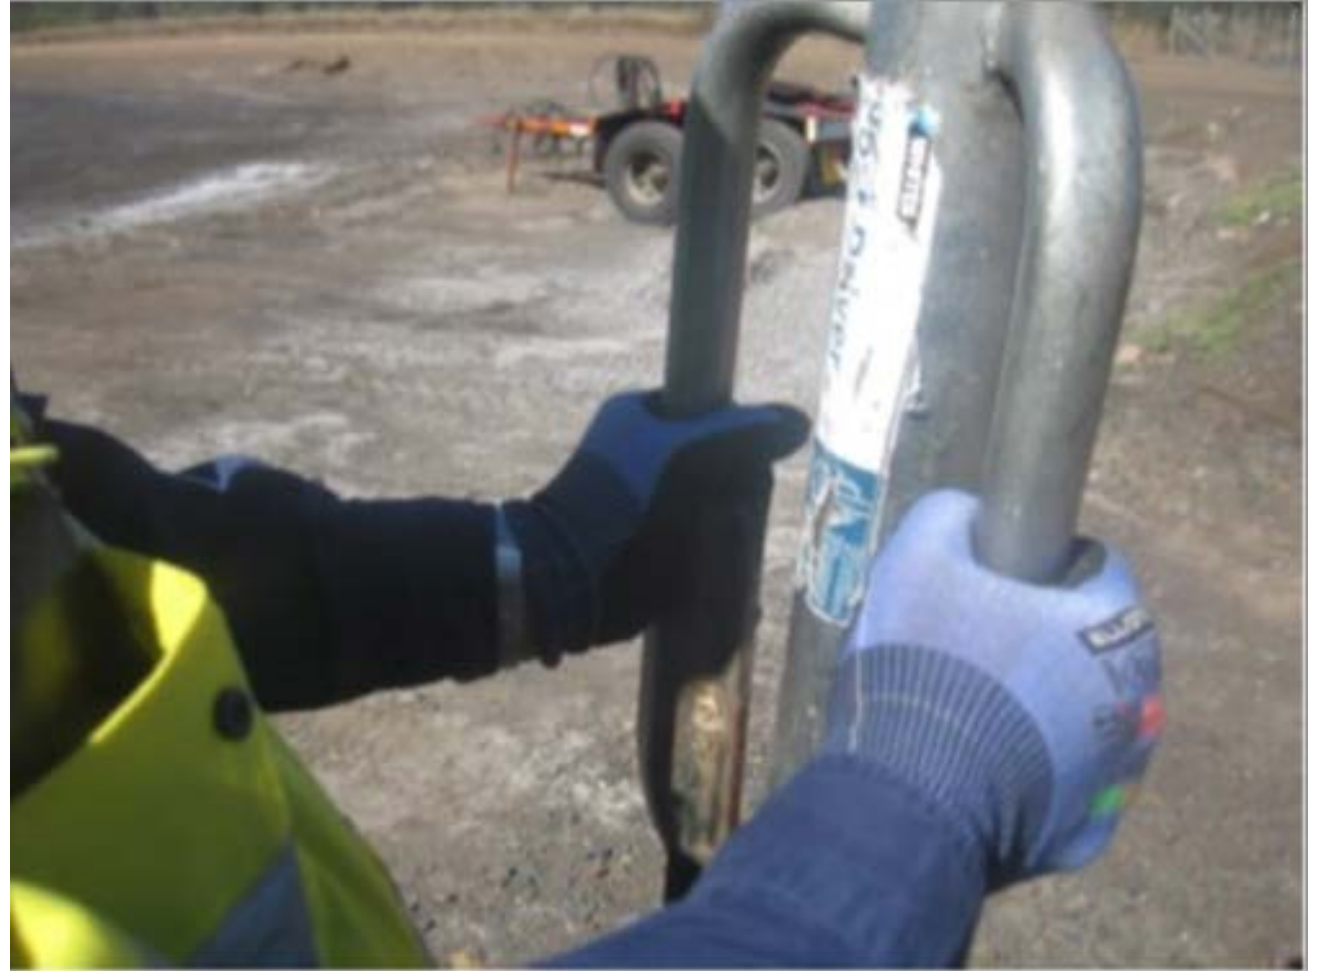
1. A coal mine worker incurred serious injuries to his left thumb when a star picket driver slid off the top of the star picket as he was driving the picket in.
2. The thumb was squashed between the driver and the top of the star picket resulting in fractures and a laceration that required remedial surgery.

- All tasks must be assessed for potential hazards / risks before being commenced.
- This incident is pertinent to safety at home as well as work. A simple type of task that many of us perform at home with the same potential risk present.
