# June 2020 Incident periodical

Recent High Potential Incidents  
Learnings and Recommendations  
Queensland Coal Mines Inspectorate

Coal Inspectorate

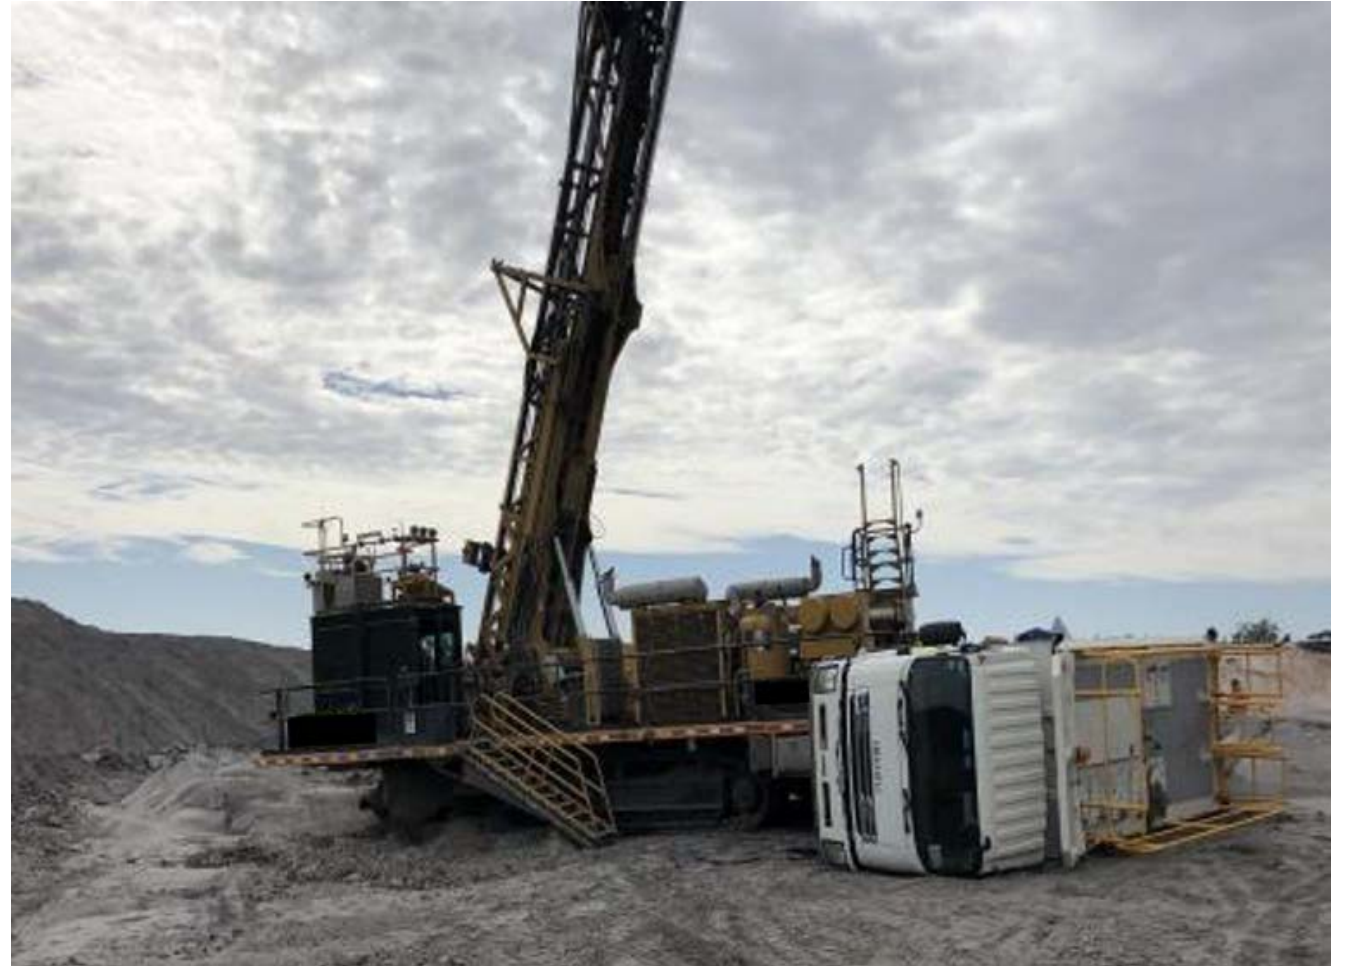
# 1. Incident – Collision – Surface Mine

1. A service truck entered a drill pad to service two drills.
2. Positive communications were confirmed with the first drill operator and the service was completed.
3. Positive communications were NOT confirmed with the second drill operator.
4. The CMW stopped the service truck behind the second drill.
5. The drill was trammed into the truck and turned the truck on its side.

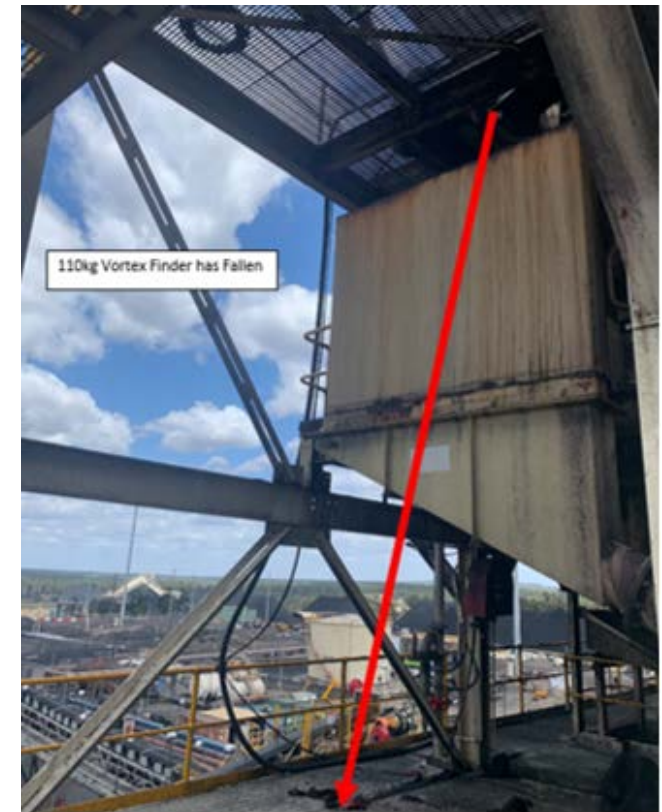
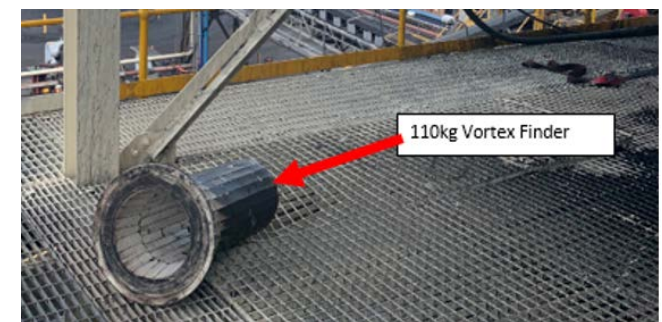
## 2. Incident – Fall from height – CHPP

1. Maintenance work in a CHPP to replace a cyclone was underway.
2. The 110 kg vortex finder inside the cyclone was not secured.
3. During the lift to remove the cyclone, the vortex finder fell out.
4. It landed on the deck floor 7 metres below.
5. No coal mine workers were in the vicinity at the time.

- Ensure the mine's risk management processes provide guidance to coal mine workers for identifying hazards that are hidden or masked.

- Ensure supervisors who are applying risk management processes are identifying hidden hazard potential at all times.

- Before commencing a task, consider the possibility of hidden hazards when conducting local risk controls.

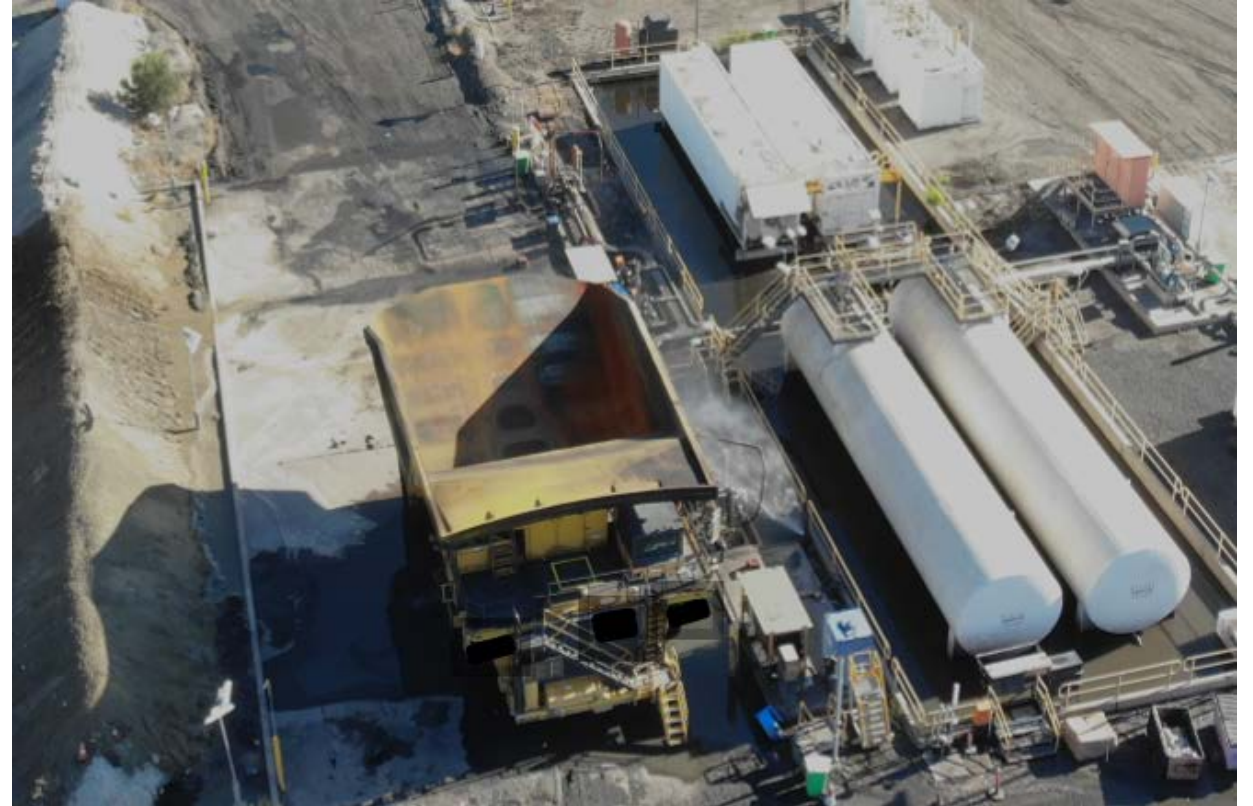
### 3. Incident – Fuel fire – Surface Mine

1. A coal mine worker was refuelling a rear dump truck at a bulk fuel storage.
2. The fuel delivery hose split and sprayed fuel onto the truck.
3. The fuel was ignited by hot components.
4. Water trucks were used to extinguish the flames and prevent the fire spreading to the bulk storage facility.

- Examine refuelling equipment diligently before use and ensure that you do not use equipment that appears to contain defects or is not fit for purpose.

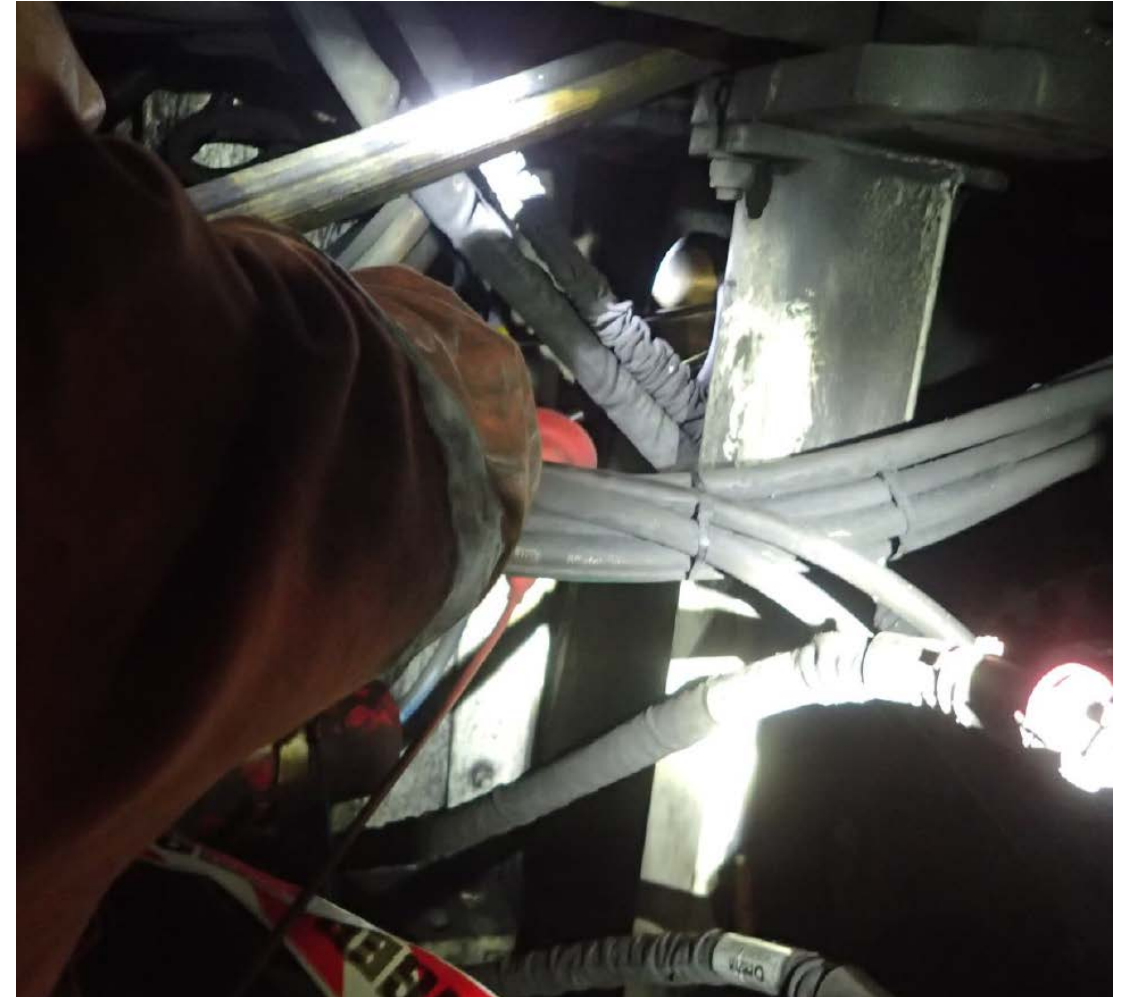
## 4. Incident – Electric Shock – Underground Mine

1. An apprentice electrical worker was conducting electrical work in a longwall.
2. The electrical worker was testing the insulation on a 3.3kv drive supply cable.
3. During the testing the electrical worker received an electric shock.
4. Investigation to identify the source of the energy is ongoing.

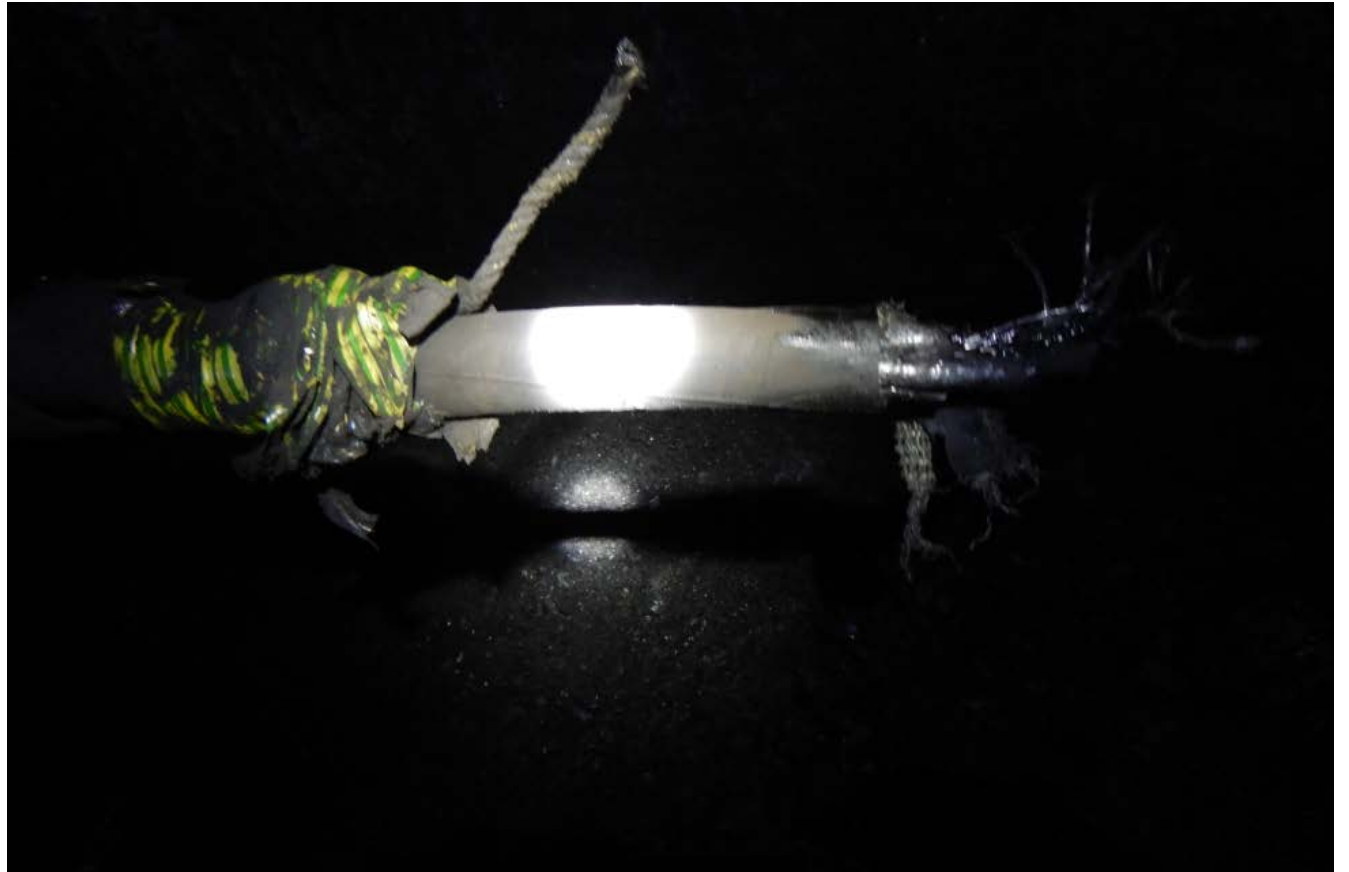
## 5. Incident – Cable failure – Underground Mine

1. A coal mine worker was trammimg a shuttle car away from the conveyor loading point.
2. As the shuttle car went past the cable anchor point, the coal mine worker saw a flash from the cable reeler and lost all power to the shuttle car.
3. The electrical protections systems activated.
4. Inspection found the cable had separated at a splice.

- Ensure the electrical engineering manager has an effective system for identifying the condition of trailing cables before an unacceptable level of risk develops.

- Confirm coal mine workers are conducting effective inspections of trailing cable condition and anchor point installation to ensure an acceptable level of risk.

- Conduct effective inspections of trailing cable condition, anchor point suitability to ensure sub-standard installation or cable condition is rectified before commencing equipment operation.

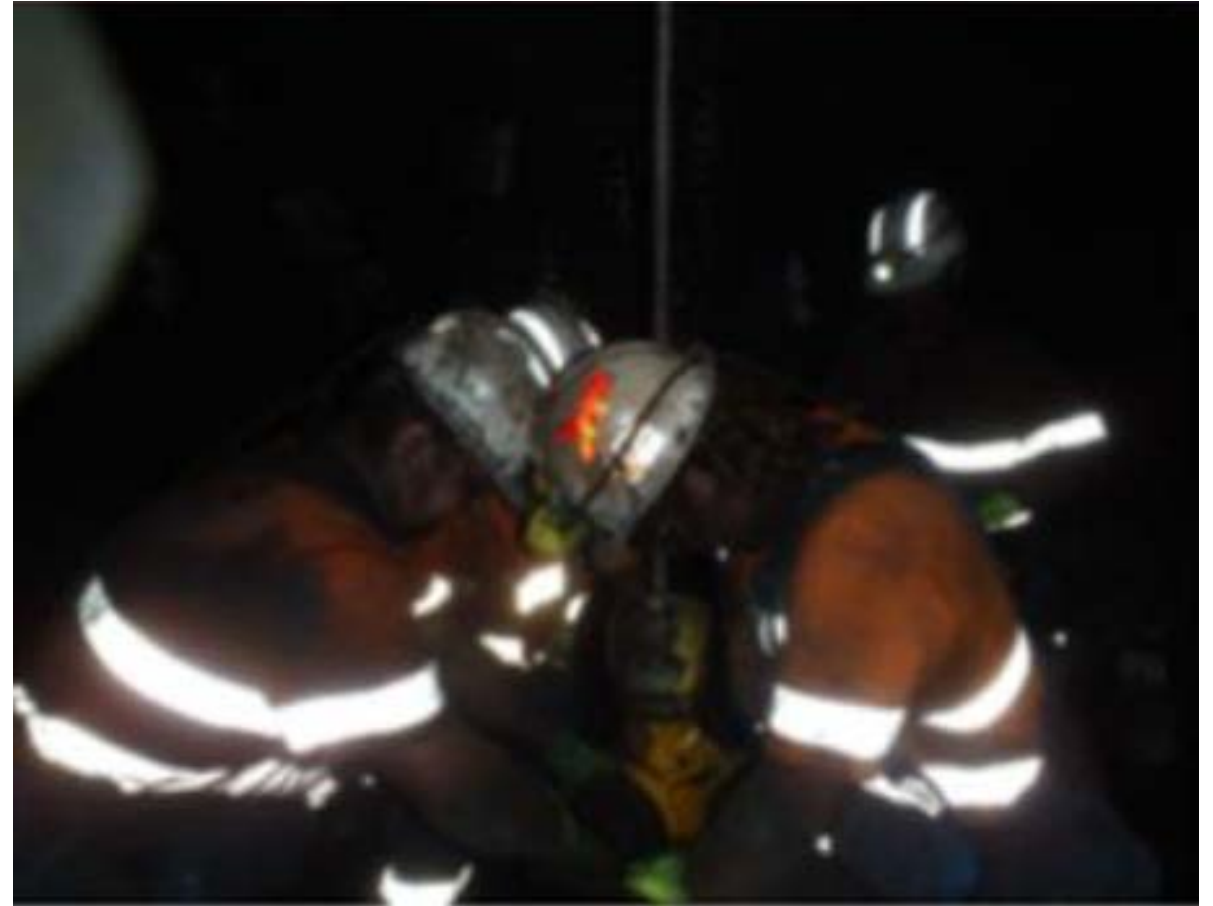
## 6. Incident – Entanglement – Underground Mine

1. Coal mine workers were installing strata support in a longwall tailgate using a portable roof bolter.
2. The drill steel got stuck in a drill hole during drilling.
3. When assisting to free the stuck drill steel, the worker's long hair was caught by the rotating drill steel.
4. Some hair was torn from the worker's scalp.

- Confirm coal mine workers have considered the hazards created by their personal grooming decisions when applying local risk controls, including loose hair, clothing and/or jewellery.

- Take into account the hazards that personal grooming preferences may expose them to and ensure when conducting local risk controls they have effectively managed the hazards, including loose hair, clothing and /or jewellery.

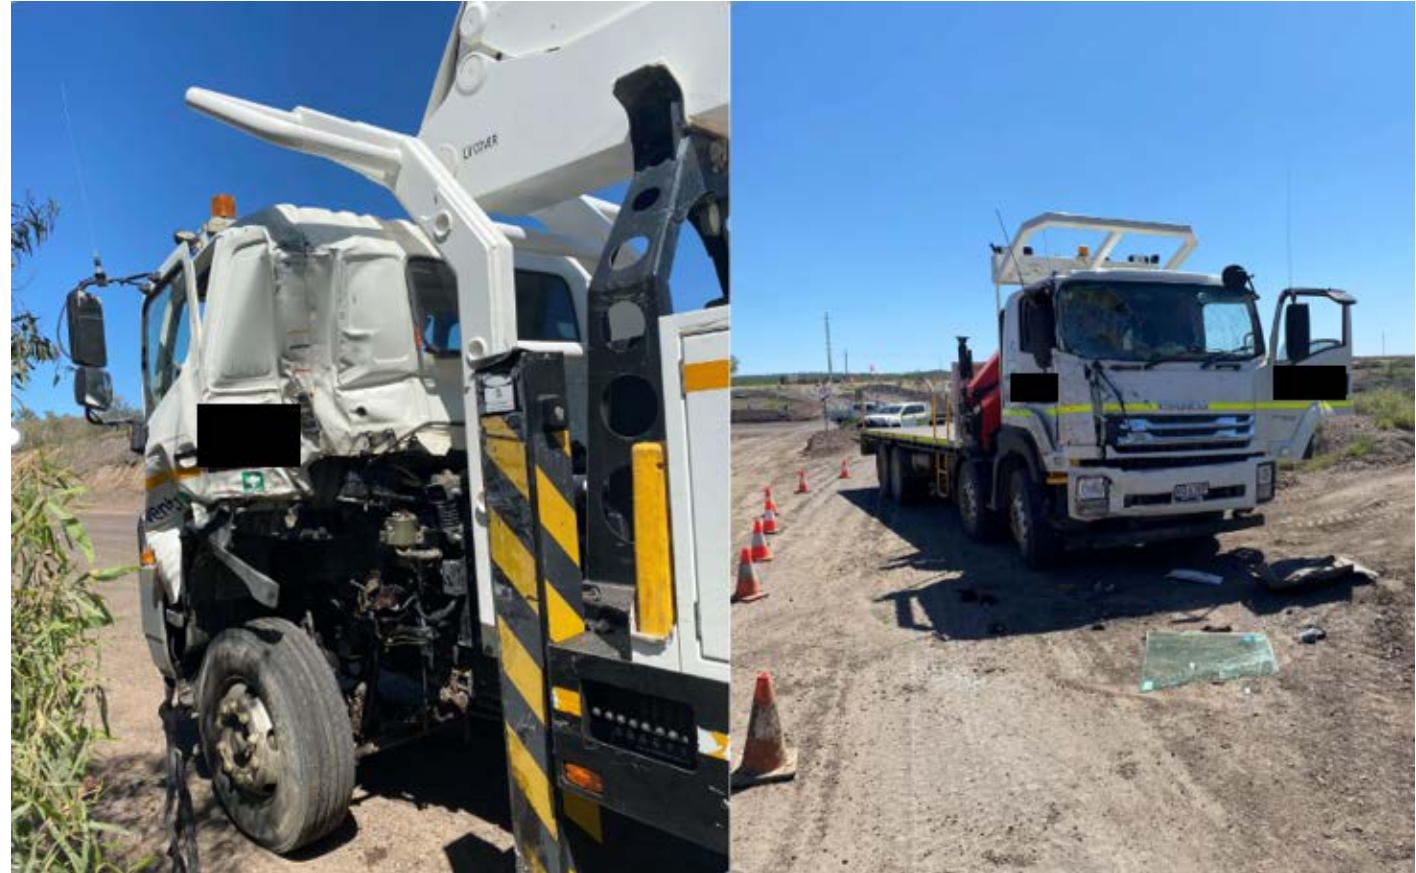
# 1. Incident – Collision – Surface Mine

1. A medium vehicle which was under escort at the time, has collided with another medium vehicle that was in the process of turning left off the access road that they were travelling on.
2. Other vehicles were travelling between the escort vehicle and the medium vehicle being escorted.
3. The driver of the last medium vehicle was not aware the medium vehicle ahead was turning to the left.
4. The track on the left hand side of the access road that the leading medium vehicle was turning into was not a designated or demarcated intersection.
5. No injuries, however significant vehicle damage resulted.

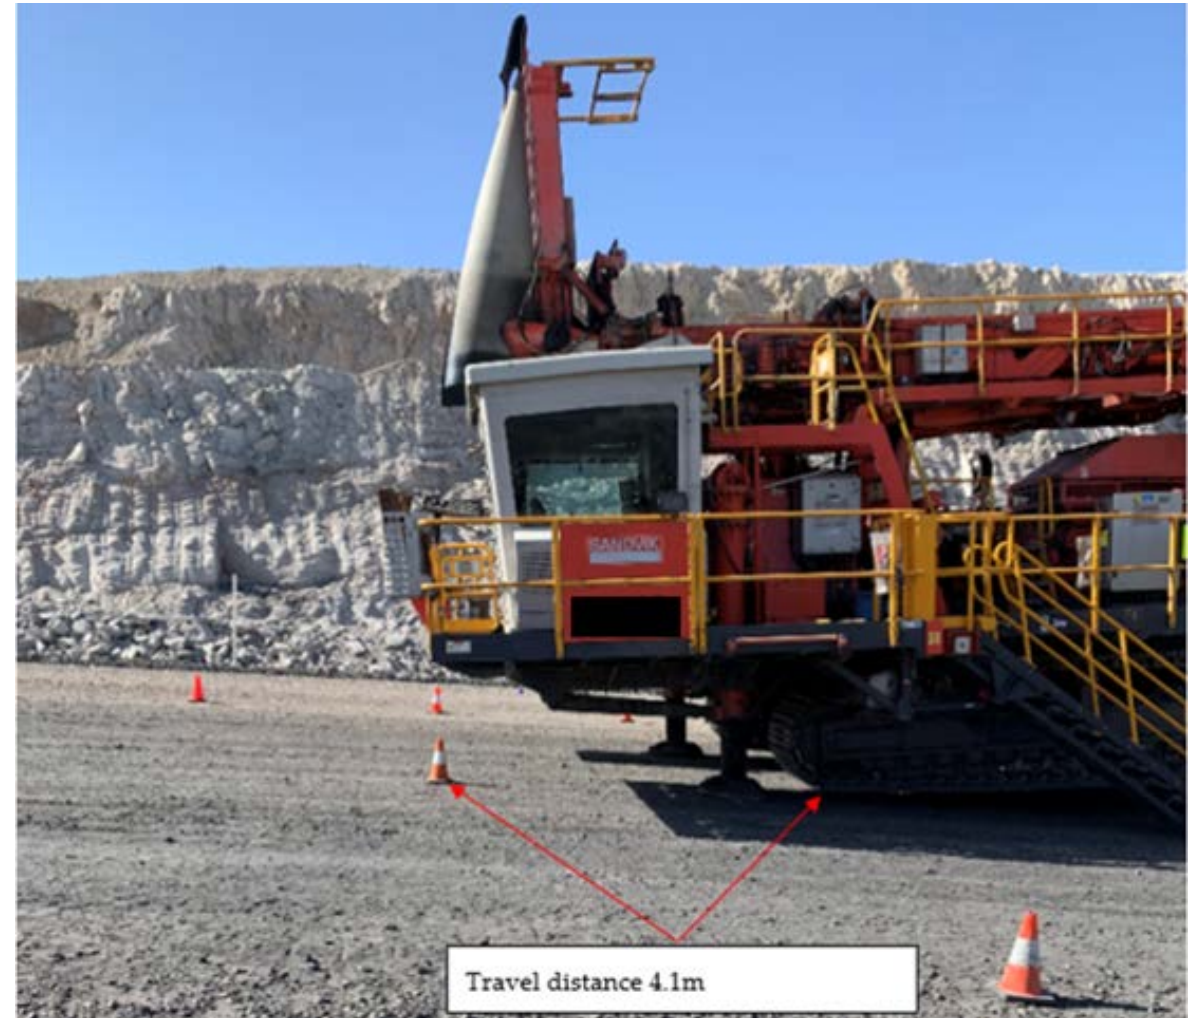
## 2. Incident – Collision – Surface Mine

1. An overburden blast hole drill was tramming up a ramp when it lost all forward travel motion, and then rolled backwards down the ramp approximately 4 metres before coming to a stop under its own control.
2. The drill's engine was still running at the time and had not shutdown.

- Ensure processes are in place to inform equipment suppliers of defects and to involve OEMs in the trouble shooting of abnormal events to enable suppliers to address obligations related to the safe use of plant.
- Make sure equipment training procedures consider operator abnormal conditions / emergency response procedures (such as loss of power and traction).

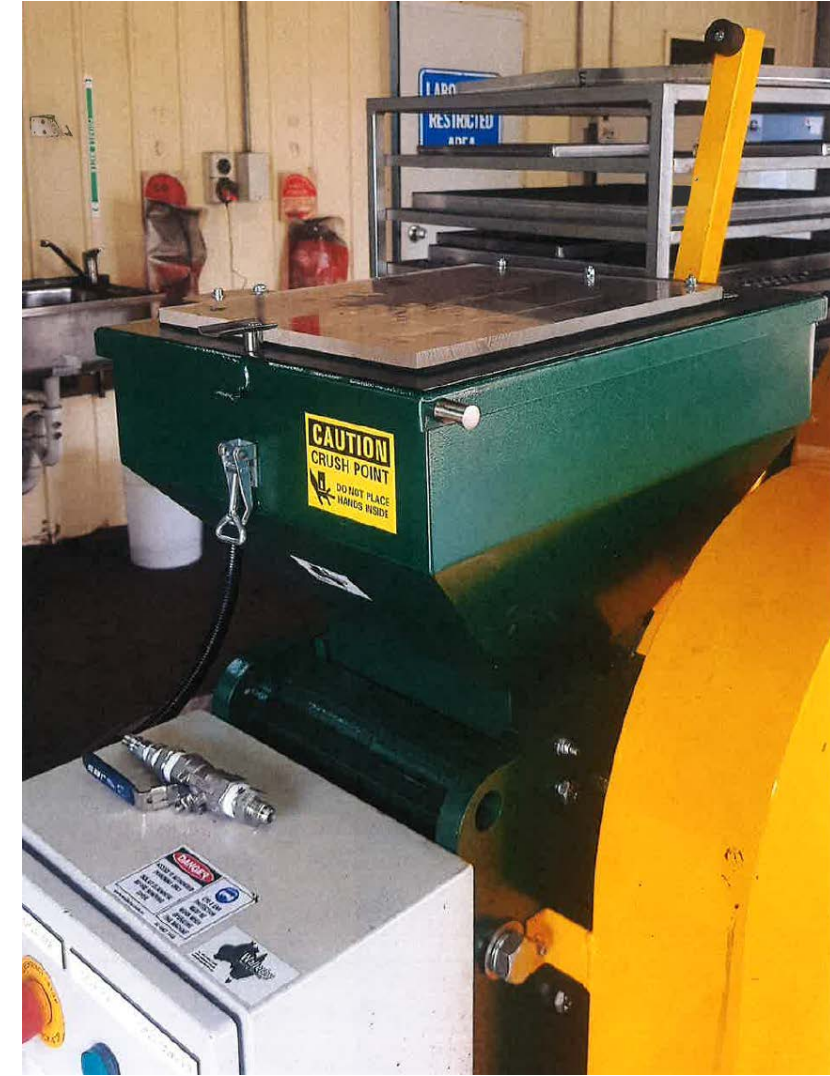
### 3. Serious accident – Crushed finger - Laboratory

1. A coal sampling lab technician was cleaning out the hopper of a Wallaby coal sample crushing benchtop machine, when the raised access cover fell forward and down onto the person's right hand.
2. The injured person was hospitalised for the treatment of a finger injury.

- Ensure the mine's Risk Management processes provide guidance to coal mine workers for identifying hazards that are developing or hidden.

- Ensure supervisors who are applying risk management processes are identifying potential hazards at all times, and ensuring effective controls are in place.

- Before commencing a task, consider the possibility of developing hazards when conducting local risk controls.

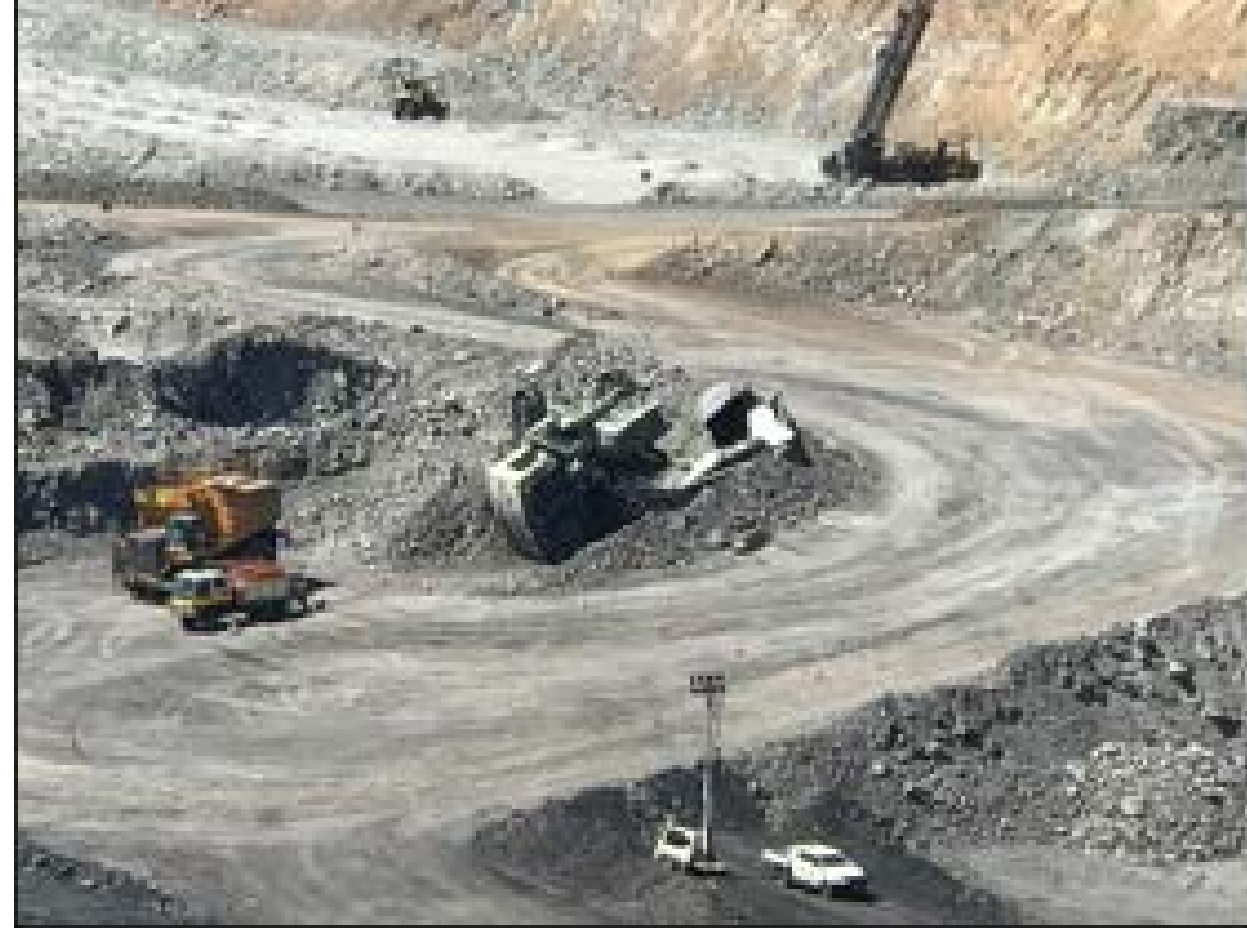
## 4. Incident – Excavator rollover – Surface Mine

1. A 350t excavator working on a bench was tramming when an uncontrolled movement off the bench occurred, and this resulted in the machine toppling over onto its side with the cabin up in the air.
2. The relatively inexperienced operator was not injured, and extricated unassisted via a portable ladder provided by ERT.

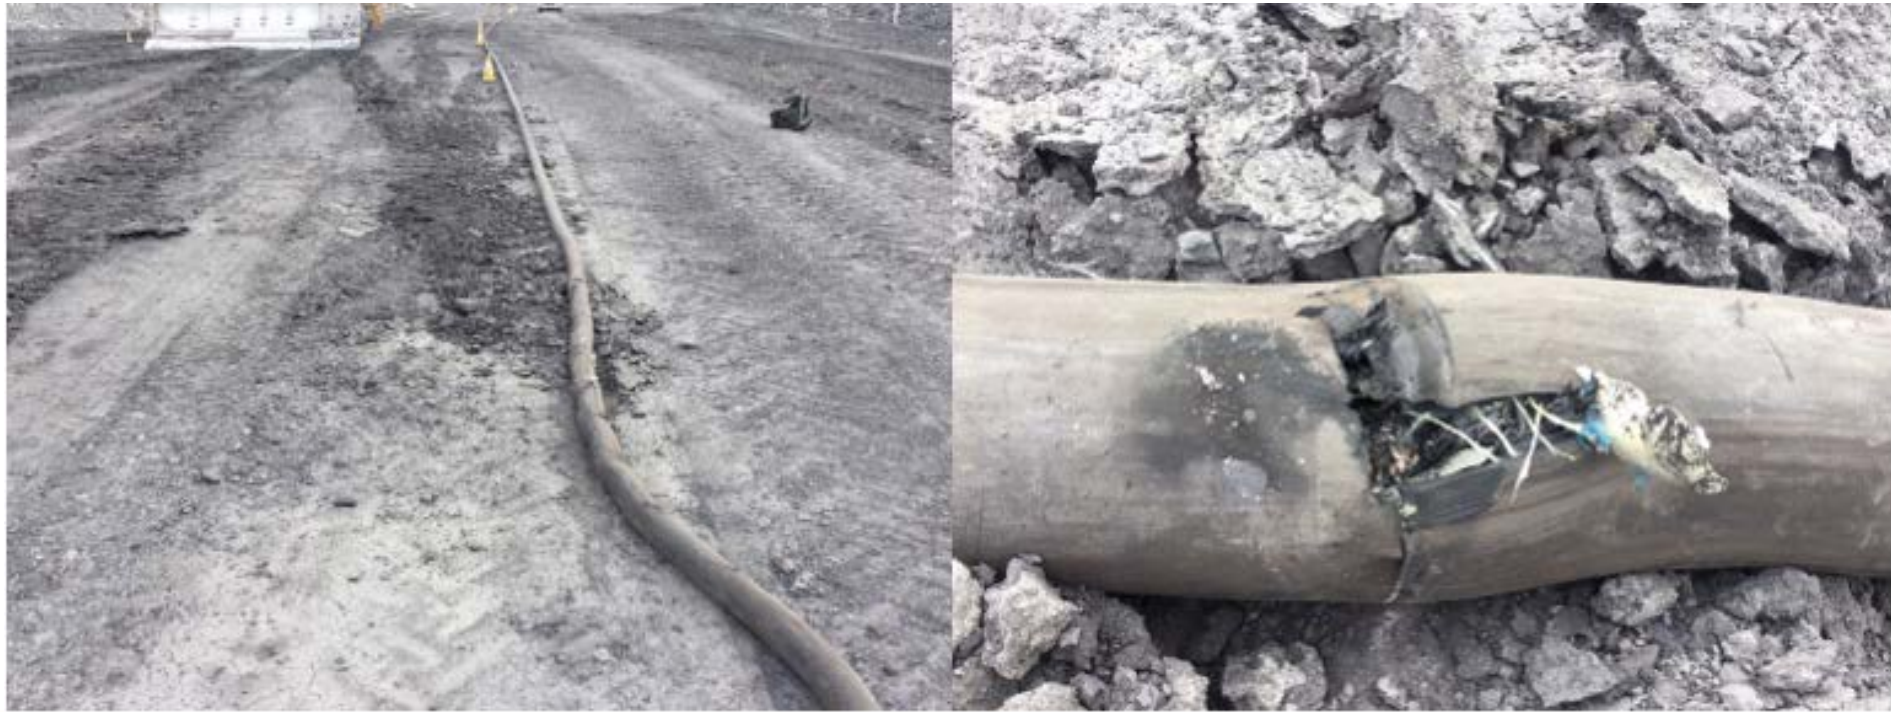
## 5. Incident – HV Cable damage – Surface Mine

1. A dozer walked onto a dragline's high voltage tail cable. This resulted in the earth continuity tripping the power back at the sub-station.
2. An inspection of the cable revealed exposed conductors.

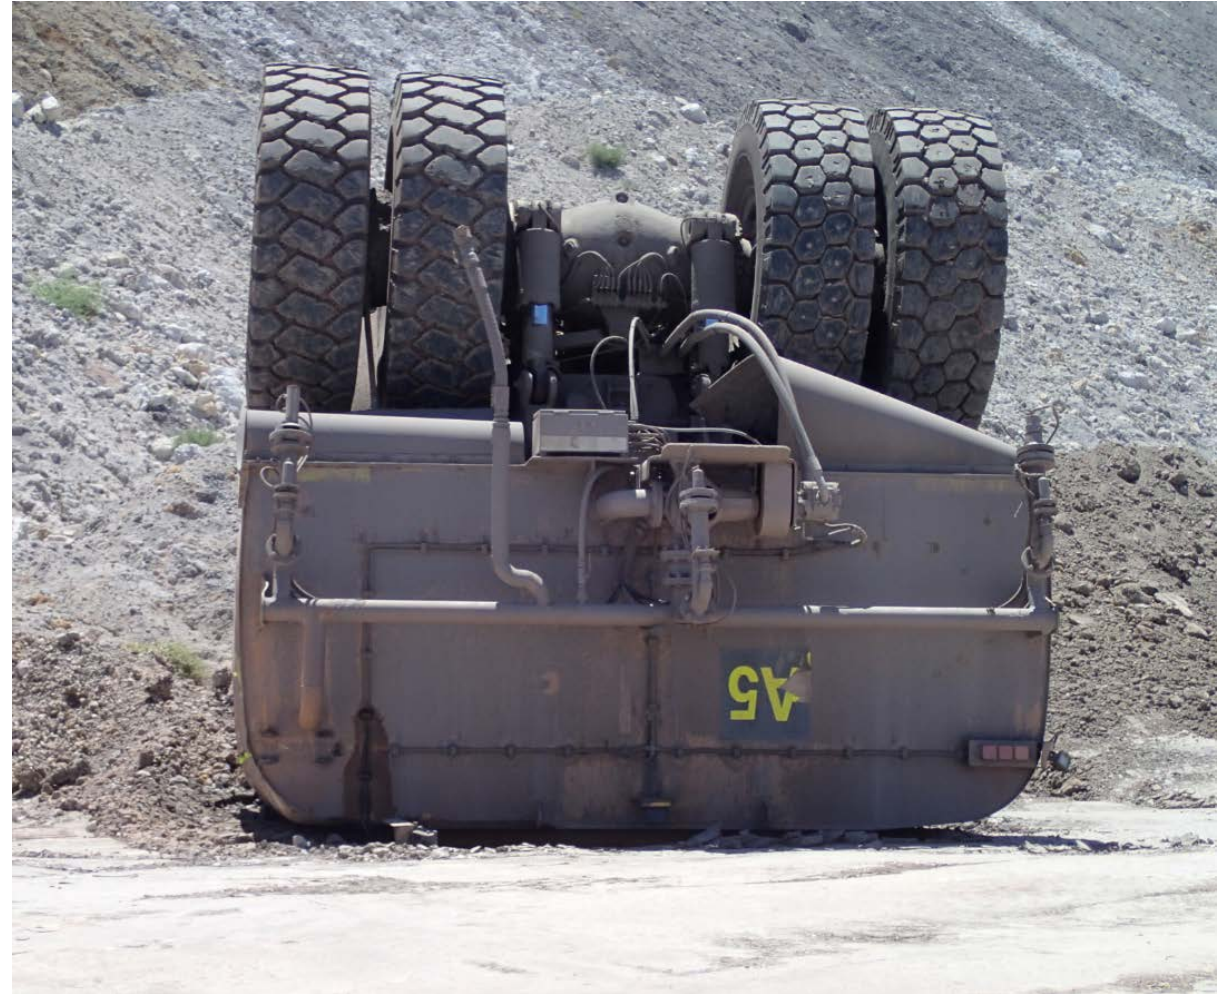
## 6. Incident – Water Cart Rollover – Surface Mine

1. A water cart was descending a recently watered ramp when it lost traction with all wheels in a wet line. This resulted in the truck contacting roadside bunding and then rolling over 180 degrees coming to rest on its roof.
2. The operator was reported as having minor lower back pain.

- Must report all hazards to their open cut examiner and supervisor.

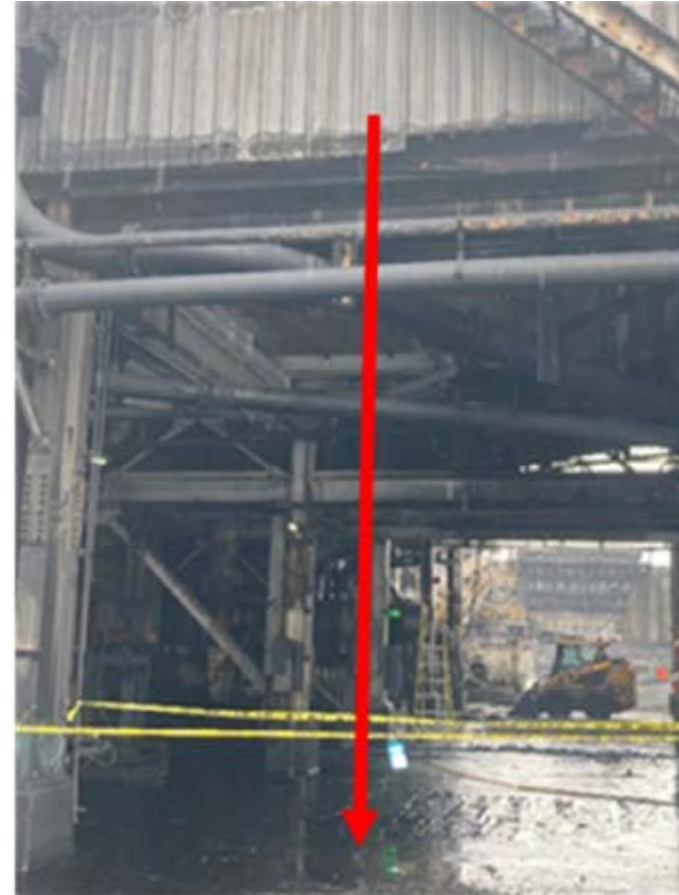
## 7. Incident – Fall from Height – Washplant

1. A crowbar was found lying in a walkway. The crowbar was moved from the walkway before it was realised that it had fallen from the floors above.
2. Initial investigation revealed that the crowbar had been placed in a Z-Purlin on an upper floor sometime earlier.
3. The Z-Purlin failed due to being heavily corroded / rusted, and this resulted in the crowbar and sections of the Z Purlin falling onto a bottom floor walkway.

Z purling's and crowbar fell 6m est.

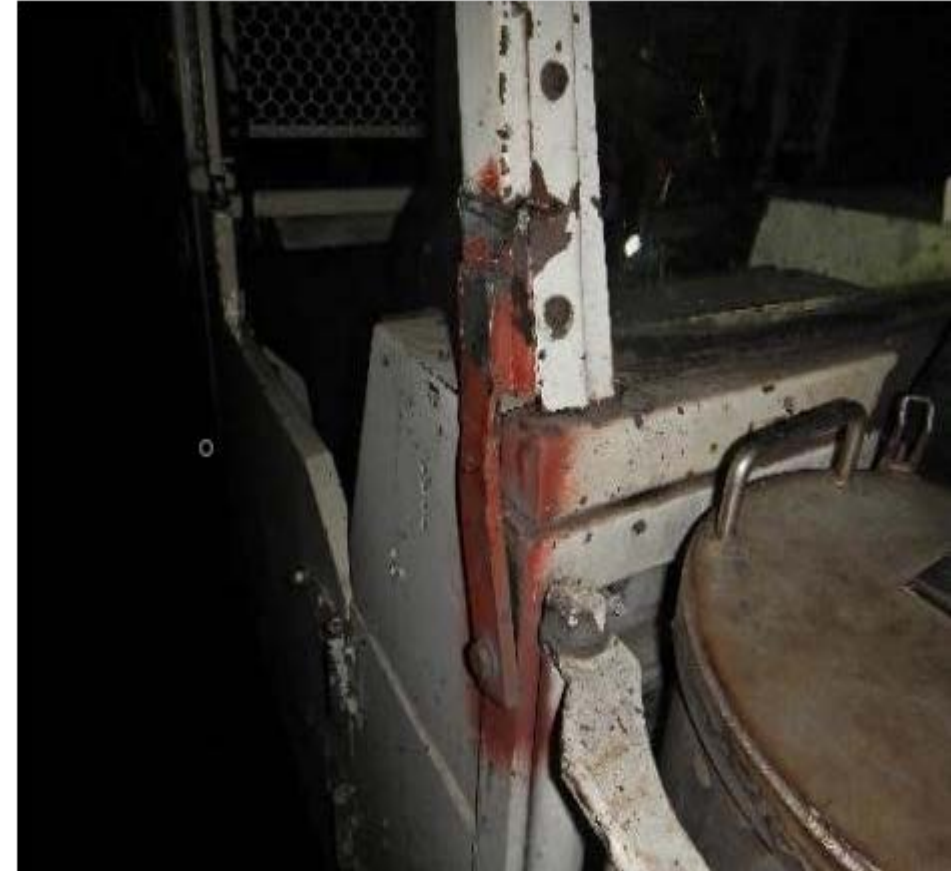
1. A load haul dump vehicle (LHD) and PJB collided in an underground coal mine in New South Wales.
2. Two PJBs were travelling in convoy passing the LHD that was in a cut through. The first PJB passed safely, but the LHD pulled out and collided with the second PJB.
3. The bucket of the LHD contacted the frame of the windscreen of the PJB on the driver's side.
4. Nobody was injured.

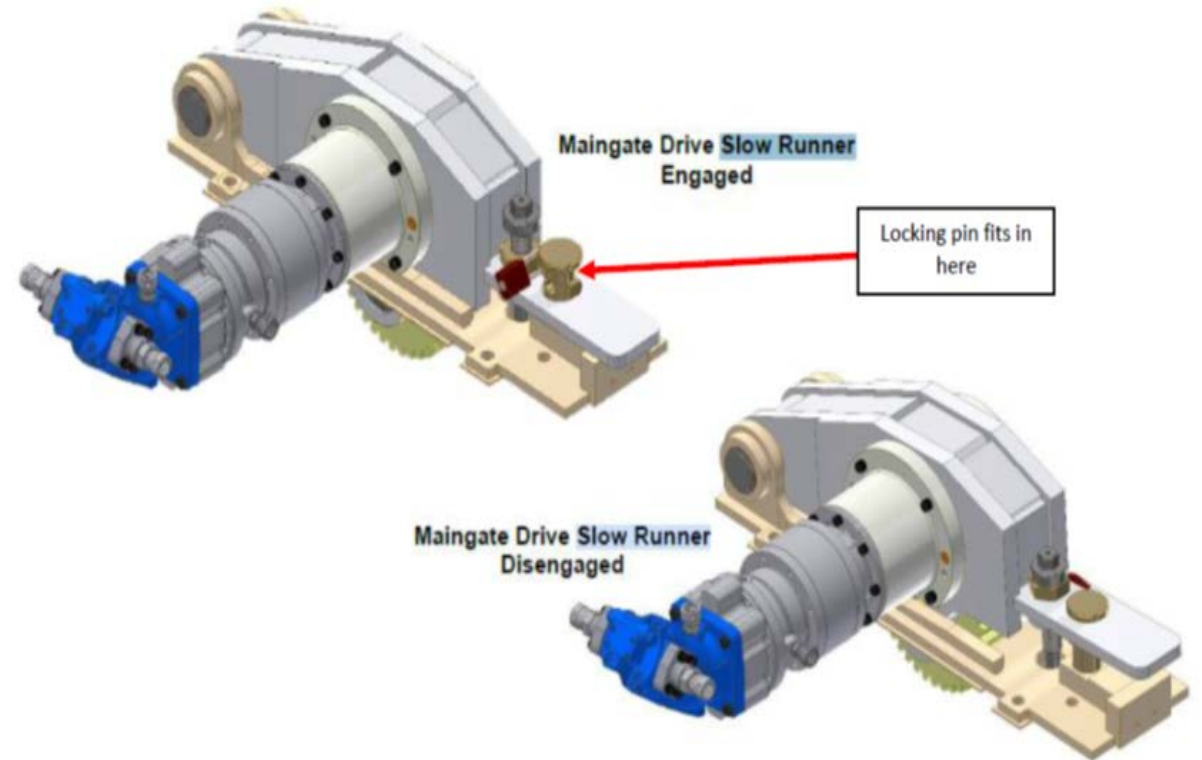
# 1. Incident – Energy Isolation Failure – Underground Mine

1. A coal mine worker was doing repairs to the AFC.
2. Electrical power to the AFC was isolated correctly.
3. The repairs required the hydraulic AFC slow runner be used to create slack in the top chain.
4. There was an energy release that allowed the chain to slip at the tailgate while the CMW was in the line of fire.
5. The energy release was due to not engaging the slow runner correctly.
6. The CMW sprained their ankle avoiding the moving chain.

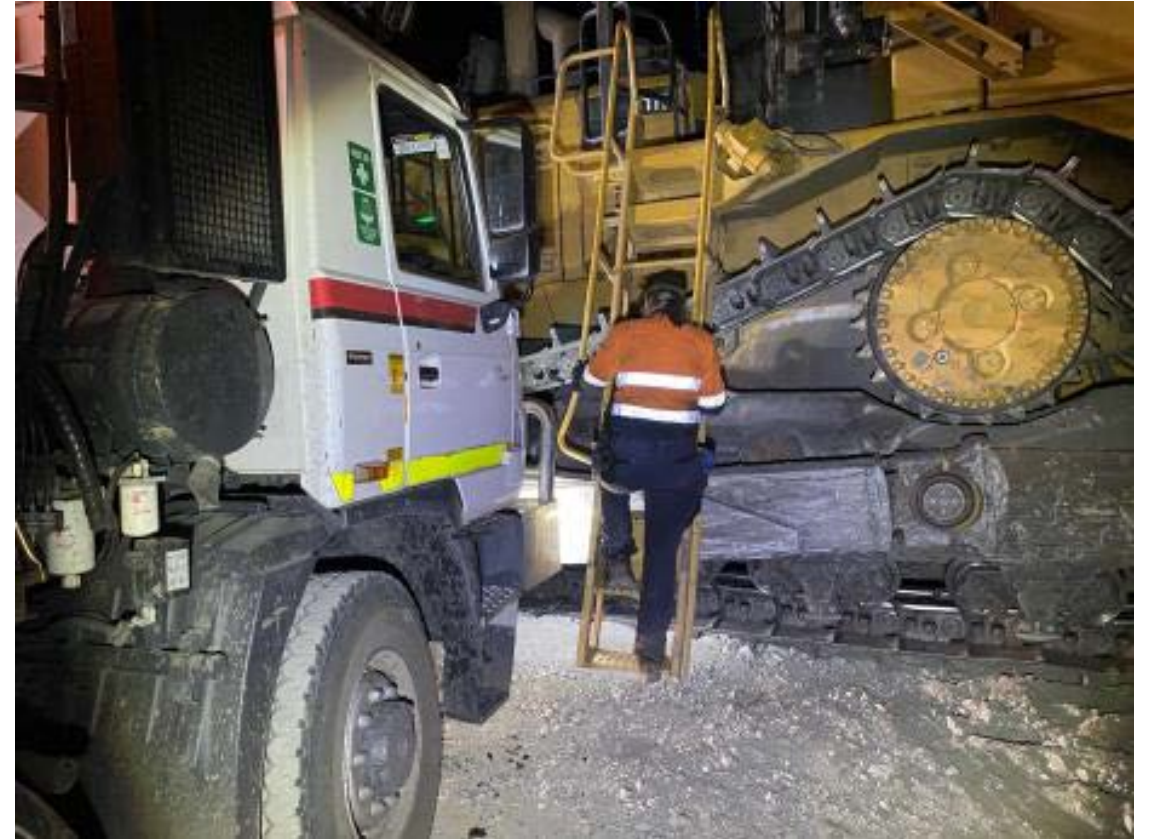
1. A coal mine worker tasked with field service work arrived to fuel a bulldozer.
2. The service truck was stopped facing the bulldozer, not parallel to it.
3. The CMW did not apply the truck's park brake before leaving the cabin.
4. As the CMW went to access the bulldozer, the truck rolled forward into the ladder.
5. The moving truck hit the side of the ladder, just missing the CMW.

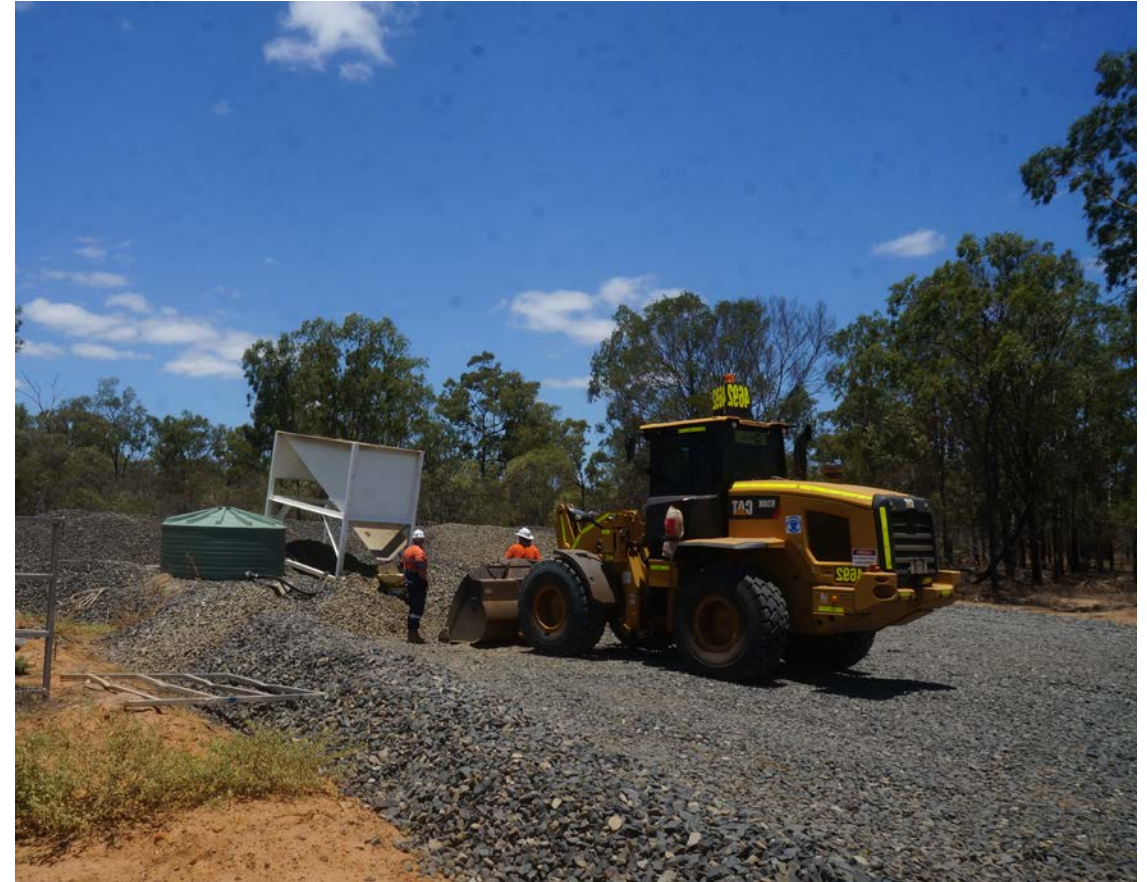
1. Boreholes are used at an underground mine, to deliver materials to underground work areas.
2. Access to boreholes lids are locked with individually keyed locks.
3. A CMW went to the wrong borehole on the surface.
4. The lock on the borehole access was not properly closed.
5. The CMW was able to open the lock with the key for the other borehole.
6. The CMW dropped ballast down the borehole.
7. A CMW had been under the borehole doing inspections just beforehand.

- Ensure the hazards of inadvertent access to a work area, are being effectively controlled by the SHMS.

- Follow the SHMS procedure for delivering materials via boreholes.
- Stop when the conditions are not as described in the procedure and review the differences with your supervisor before recommencing work.

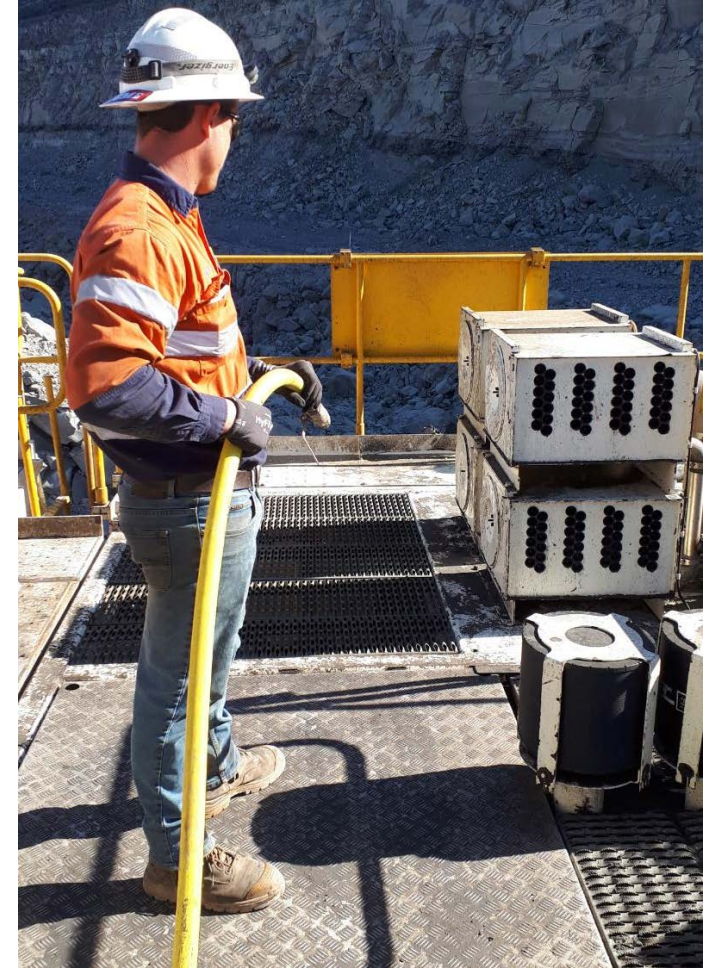
1. A CMW was cleaning the top of the excavator house using a water hose.
2. The CMW's feet got tangled in the hose and the CMW fell over.
3. The CMW landed on their shoulder in the fall and required medical treatment.
4. The humerus bone was fractured during the fall.

- Ensure the SHMS adequately provides controls for the hazards requiring management during manual handling and housekeeping tasks.
- Provide CMWs conducting housekeeping for maintenance with a competency such as RIISAM207E - Apply operational maintenance skills, or similar.

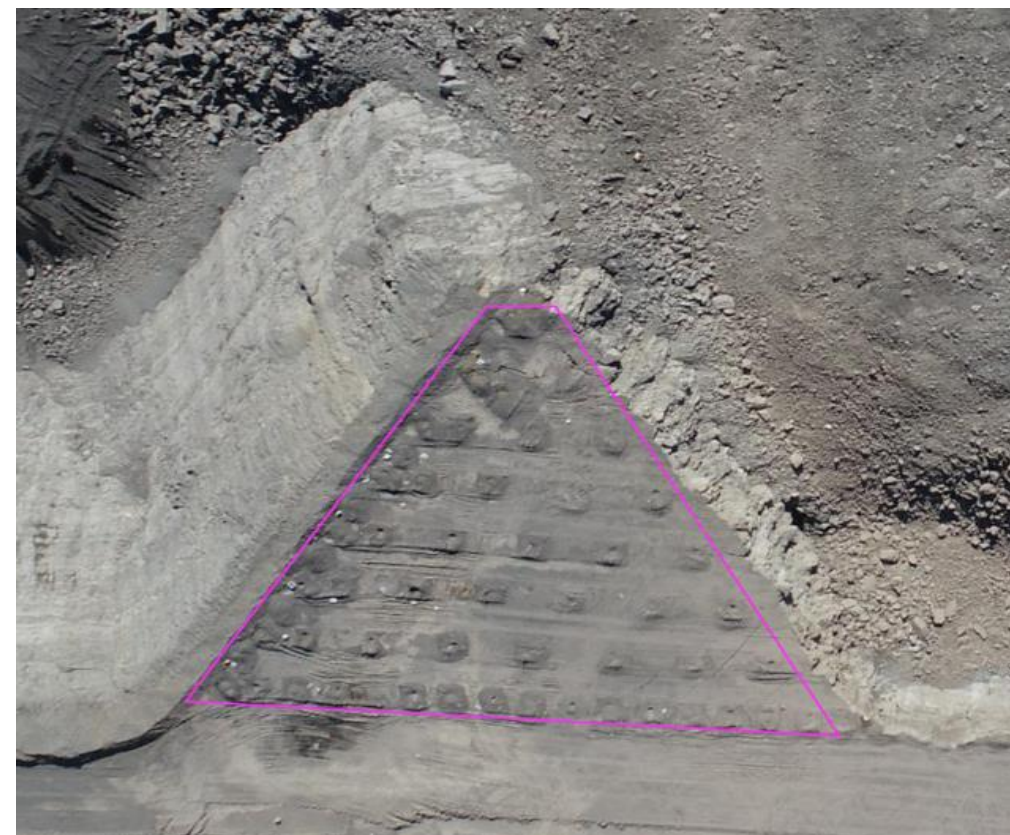
1. Forty nine holes misfired during an overburden blast.
2. The post blast inspection found a non-electric surface lead had been damaged by flyrock, causing the misfire.
3. Inspections confirmed the misfire could be reconnected and fired.
4. All holes fired at the second attempt.
