# June 2020 Incident periodical

Recent High Potential Incidents  
Learnings and Recommendations  
Queensland Coal Mines Inspectorate

Coal Inspectorate

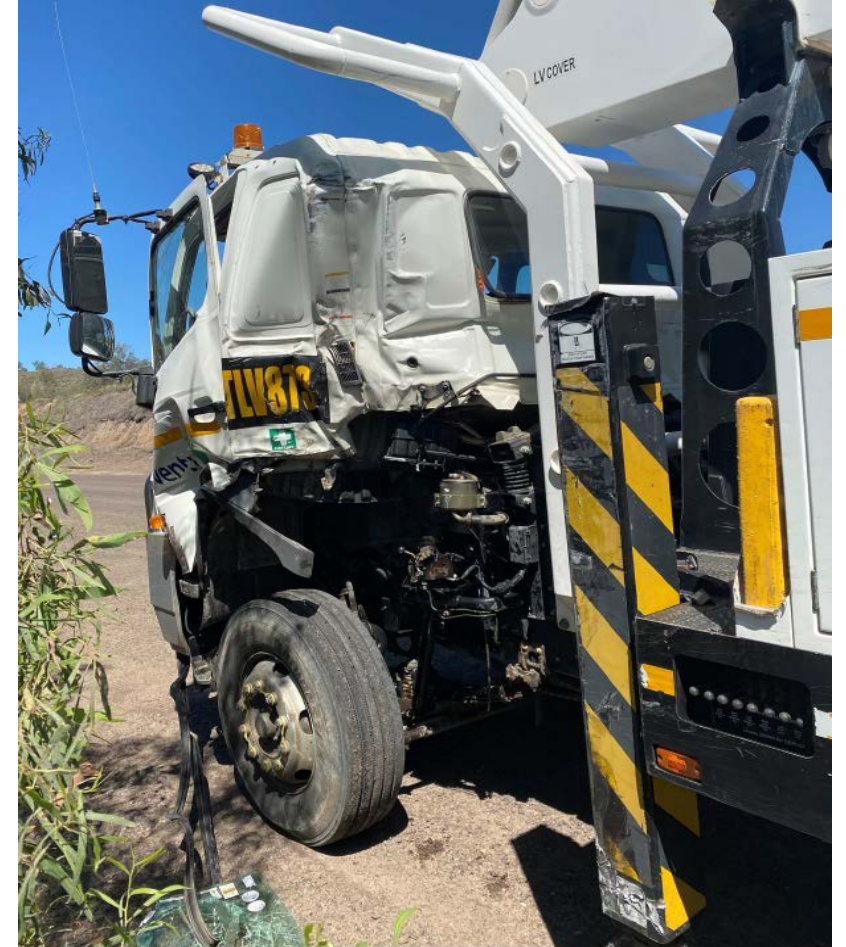
1. A vehicle was being escorted through a surface mine.
2. The escort driver allowed a gap to grow behind them to the vehicle they were escorting.
3. A truck entered that gap.
4. The truck then slowed to turn off the road.
5. The driver of the vehicle under escort thought the truck was making a right hand turn.
6. The truck veered right then turned left and the vehicle under escort crashed into the side of the truck's cab.
7. No injuries were reported.
