Incident periodical

Recent High Potential Incidents
Learnings and Recommendations
Reporting + Communications

Queensland Coal Mines Inspectorate

October 2023

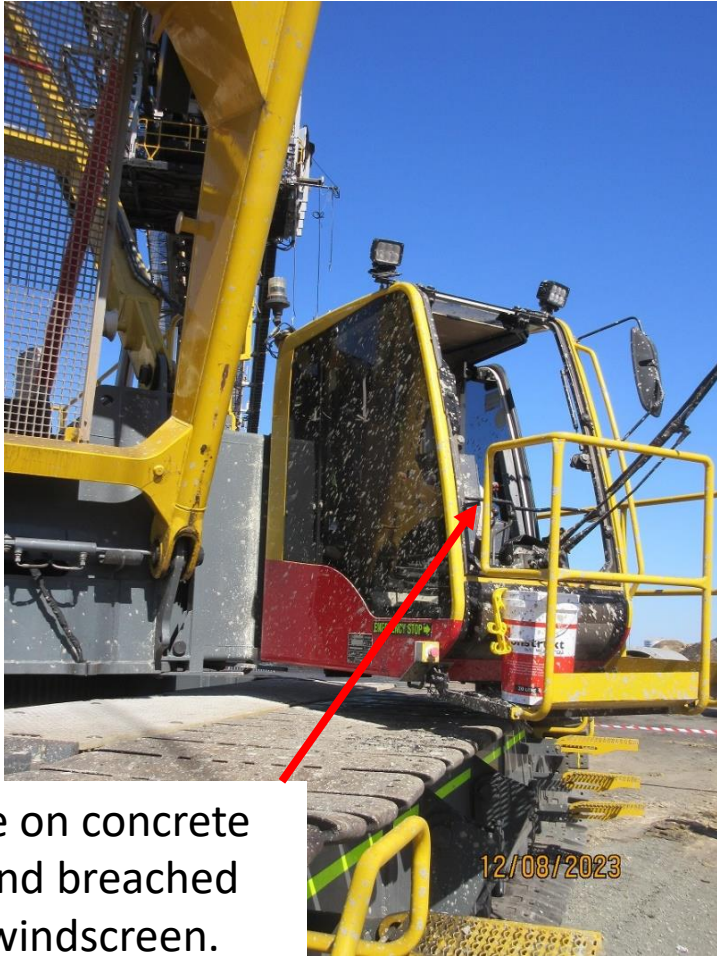
During August 2023 there were two high potential incidents (HPIs) reported that involved the failure of components on concrete boom delivery systems that resulted in the ejection of concrete material and damage to mobile plant.

On both occasions windows were struck and either shattered or breached. No personal injuries were sustained.

Ruptured hose on concrete boom pump and breached drill rig cabin windscreen.

- Does your mine have a robust process for introduction of plant to site?
- Does this include all components of the plant including attachments and consumable components?

- Does this system include plant operated by short and long term contractors?
- Are records kept of maintenance and inspection history; especially of wearing components (i.e. pipes concrete is being pumped through)?

- Has site considered the impact rating of glass in various pieces of mobile plant?
- Do Coal Mine Workers (CMWs) consider park up position of mobile plant when conducting tasks that have the potential to impact nearby work areas?

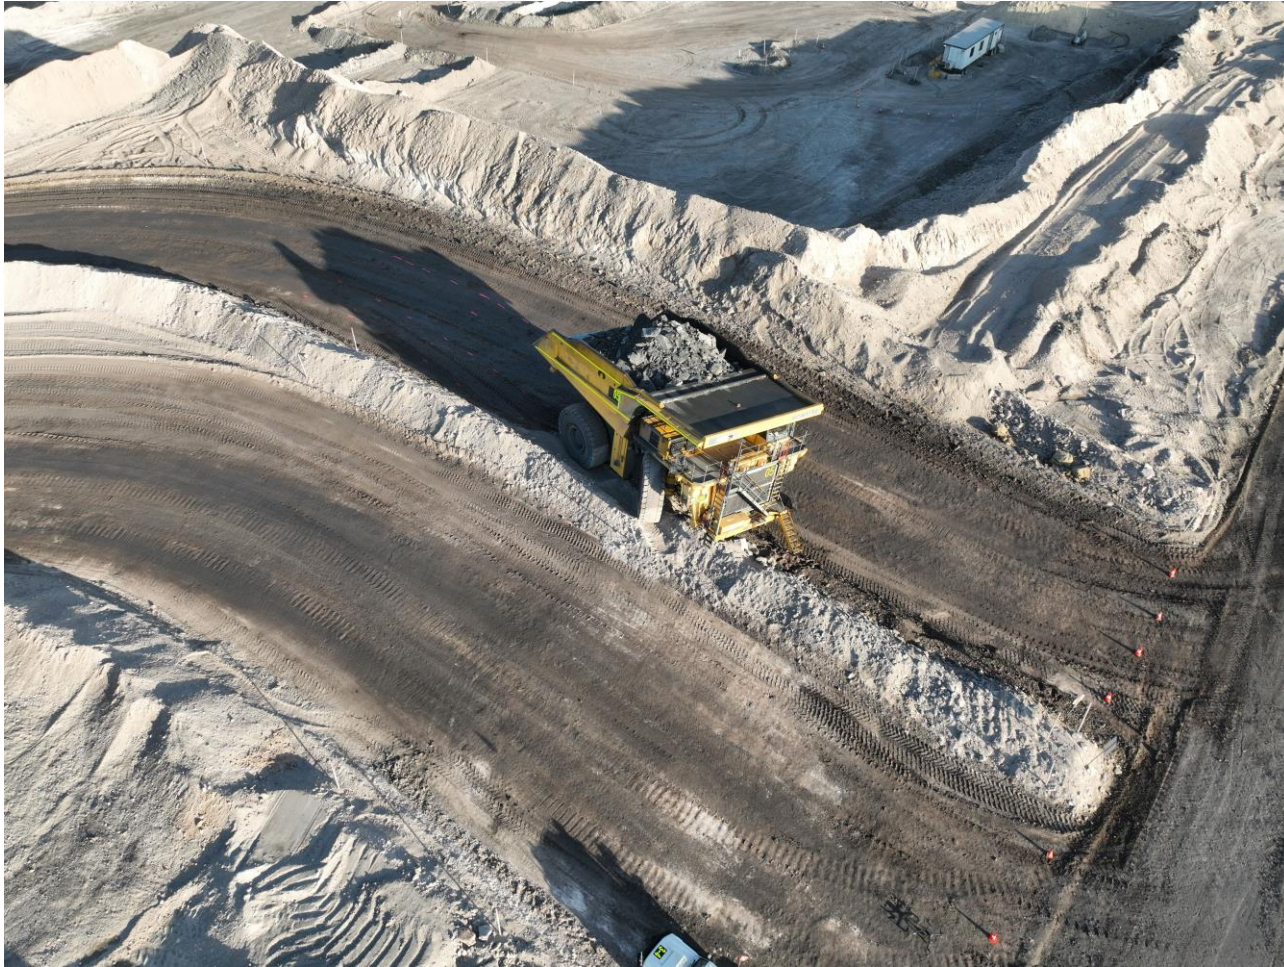
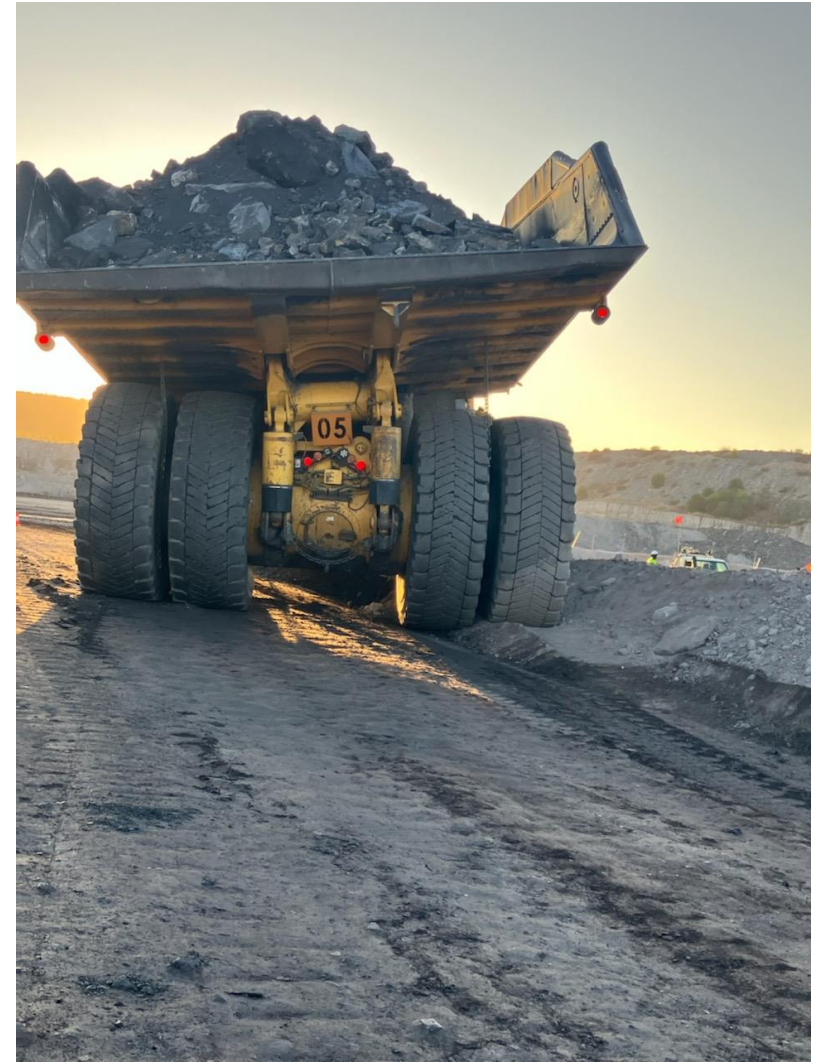
2. Incident – Microsleep

A rear dump truck (RDT) operator has had a microsleep and the loaded RDT has come into contact and mounted the centre bund, waking the operator who stopped the truck. No injury was sustained.

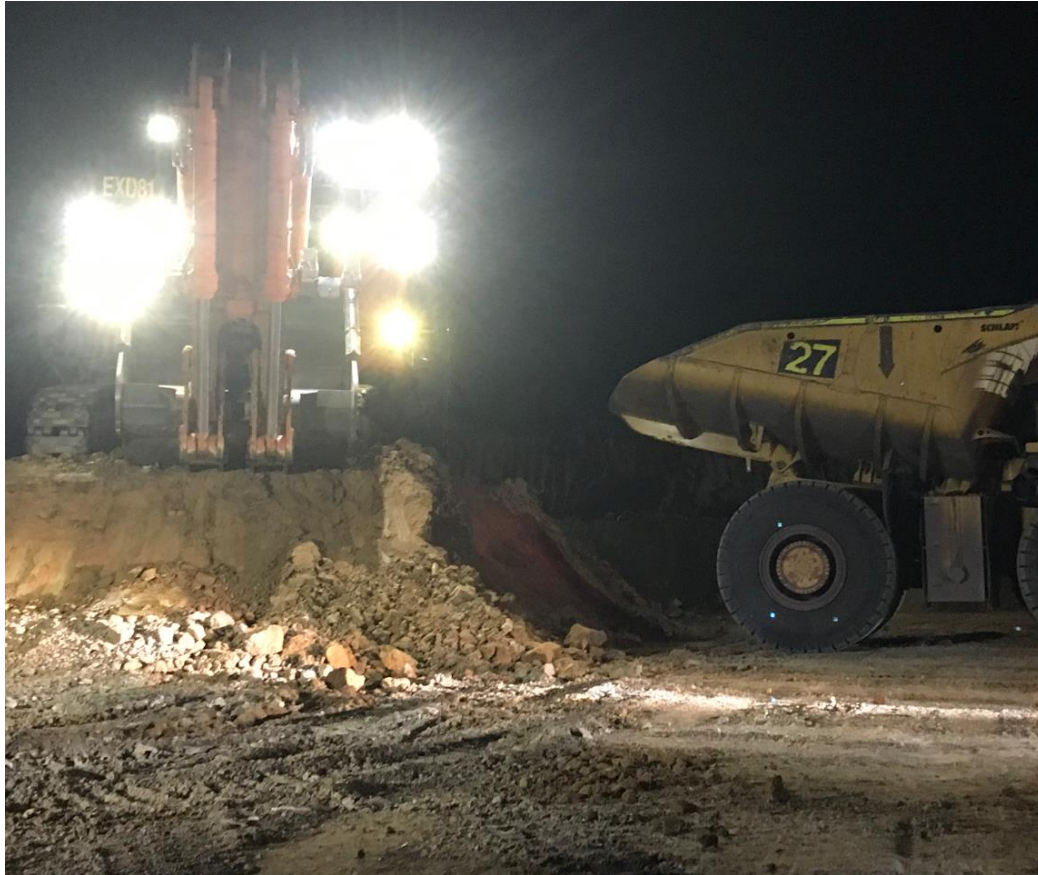
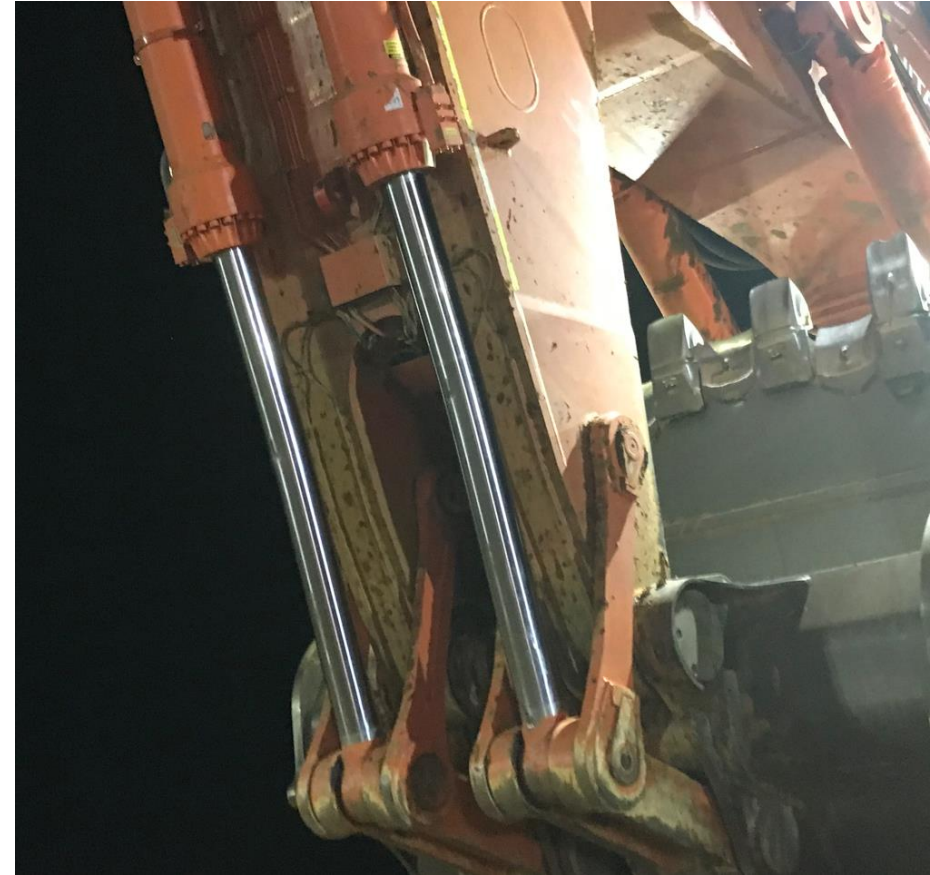
3. Incident – Collision of Mobile Equipment (Autonomous and Manual operation)

A loss of comms occurred on an autonomous circuit. The excavator operator grounded the bucket and exited the cab. While moving back to re-enter the cab, comms was restored and a rear dump that had been spotted into position started reversing toward the excavator. The CMW was unable to move the boom out of the way in time resulting in damage to the stick cylinder. There were no injuries to the CMW.

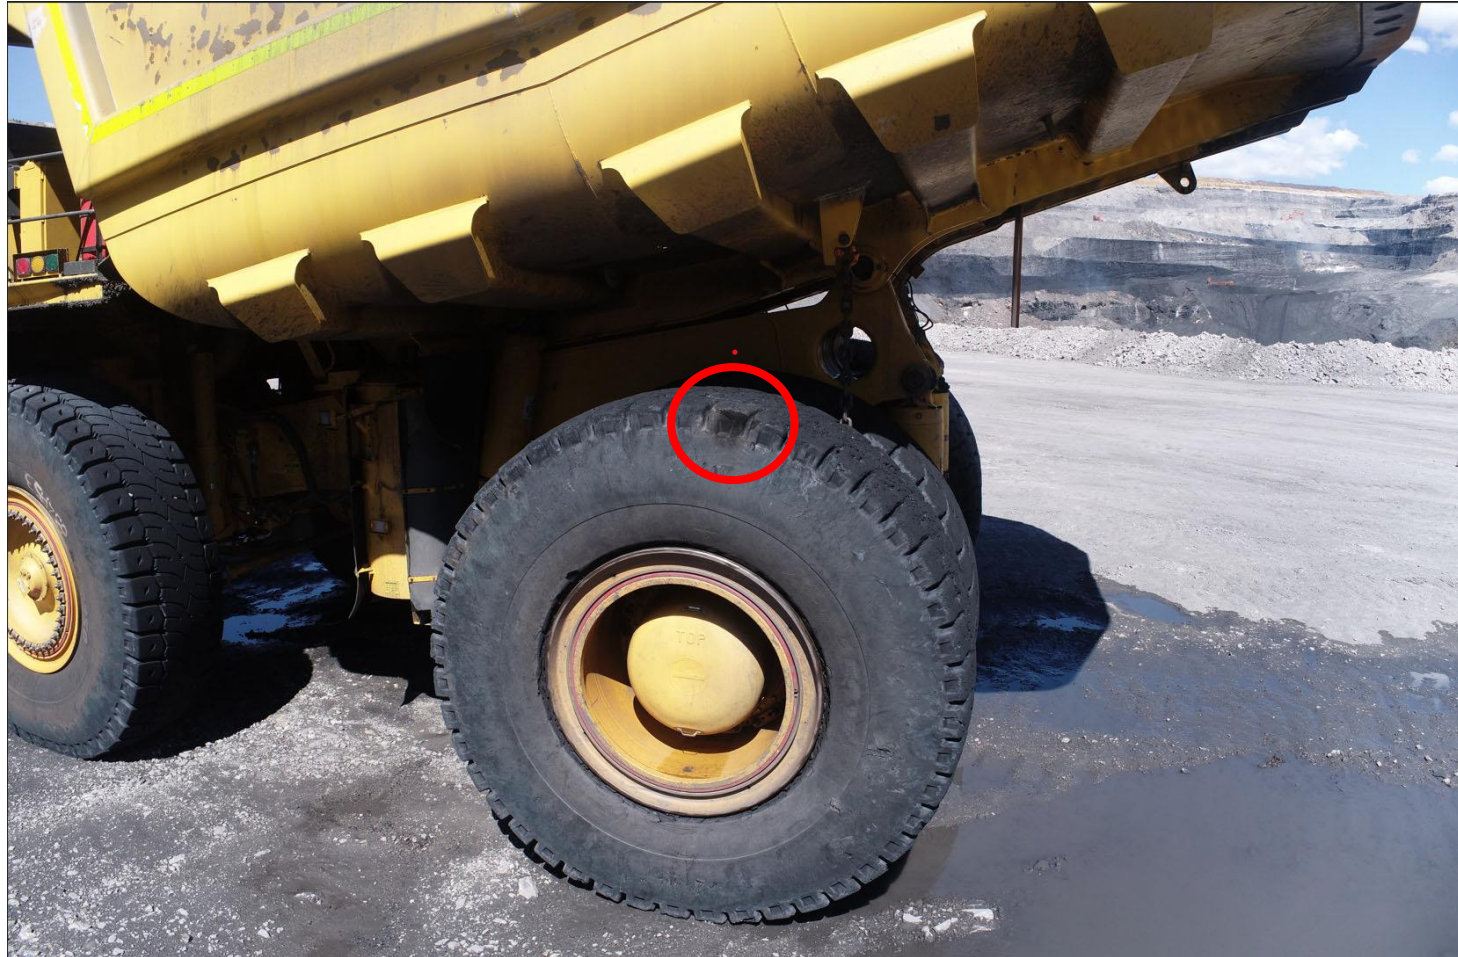
4. Incident – Tyre Fire from hot ground

A dump truck carting clean waste material has come into contact with heated material at a tip head.

The heated material had been previously dumped by another truck and caused POS 3 tyre to catch on fire.

An exclusion zone established was established and the tyre monitored. The situation was managed without further incident.

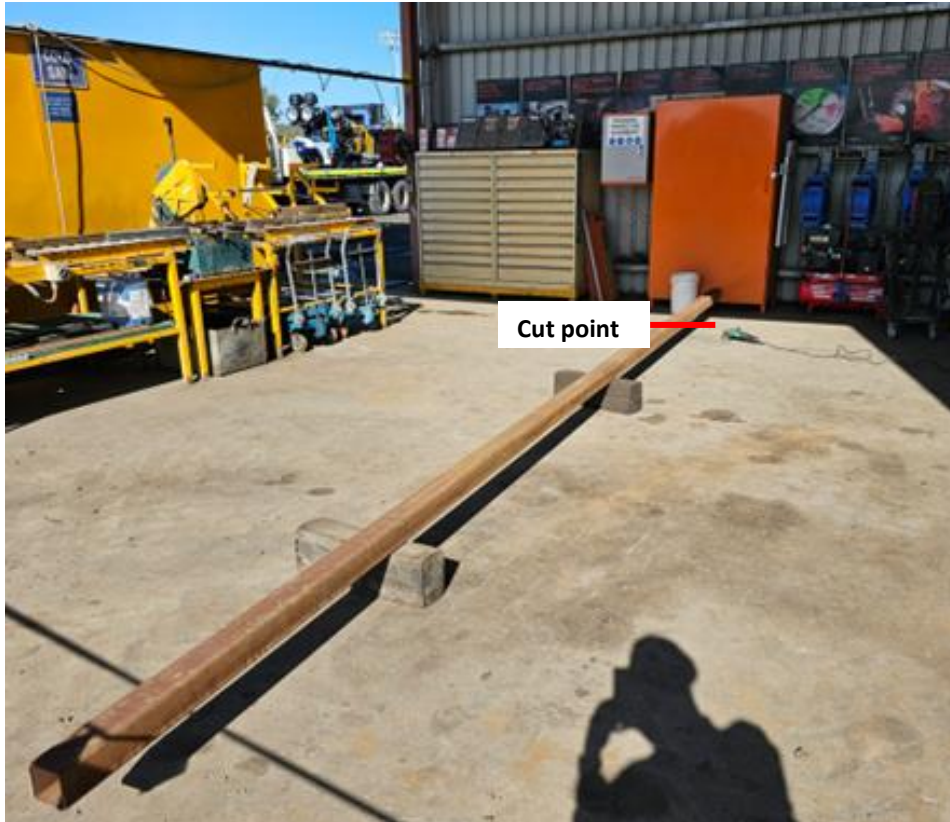
The boilermaker proceeded to cut the vertical section in a downward motion. The end section of the steel beam was unsupported. The final vertical cut has allowed the end section of steel to drop, pinching the cutting disc. This has caused the grinder to kickback, contacting the boilermaker on his inner right thigh.

Photo showing layout of beam and cut point. End section unsupported.

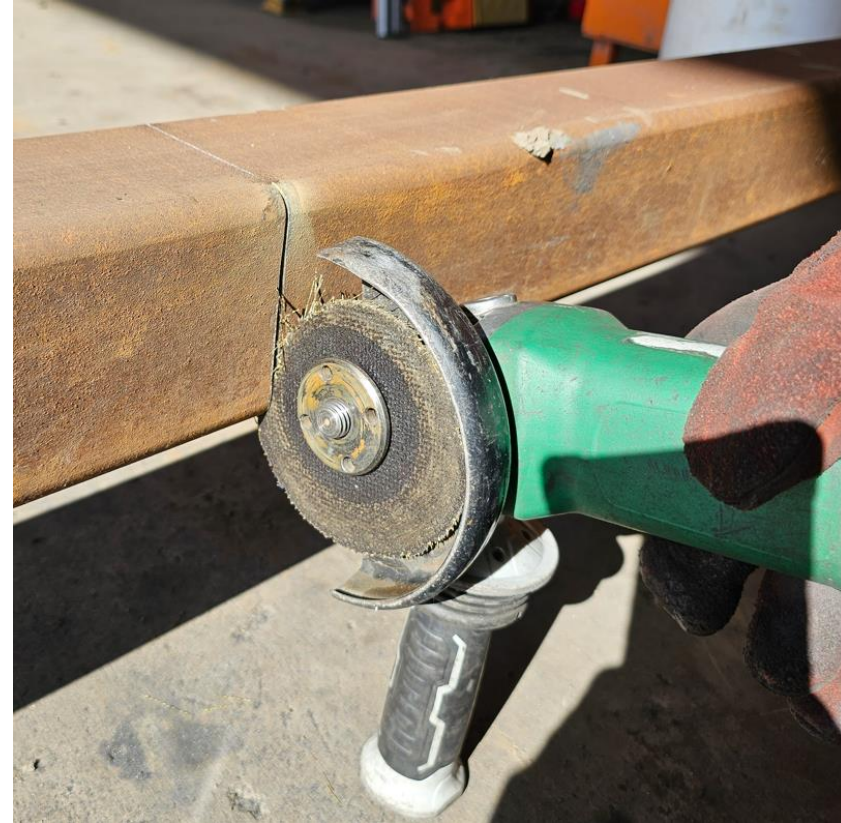
Re-enactment photo showing point at which grinder grabbed and kicked back

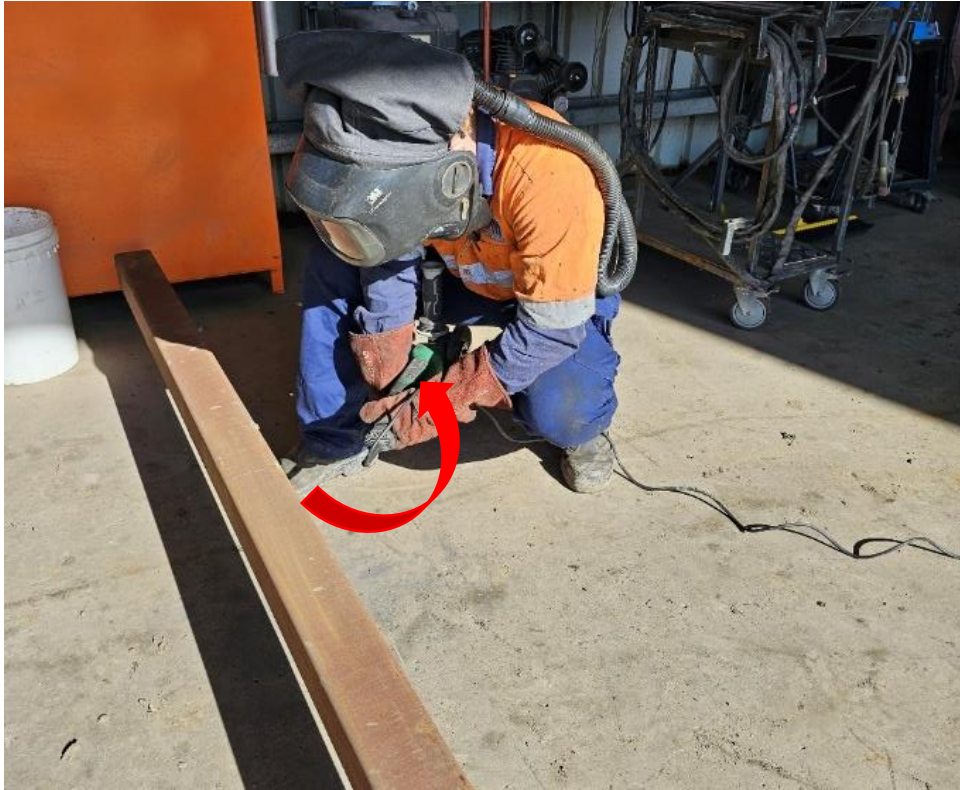
Re-enactment photo showing direction of movement by the grinder after kickback

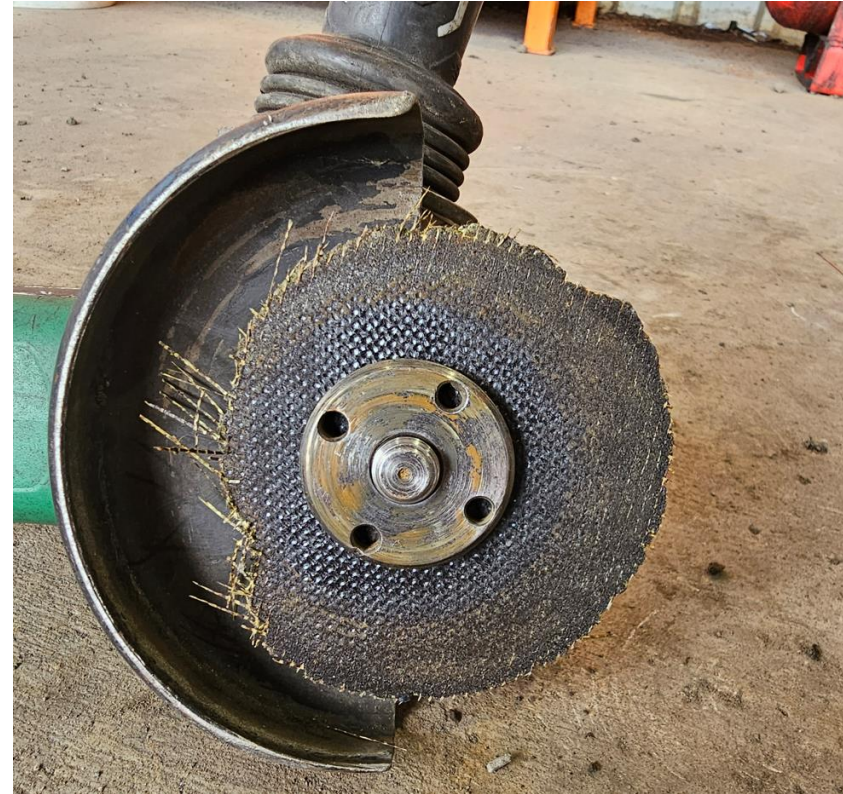
Photo showing condition of the disc after incident

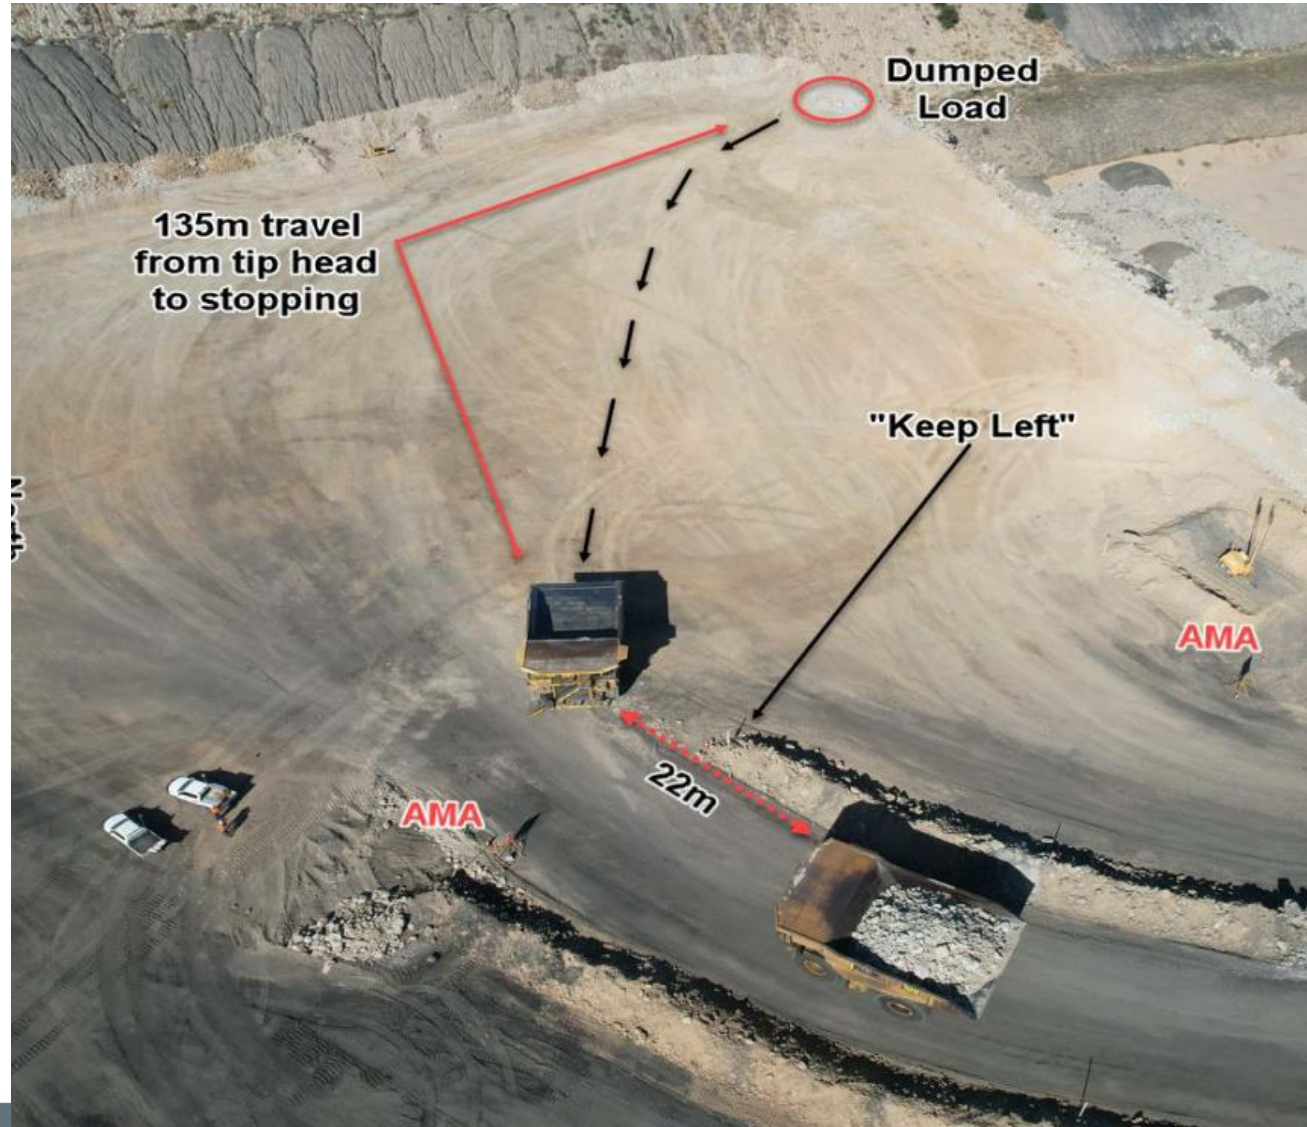
6. Incident – Distracted driver – Near Miss

While departing a tip head the operator of a RDT has become distracted while trying to change the 2-way radio channels in order to report a maintenance issue. This has resulted in the truck leaving the dump on the wrong side of the road. At this time another RDT was approaching the dump. Both trucks have stopped approximately 30 metres apart.

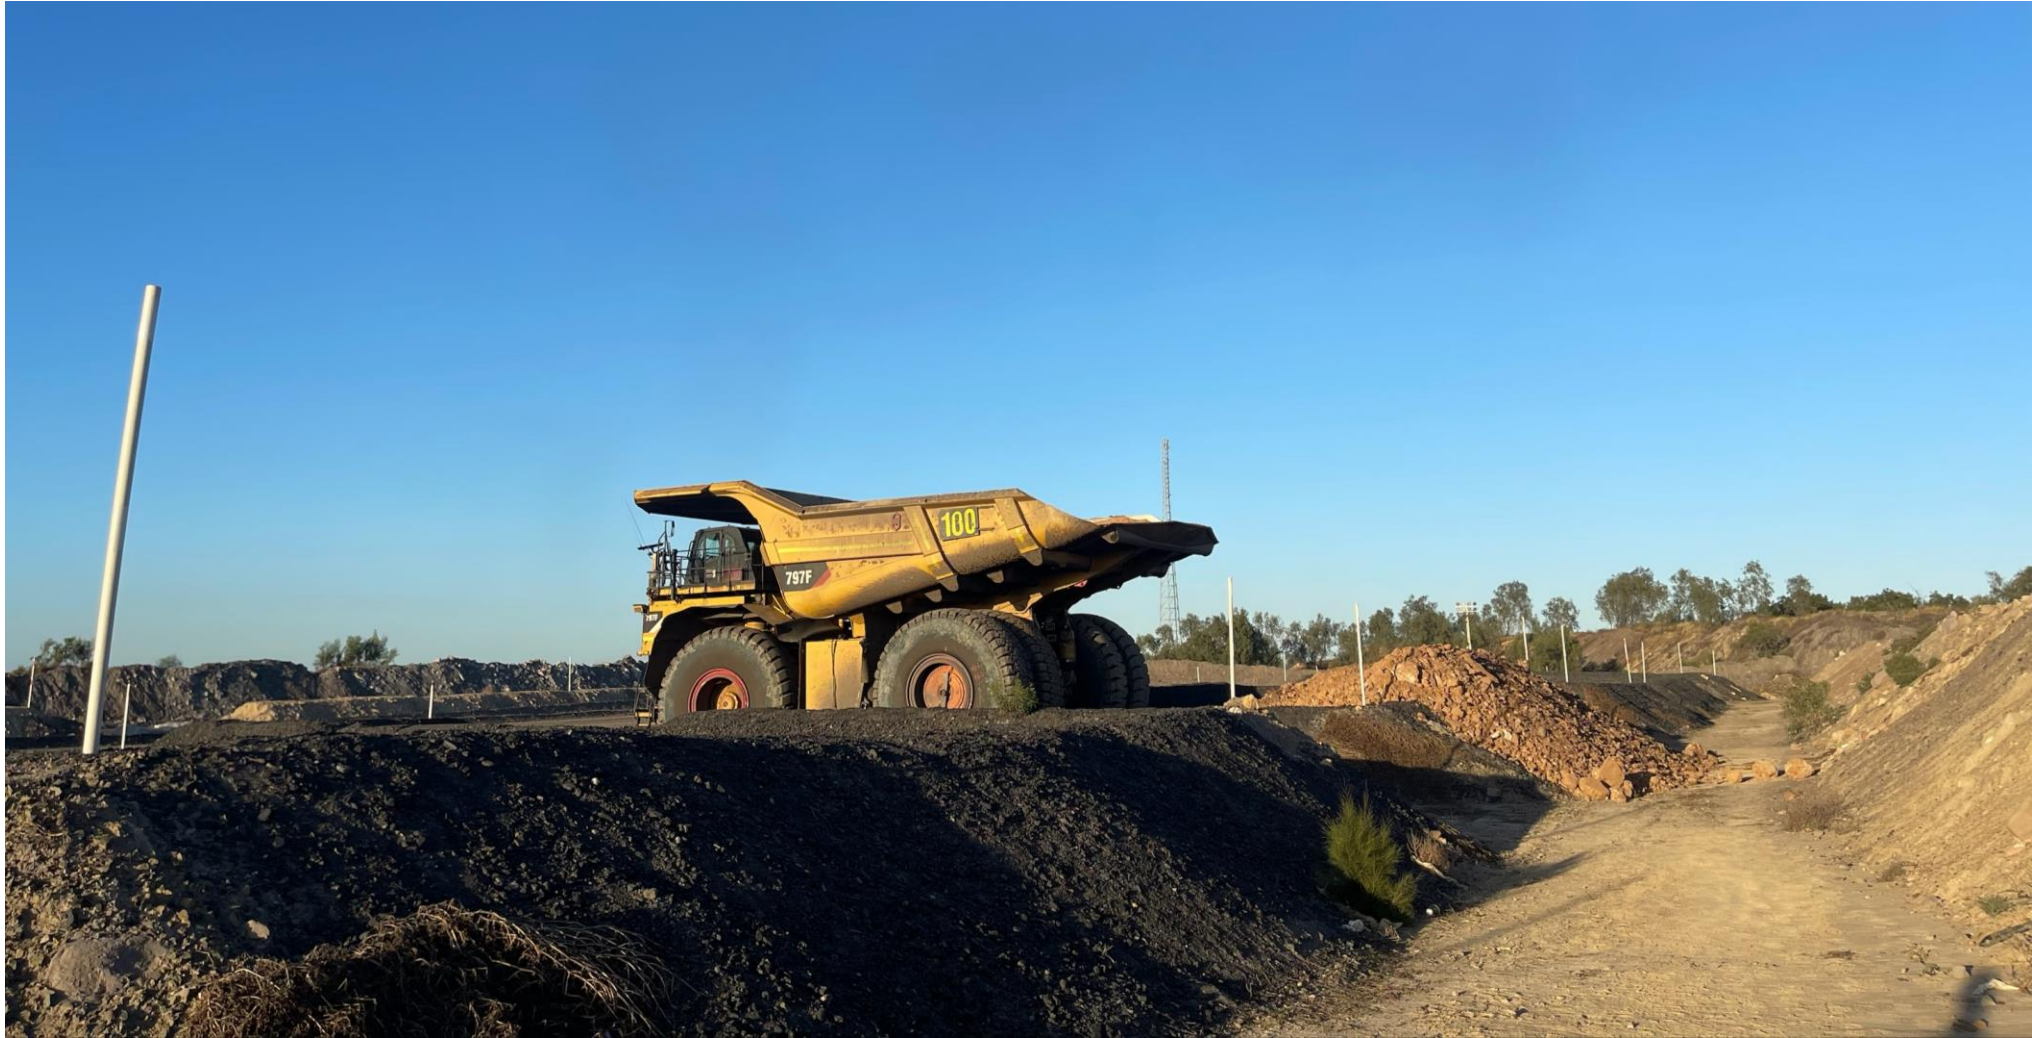
7. Incident – Materials discharged at go-line impacting walkway

CMW operating a RDT was observe to partially dump a load on circuit and continue to the go line. When arriving at the go line, another CMW contacted the operator informing them of hang up in the tray.

The CMW has proceeded to reverse all the way to the back bund of a park up bay, lift their tray and release approximately half a load onto the bunding. The material has rolled out over the bund and onto the pedestrian walkway behind the park up bay.

The CMW has then rolled forward into the V-drain and continue with their shift change.
