Resources Safety & Health  
Queensland

# MMQ Quarterly Report

High Potential Incidents and Serious Accident Summary  
Queensland Mineral Mines and Quarries Inspectorate  
*October – December 2023 quarter (FY24Q2)*

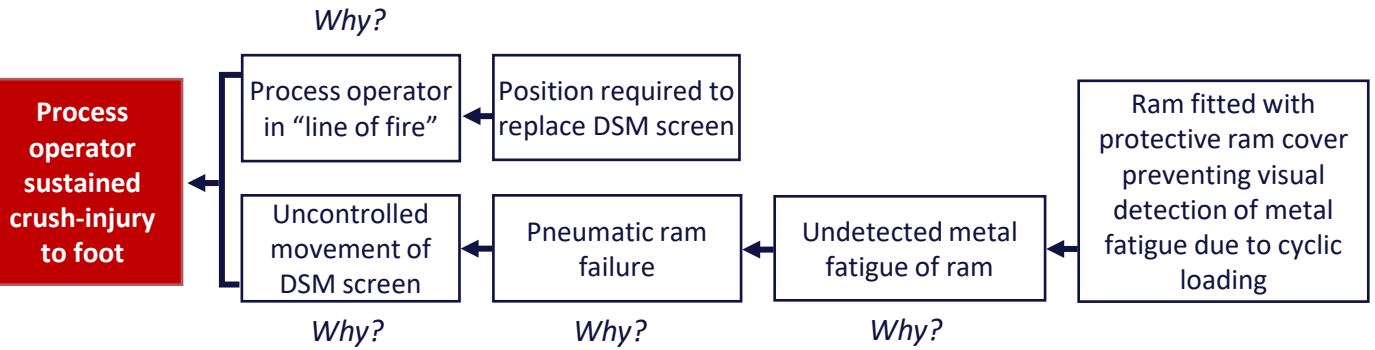
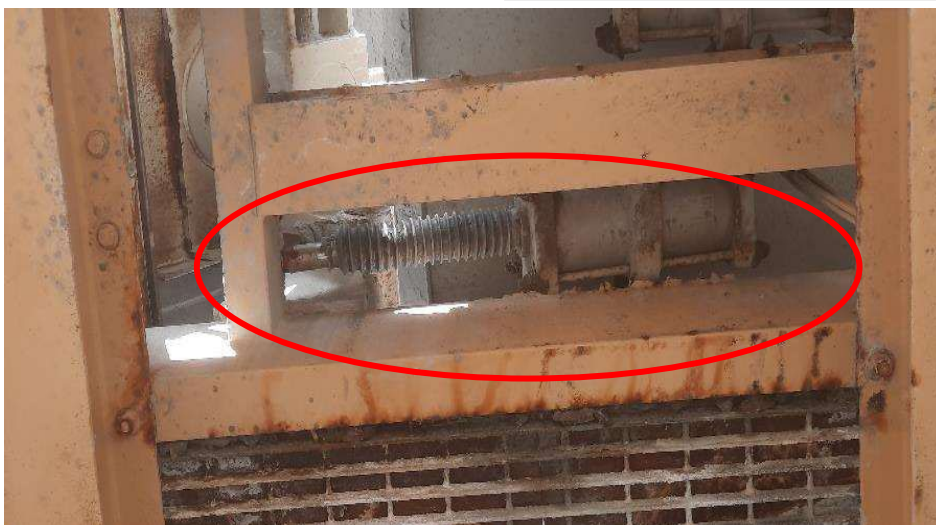
Fig 1 Failed pneumatic ram

A process operator had his foot crushed while changing a screen panel on a DSM screen. Preliminary information suggests that one of the pneumatic rams that brings the screen deck into position for maintenance failed, causing an uncontrolled movement of the screen.

- Corrosive environment.
- Pneumatic ram not maintained regularly.
- No visual inspection of pneumatic ram assembly prior to the task commencing due to protective ram cover.
- Reliance on pneumatic ram alone to support the weight of the screen assembly in its maintenance position.
- Worker positioned in the “line of fire” to gain access to the worn screen when ram failure occurred.

- Always inspect all components of lifting and load bearing equipment prior to use. Ensure all lifting equipment, including rams, are part of a register and regularly inspected to ensure it is fit for use in its intended environment.
- Do not rely solely on pneumatic or hydraulic systems to support loads while carrying out maintenance activities. Consider chocks, locks or pins as a more reliable form of isolation.
- Stay clear of suspended or hoisted items of plant. Identify exclusion zones in case of load lifting equipment failure.

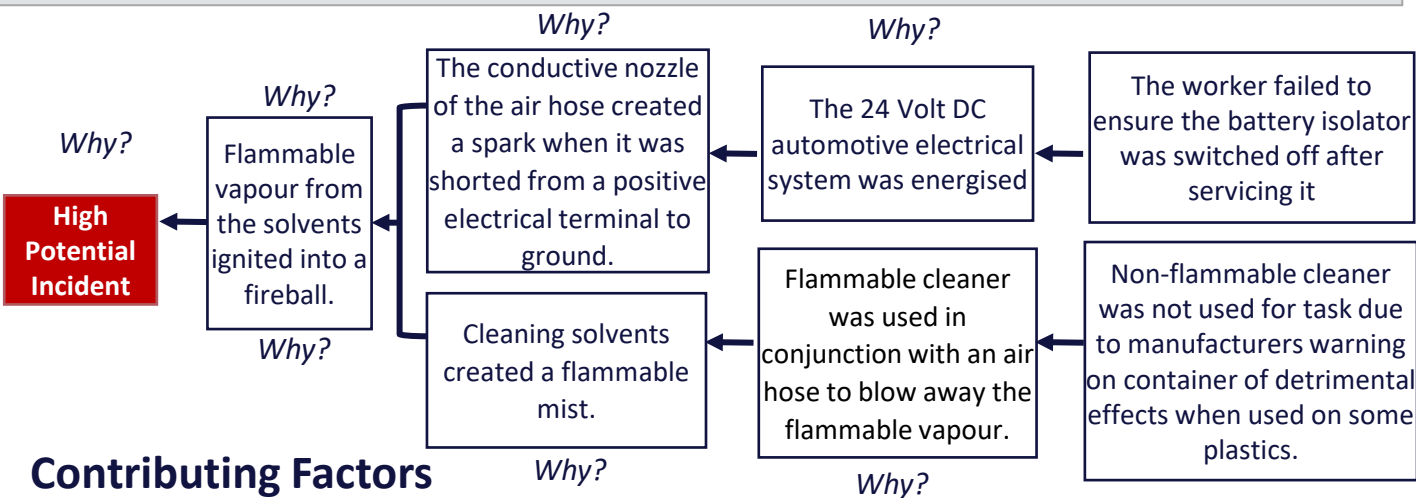
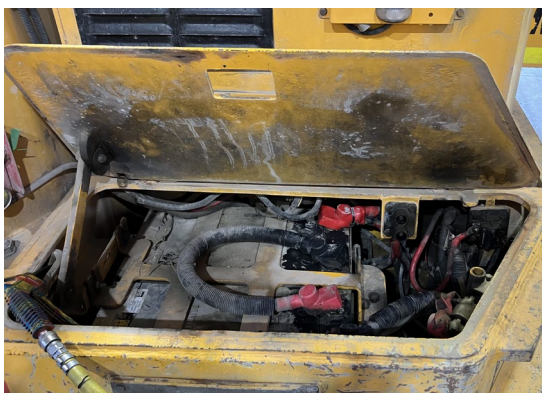
A service was being performed on an underground dump truck. The electrical system was isolated at the battery isolator. During the service it was reported to the auto electrician that the main battery isolator was "sticky" to operate. The isolation point was changed to the starter motor so work could be completed on the battery isolator. The worker proceeded to repair this defect using spray cans of brake cleaner and CO contact cleaner, both of which have flammable vapours. The worker then failed to ensure the battery isolator was in the off position when proceeding with the service to clean electrical terminals inside the battery compartment using flammable cleaner. The worker was aware the vapours were flammable and was using an air hose to blow away the vapours, when the metal nozzle of the air hose shorted from a live 24 Volt positive circuit breaker terminal to the negative vehicle body creating a spark and igniting the flammable vapour. The worker received burns to their face.

The mine risk management process was followed at the start of the job, but the hazards and controls were not reassessed when a change in the original job task occurred. (Change Management).

The energy source was not isolated when performing this task. The energy source could have been isolated while performing this task, eliminating any spark potential from this energy.

- Working on energised plant must not occur when work could be performed with the plant de-energised and isolated.
- The hazard identification process must review the hazards and controls before any changes to the work environment or tasks occur while the job is being conducted.
- As a mitigating control, consideration should be given to using insulated tools around exposed live automotive electrical systems.
- Risks involving cleaning live electrical switch terminals using flammable solvents also need to be controlled.

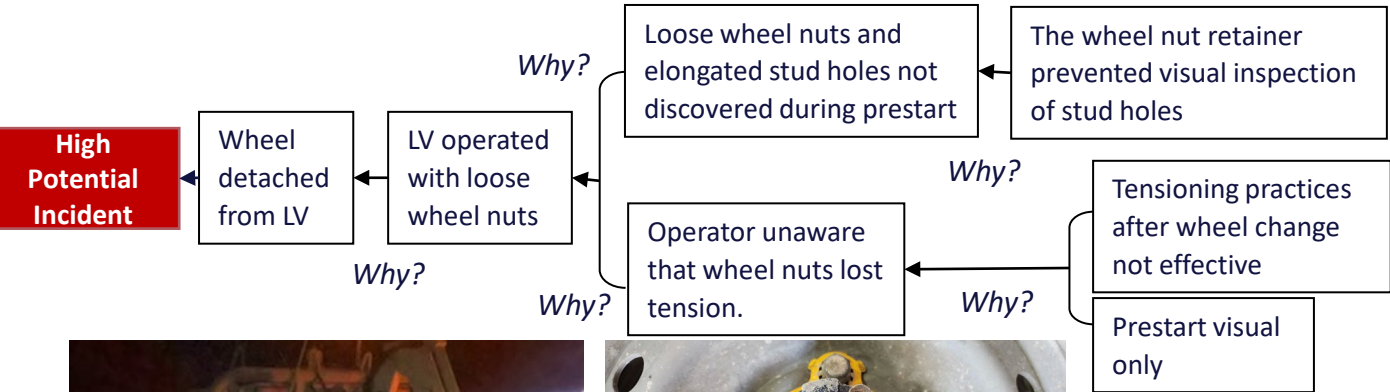
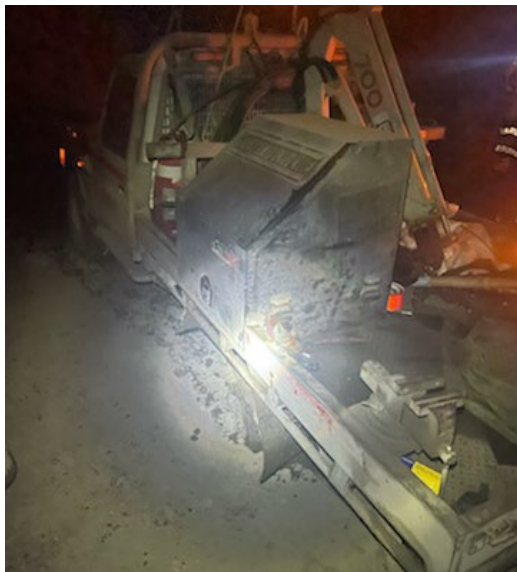
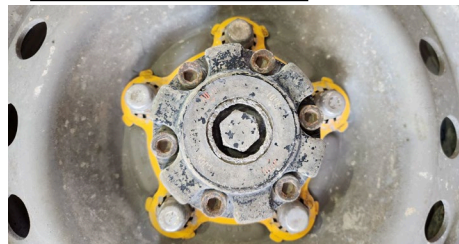
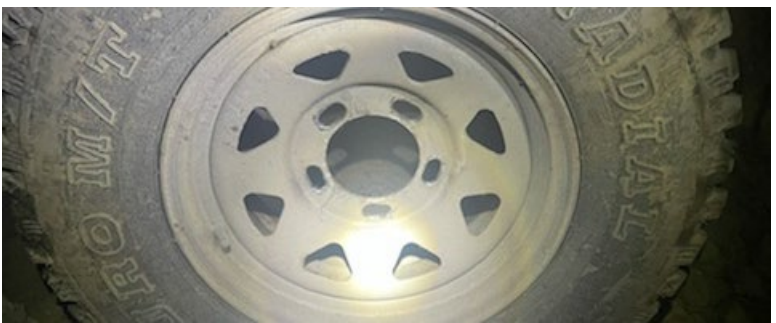
While travelling on the decline, the operator of a light vehicle (LV) felt vibration in the rear. The operator stopped and reversed slowly off decline into a cuddy. During this manoeuvre, the passenger side rear wheel detached.

Figure 1, 2 & 3 – Photos showing LV, detached wheel and wheel nut retainer

- The wheel had been changed several days prior to the failure and the wheel was found to have elongated mounting holes from a period of running loose on the hub.
- The locking-ring style wheel nut retainer did not stop the nuts from coming loose.
- Periodic tensioning of wheel nuts after the wheel change was not effective.
- Prestart check relating to wheels was visual only.

- Tapered mounting surfaces on wheel nuts and wheels must be inspected for damage during wheel change to ensure correct matching components are used.
- Hubs, studs and wheel mounting faces must be clean and free from debris before fitment.
- Sites should ensure wheels on LVs are correctly torqued, and subjected to periodic checks and re-torqued after a wheel change.
- While wheel nut retainers can provide a level of security, appropriate wheel nut tension should still be periodically checked with a tool, for example during the prestart.
