**Resources Safety & Health**  
Queensland

Summary report regarding death of worker  
at Red October Mine (ML 95357) Queensland  
on 26 November 2022

*Mining and Quarrying Safety and Health Act 1999*

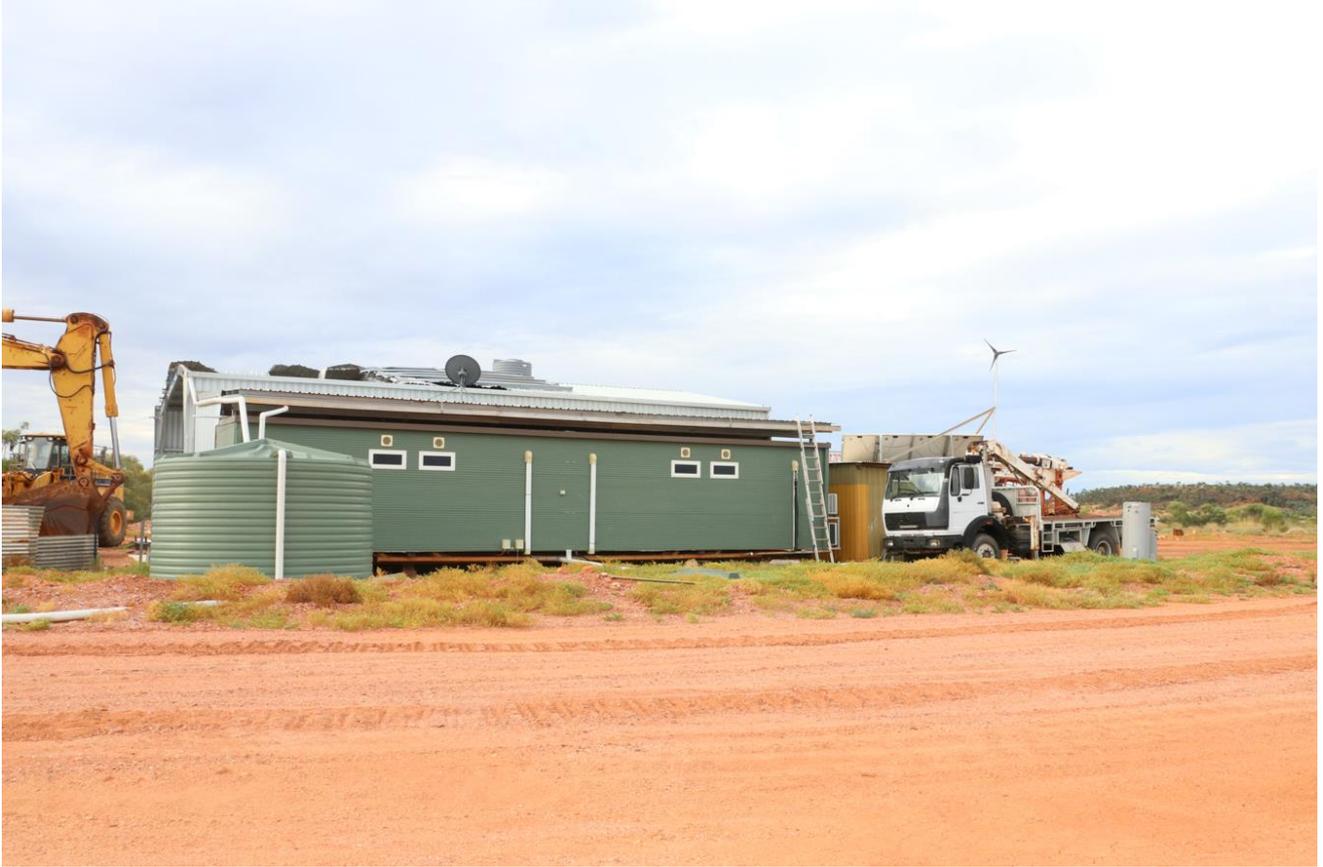
Mr Selig accessed the workshop roof via the roof of the adjoining accommodation building using an extension ladder. Once on the workshop roof, he commenced removing roofing screws from its purlins.

*Photo 1: Workshop area layout – looking north (Note: Extension ladder used by Mr Selig to access workshop roof)*

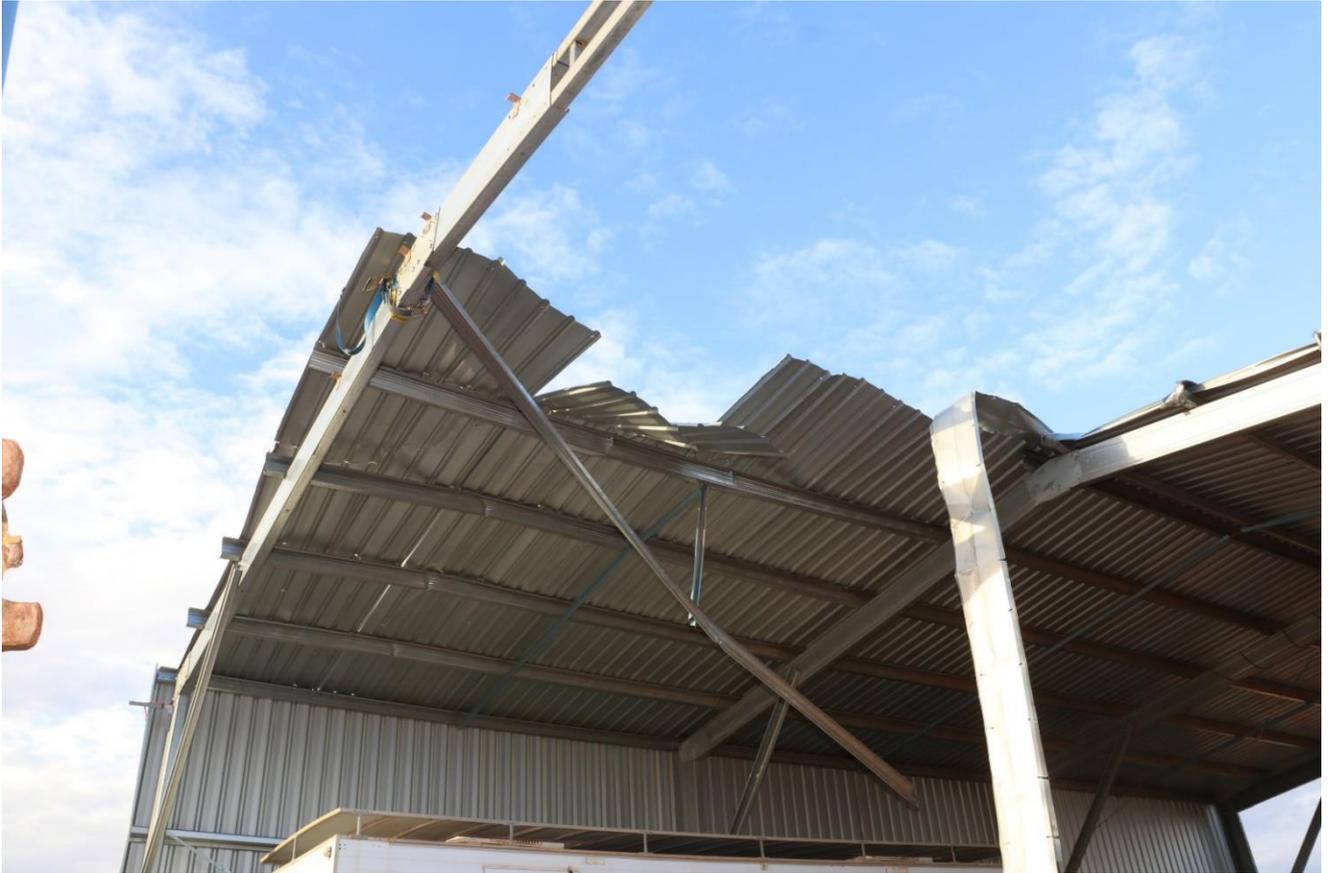
Mr Selig had been undertaking repairs to the roof of a workshop that had been damaged during a severe weather event. Whilst Mr Selig was walking along the damaged roof line, the ridge purlin gave way causing Mr Selig to fall through the roof sheeting to the ground.

*Photo 2: Section of roof structure where Mr Selig was working at time of accident*

In 2020, the workshop's end frame was damaged when it was contacted by heavy mobile plant.

In 2021, repairs were made to the workshop's damaged end frame. These repairs were a modification to the original design & installation of the structure.

Further damage was caused on or before 24 November 2022 during a severe weather event. At the time of the accident Mr Selig and the other worker were attempting to repair this damage.
