# Incident periodical

High Potential Incidents summary

Queensland Mineral Mines & Quarries Inspectorate

April 2020

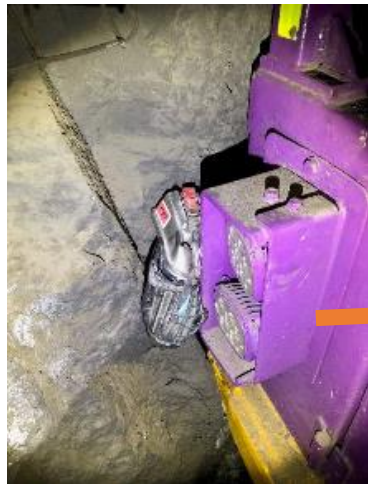
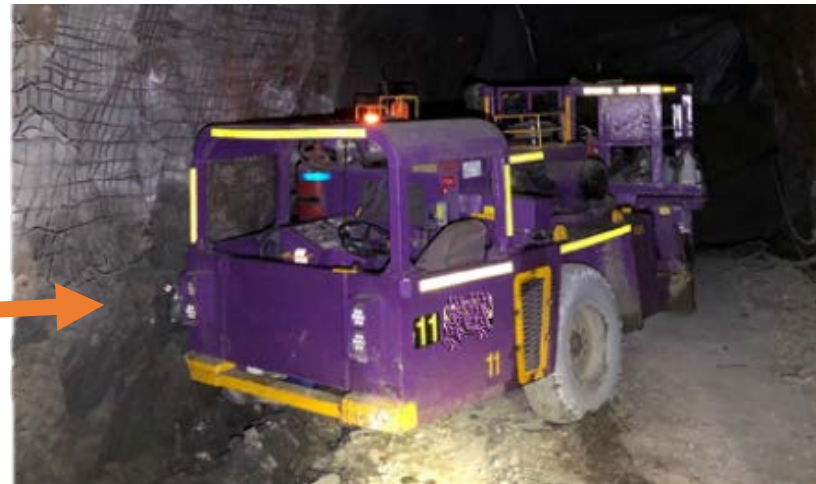
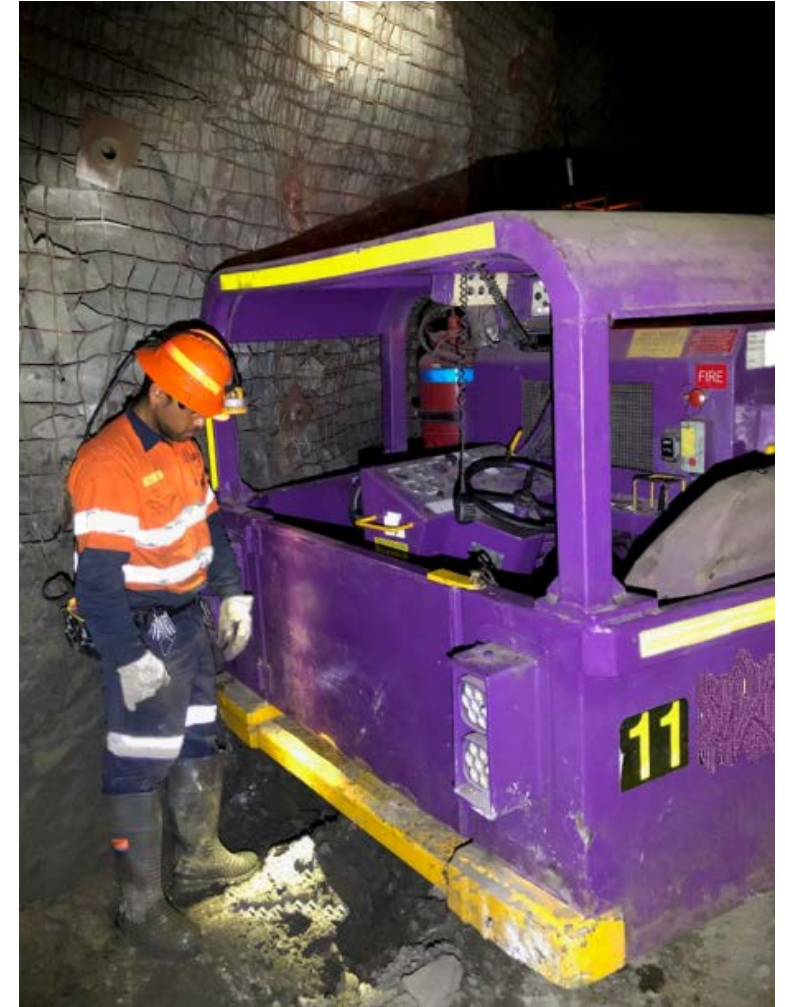
When the braking systems of a Getman EWP failed, the operator steered the unit into the wall to bring it to a stop. A worker positioned nearby evaded the unit and was unharmed. The vehicle came to a stop against the wall and in the process had pinned the self-rescuer of the nearby worker.

While attempting to reverse a Getman EWP up a decline, the operator selected reverse gear and disengaged the park brake. Despite reverse gear engaging the Getman has rolled forwards down the decline. The Operator then attempted to use the service brake and the park brake to stop the Getman rolling. Neither of these worked due to incorrect installation of the hydraulic dump valve two days previously.

- Maintenance of the contractor's equipment was inconsistent and did not follow OEM requirements, and was not as required by the mine safety and health management system or standards for mobile plant
- Previous faults identified were not booked out
- The system for tracking and registering faults was not implemented effectively for Contractor supplied mobile plant.
- The hydraulic dump valve supplied was different to the one required for replacement
- An incorrect hydraulic schematic used to fault find park brake issue when installing the hydraulic dump valve

- All mobile plant prestart checklists, including contractor, must state required action to be taken for identified faults. [Administrative]
- The mine safety and health management system must document how all mobile plant prestart checklists, including contractors, are monitored for effectiveness. [Administrative]
- Review all contractor supplied plant to ensure it is maintained and repaired as per OEM requirements and correct technical information is available for workers carrying out repairs and maintenance. [Administrative]
- Maintenance procedures must state how work is checked to ensure reference was made to correct technical information when carrying out repairs or maintenance. [Administrative]

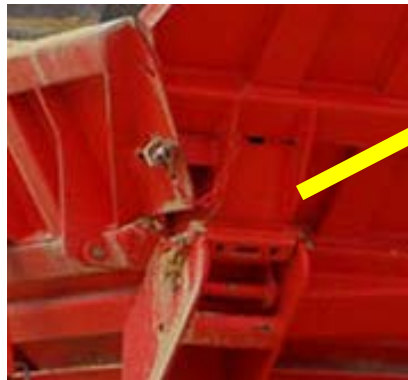
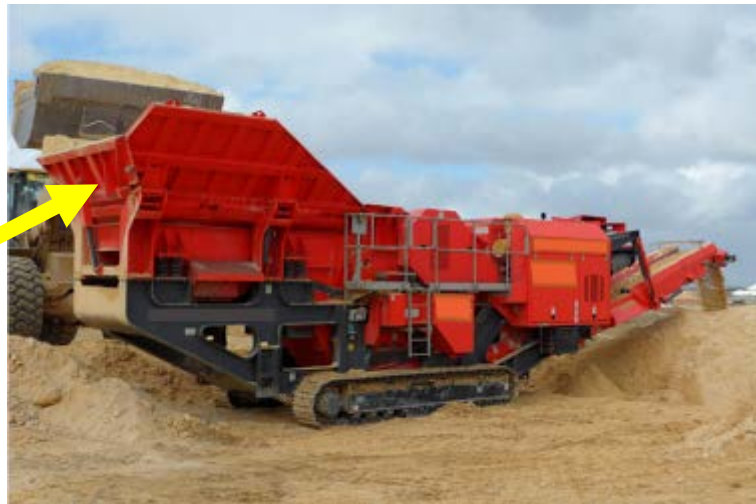
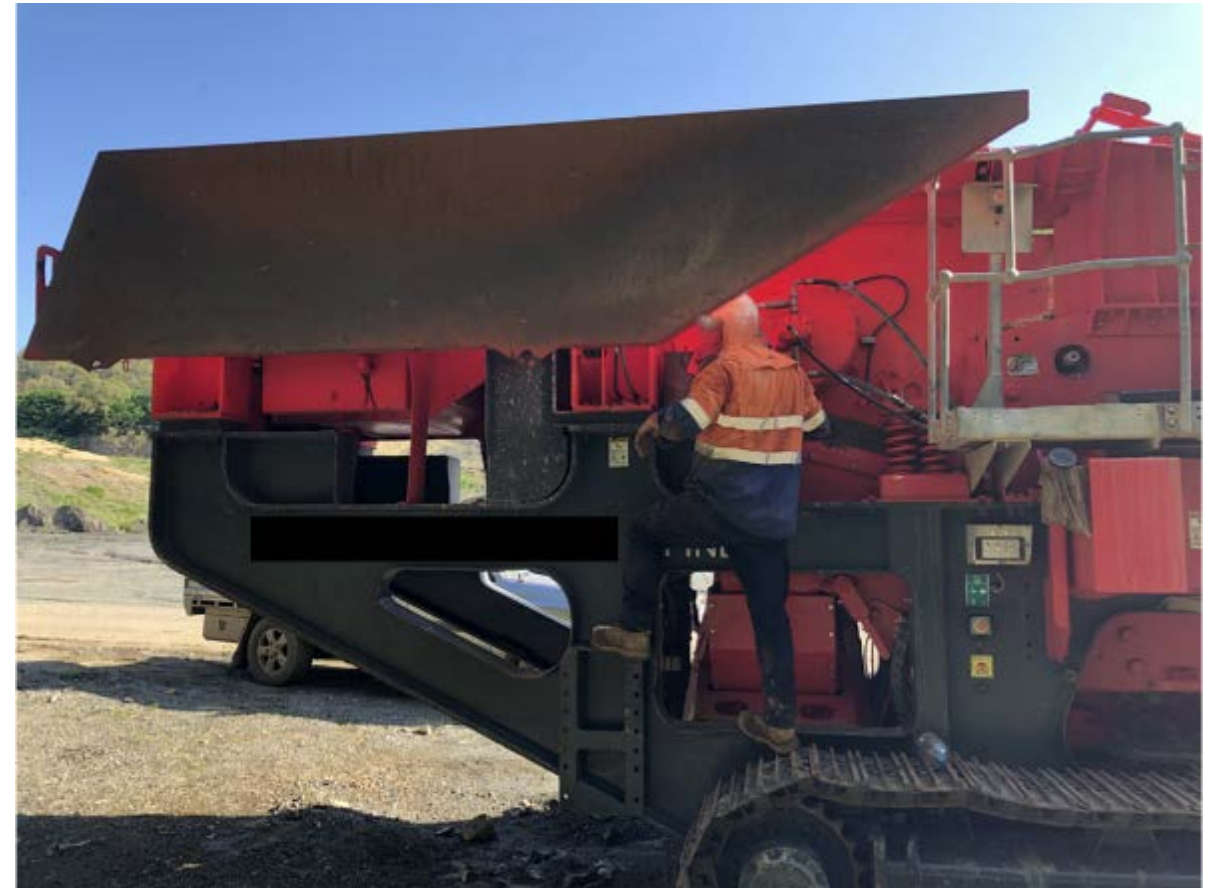
Quarry workers were in the process of demobilising a mobile jaw crusher for transport. As part of this process the feed hopper wing walls can be folded down. A wing wall fell in an uncontrolled manner to its folded position striking a worker on the neck.

As part of this process the feed hopper wing walls can be folded down. The mechanical wedges that tie the wing wall to the one at the rear of the hopper had been removed.

With the mechanical wedges removed, the wing wall can be lowered in a controlled manner using a hydraulic ram. The clevis pin and retaining pin which would normally attach one end of the ram to the folding wing wall was missing. This left the wing wall unsupported when the mechanical wedges were removed.

A worker climbed onto the track and frame of the jaw crusher in order to observe why the wing wall was not moving when the ram was being actuated. The wing wall fell in an uncontrolled manner to its folded position striking the worker on the neck.

- Clevis pin was missing on a hydraulic ram used for the lowering and raising of wing walls.

- Audit all plant hydraulic ram attachments to ensure that the design of the clevis pin retainer used is such that it cannot become dislodged as a result of shock loading or vibration. [Engineering]
- Implement a method to check that clevis and retaining pins are in place and secure. [Administrative]

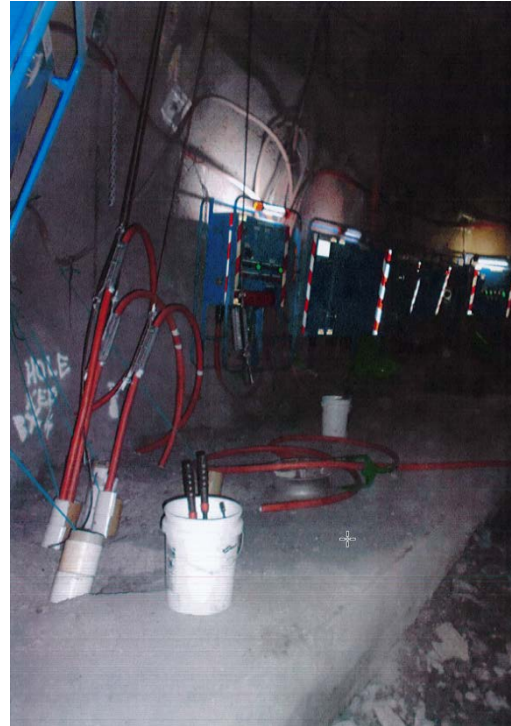
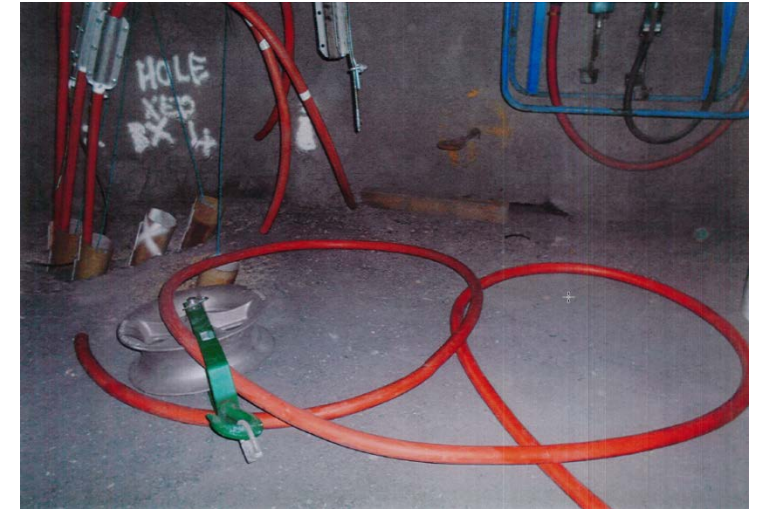
A team of workers was tasked with installing 95mm, 3 core and earth steel wired armoured power cables down service. The set-up for this task involved installing a pulley off a resin bolt on the backs of the drive. Cable was to be wound off the drum, through the pulley and down the service holes. At the completion of the installation of the third cable the cable was cut and the job paused while two of the workers went to straighten the cables on the level below. During this time the pulley and the cable have detached from the backs of the drive falling to the floor. One of the workers was struck by the cable and suffered muscular-skeletal pain to his neck.

- Use of non rated rigging equipment (D-Nut) and rigging not correctly installed (not enough thread left on bolt to enable D-Nut to be threaded on fully)
- The anchorage point for the cable pulley was not tested prior to use
- Competency of worker rigging cable drop (No rigging or dogging qualifications)
- Hazard identification – Line of fire (Drop zones not demarcated/barricaded)
- Installation methodology differed to cable installation procedure.

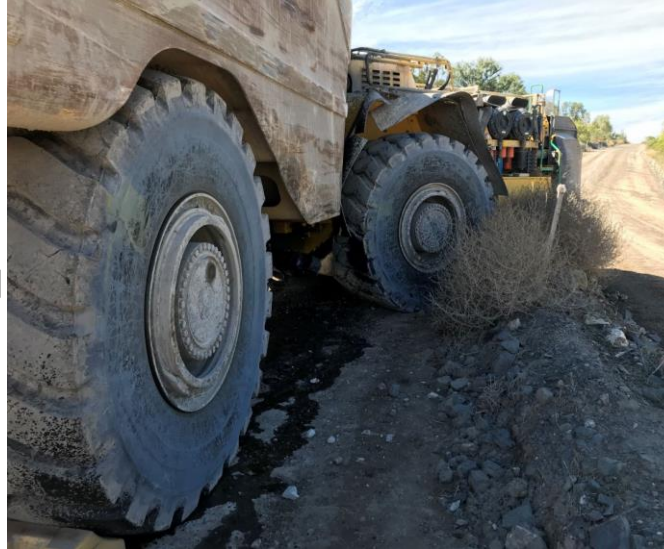
On 6 July 2020, a haul truck suffered a steering component failure in the articulation area, causing the truck to slew and impact the road bunding.

The investigation found that the retaining bolts of the right-hand steering cylinder had failed and allowed the retaining pin to fall under gravity.

Subsequently, one end of the steering cylinder detached from the truck frame.

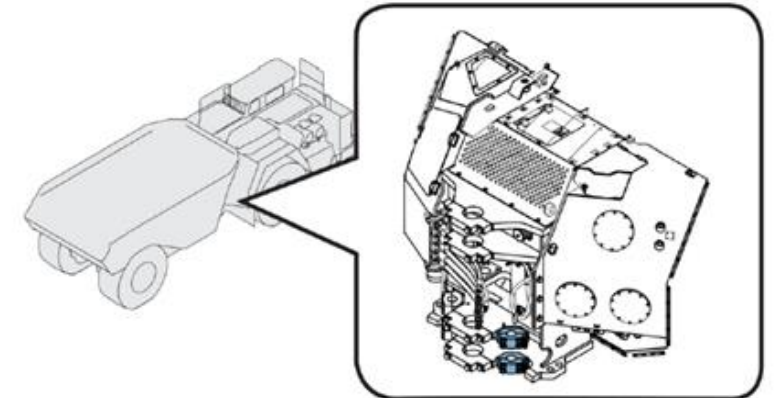
OEM manual extract

## 11.30 Check Steering Trunnion Caps

- Check trunnion caps to ensure that all marks are aligned.

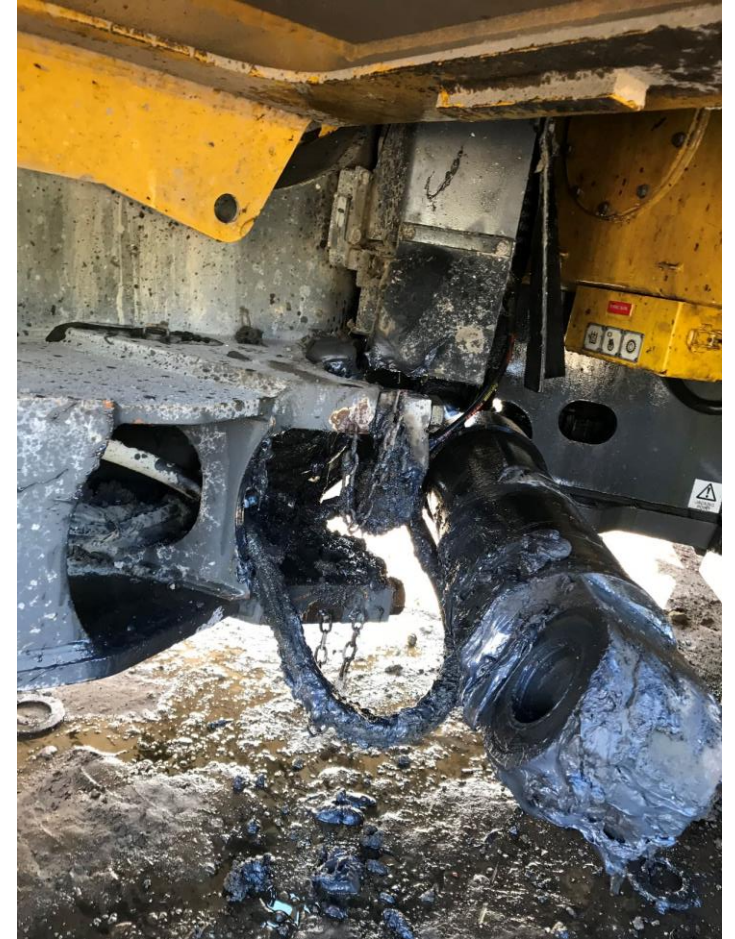
- Original Equipment Manufacture recommendations regarding steering components lost or not acted on.
- Existing procedure for inspection of steering bolts was insufficiently detailed.
- Equipment integrity - Bolts sheared – under normal operating conditions.

- SSE should:
  - Replace steering cylinder retaining (trunnion cap) bolts on similar trucks. [Engineering]
  - Implement a system to detect pressure spikes in the steering system (e.g. from wall impact) that could potentially contribute to premature bolt failure [Engineering]

- Establish a preventative maintenance task to regularly replace bolts - OEM recommends replacement at 4000 engine hours; the mine has adopted a more conservative 2000 hour replacement interval. [Engineering]

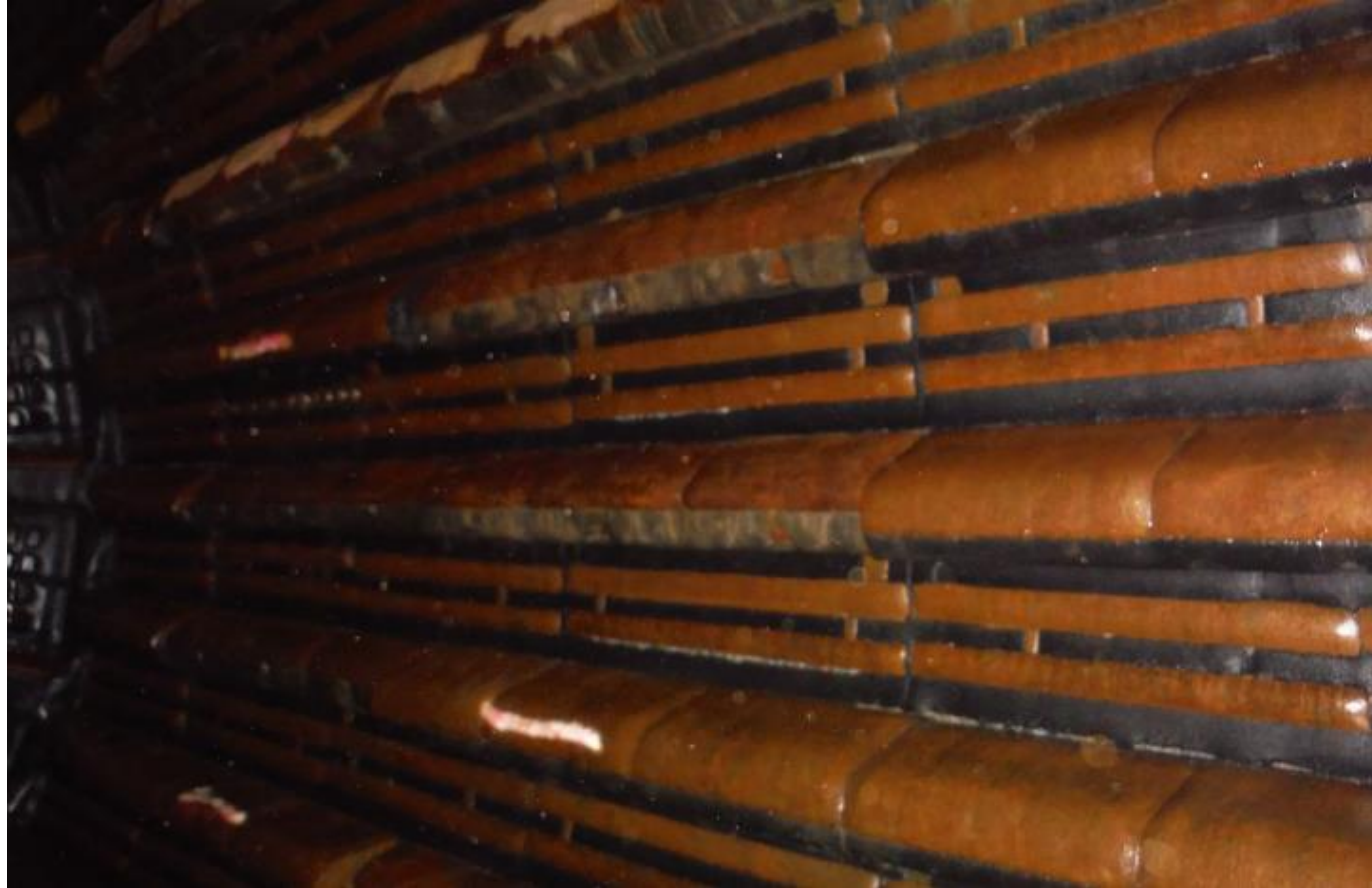
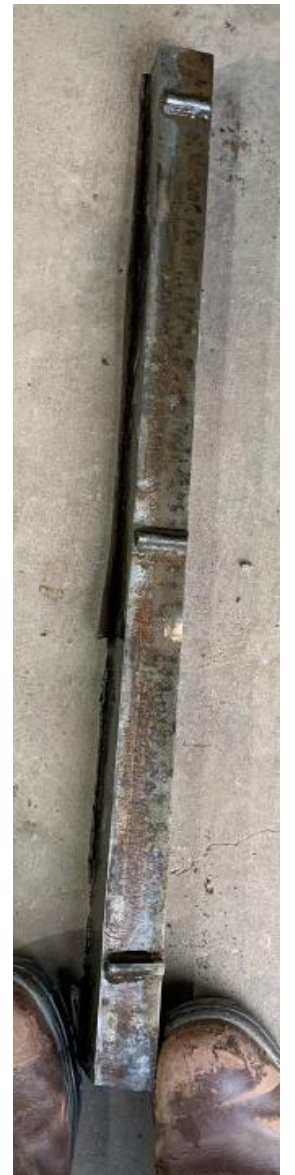
Without warning, a Hardox wear bar from one of the mill liner plates fell from the top of the mill, narrowly missing the reline crew.

The investigation by the manufacturer found that the interface between the rubber and steel layered structure in lifter bars and shell plates failed, severely reducing their load-bearing capacity.

The interface debonding has been attributed to the lapses in the manufacturing process of the second and third ring of lifter bars and shell plates. It was found that the gauge used for monitoring the time and temperature produced incorrect readings which led to faulty manufacture of the product.

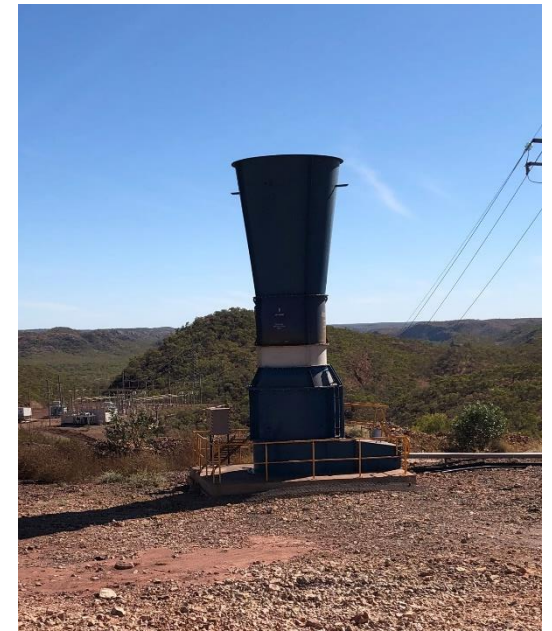
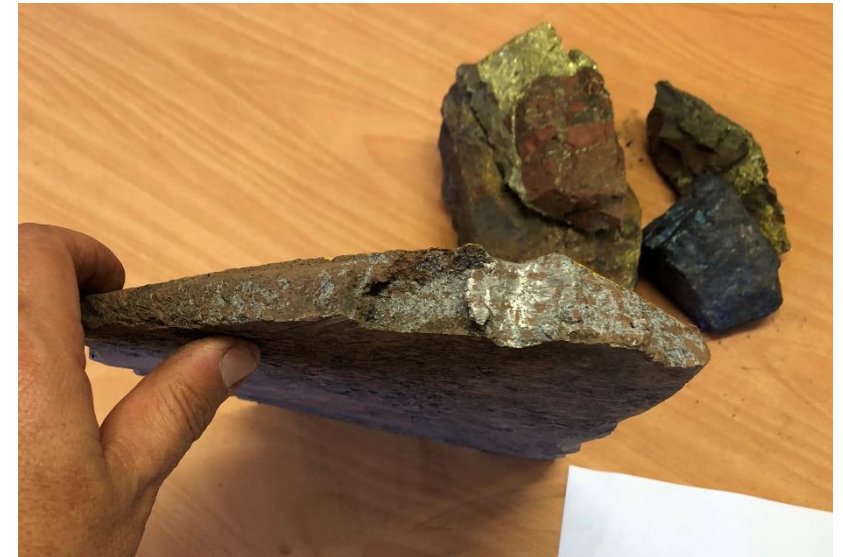
On 31 July 2020, a failure in the primary fan destroyed all fan blades and left palm-sized fragments within a 15 metre radius of the installation.

The fan cowling and evasé were not damaged by the disintegration of the fan components; the fragments were ejected out of the top of the evasé.

- SSE should:
  - Reduce pitch of fans from 54 to 43 degrees. [Engineering]
  - Establish mechanical maintenance strategy as per OEM documentation [Administration]
  - Conduct detailed mechanical inspections of all fans onsite [Administration]

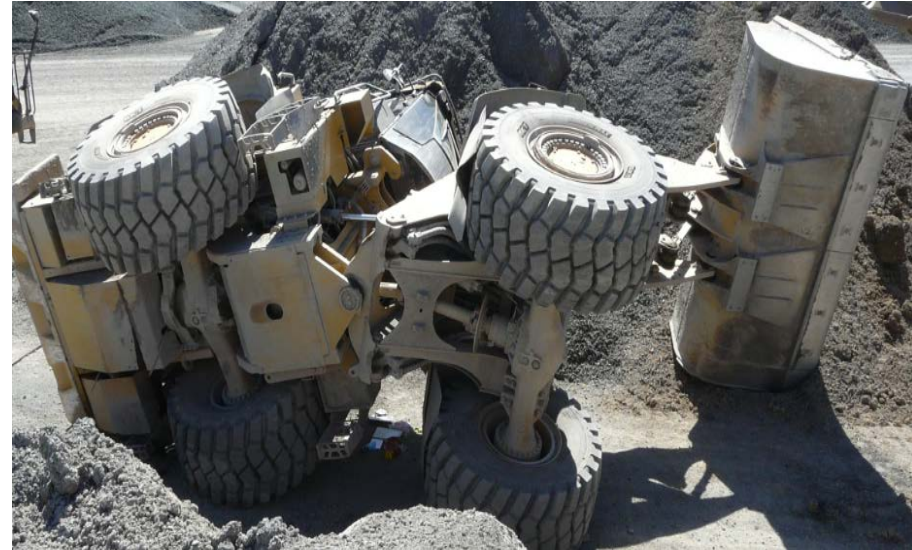
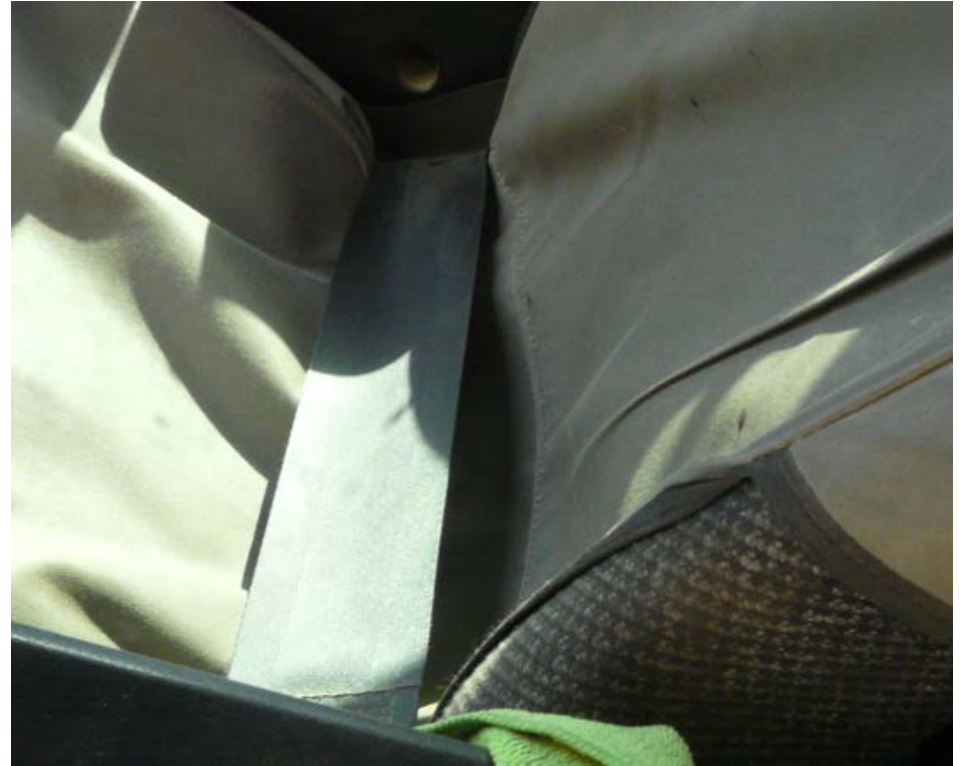
On 31 August 2020 a loader was stockpiling road base and travelling up the stockpile ramp nearing the top when it veered to the left, tipped over and rolled down the side of the stockpile.

The investigation by the quarry found that the loaded bucket was raised and the loader was articulated.

The operator was not wearing the seat belt even though he had signed off on the requirement on two recent occasions. The seat belt was fastened and then sat on so that the reminder indicator and recording system were defeated.

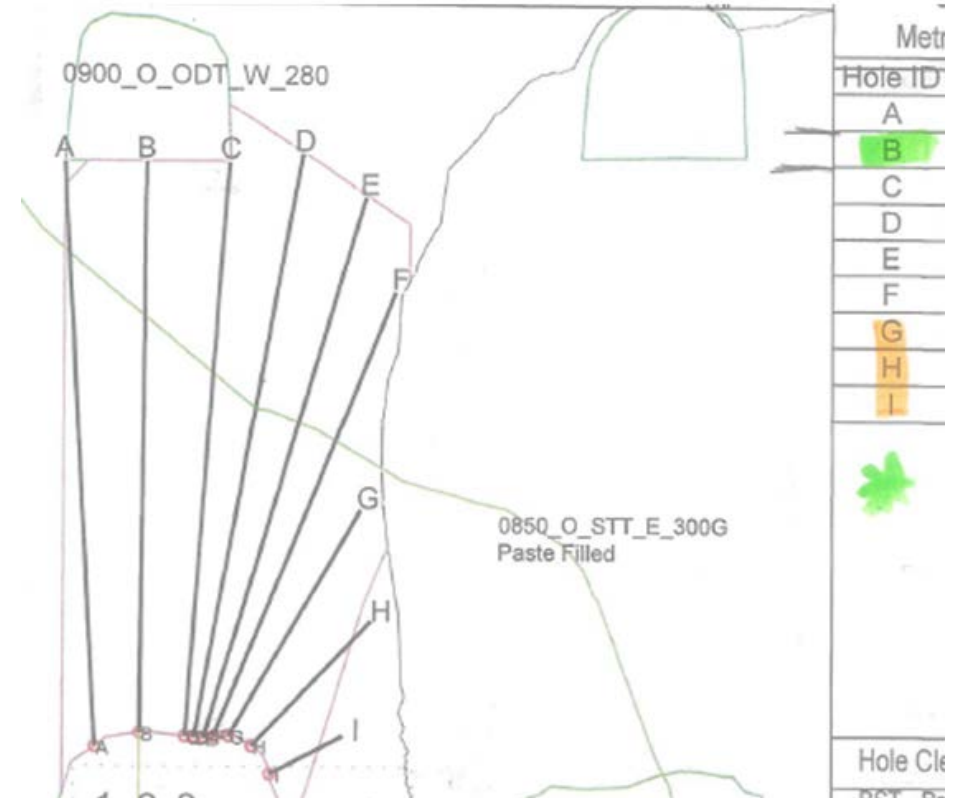
The drillers were working to the drill plan that was not marked up and knew they would break through into the upper level drilling hole **B**. The drillers thought that the cross shifts had put the barricading in place and did not check it themselves.

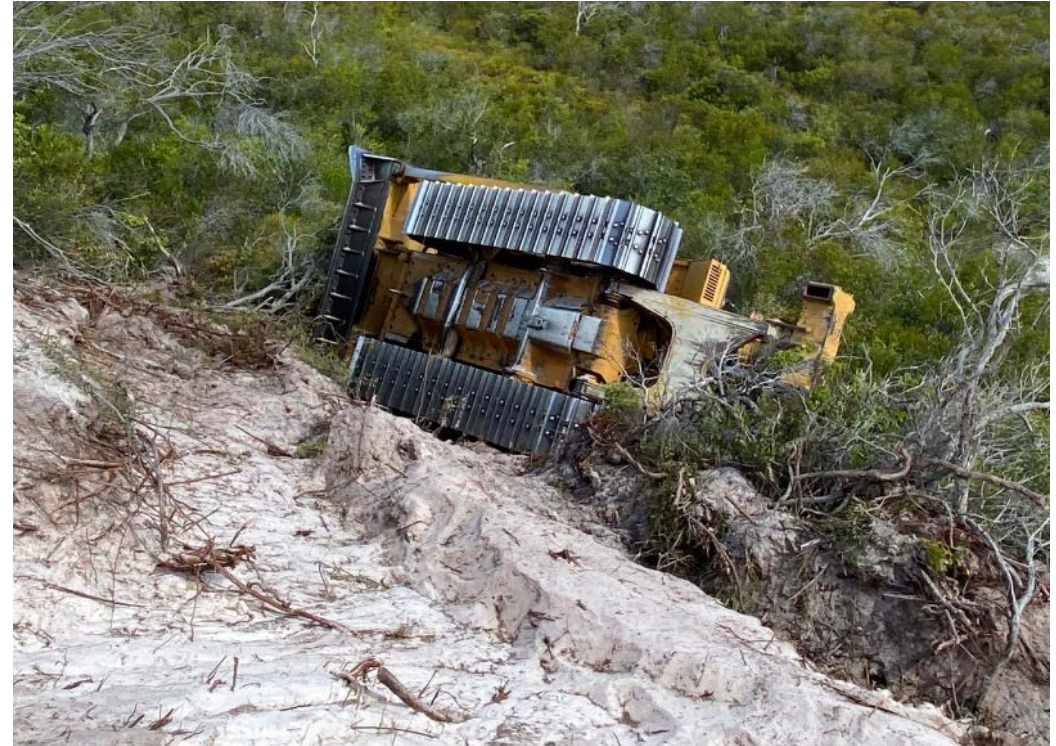
On 15 September 2020, a dozer operator was creating a track on a the ridge of a sand dune when the dozer slid sideways and veered to the right hand side. The dozer was still stable at this point and only rolled over when the operator tried to reverse back up onto the ridge. The operator was wearing the seat belt and was not injured.

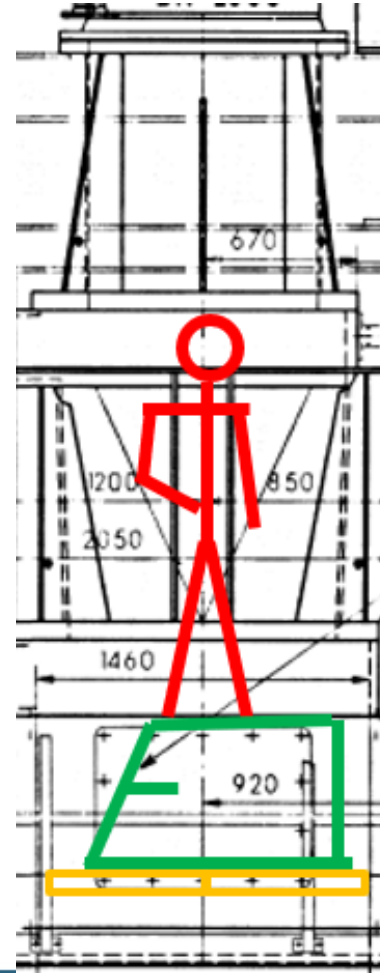
Cross sectional illustration of discharge chamber.

The worker sustained a compound fracture to their right leg.

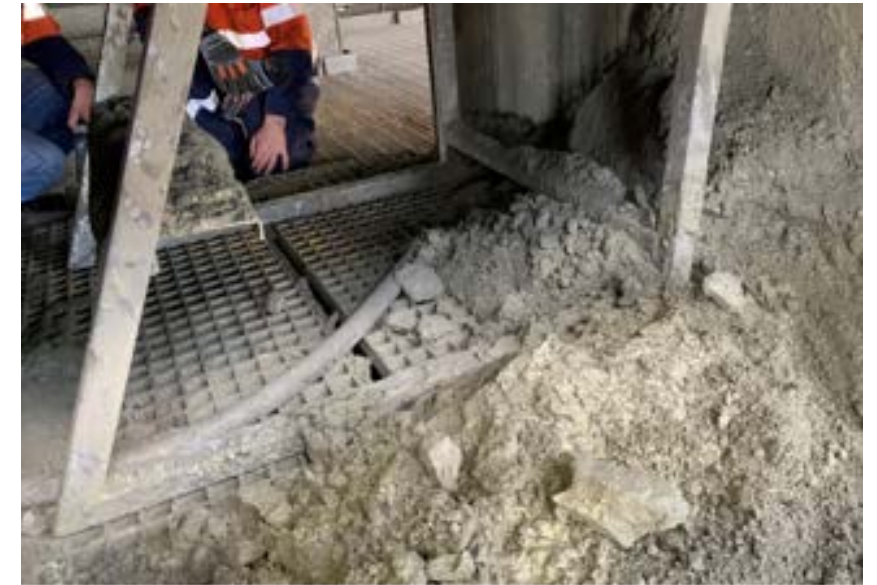
Inside the chamber after the incident

The Standard Work Instruction (SWI) related to cleaning the chamber from the top before entering the chamber at the bottom and was not followed. The SWI required a SLAM (Stop, Look, Analyze, and Manage) to be completed but was not found after the incident.

As proposed by the mine, eliminate the hazard by installing: [Elimination]

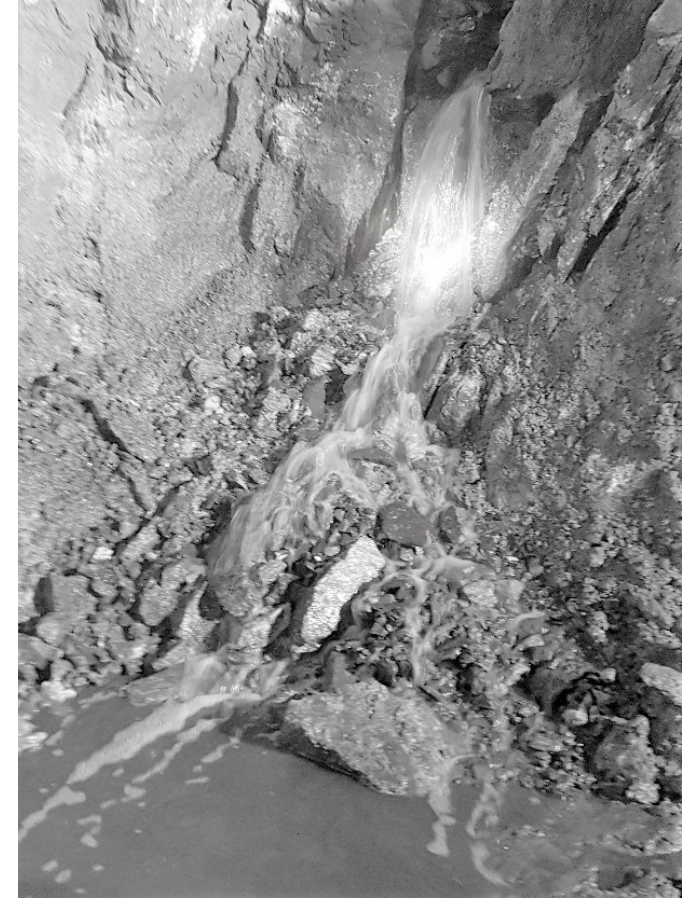
The inrush then went along the level and down to the charged decline face 60 m below. The water then backed up to the development level. No workers were in the decline at the time but this does not detract from the seriousness of the incident.

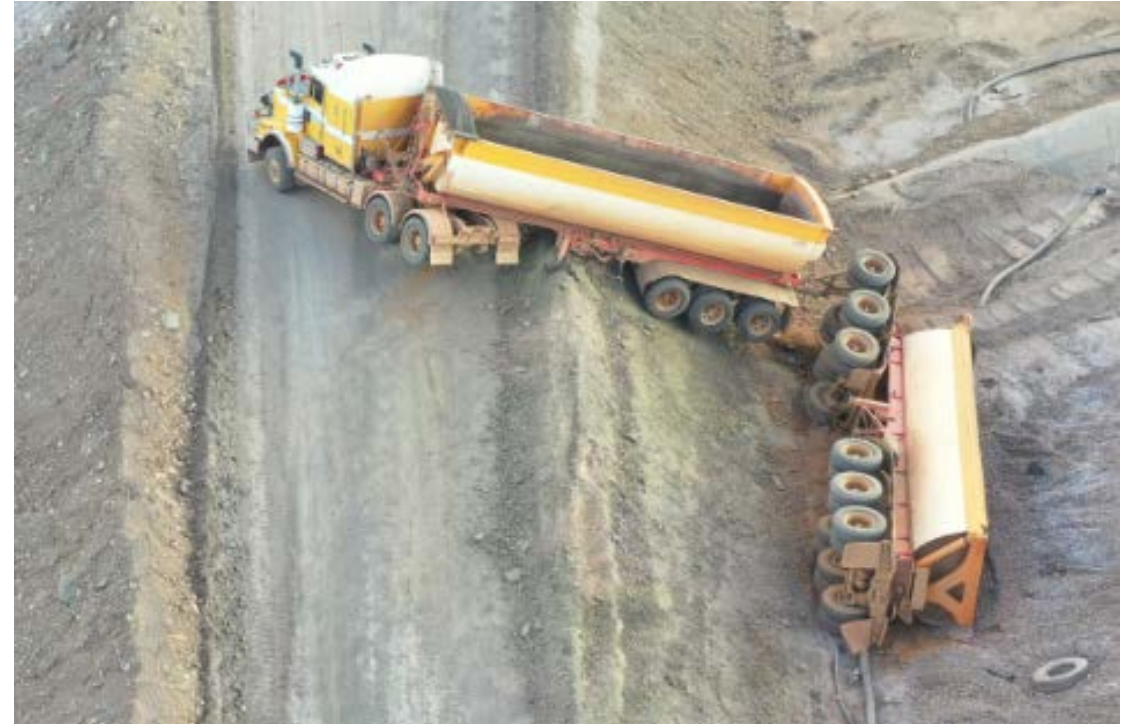
The driver was not injured.

- Travelling too fast for the loaded condition.
- In a hurry as it was the last load of the day.
- Fatigue – Allowed to work in excess of the rostered timetable.

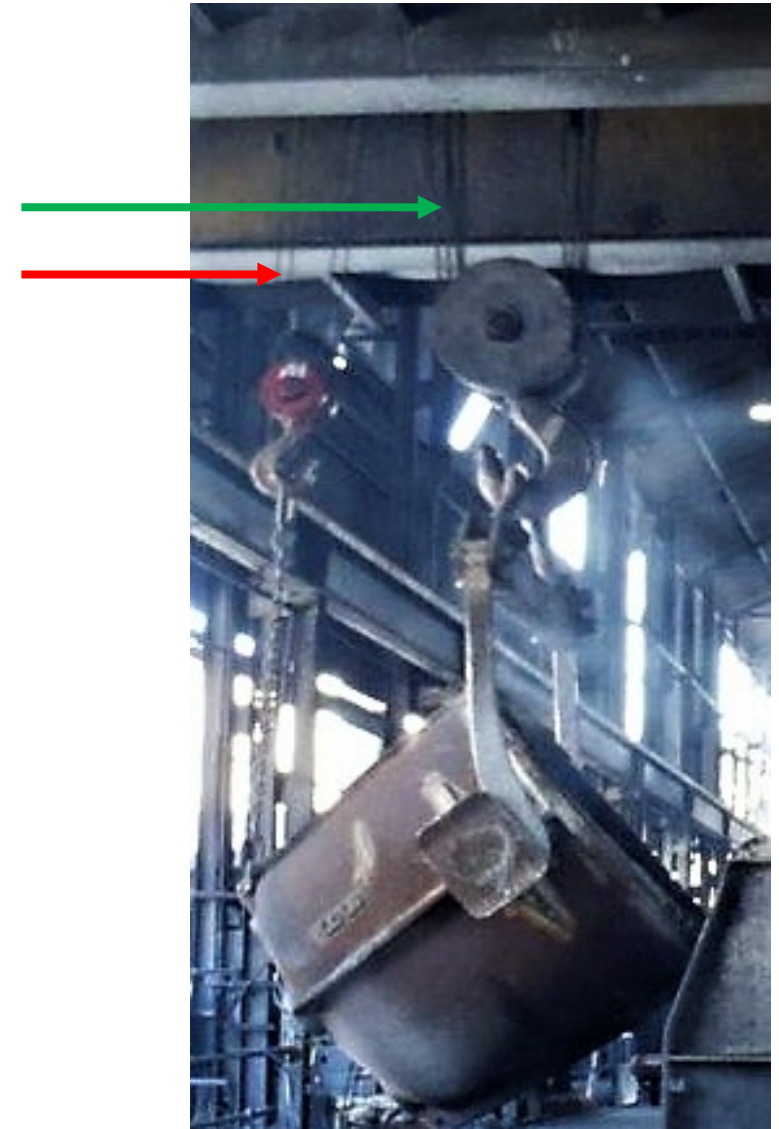
On 13 November 2020, the 10 mm diameter **auxiliary rope** on a overhead gantry crane in a hot metal plant failed during a lift. The auxiliary hoist tilts the pot and allows it to return its vertical position. The **main hoist rope** raises and lowers the pot.

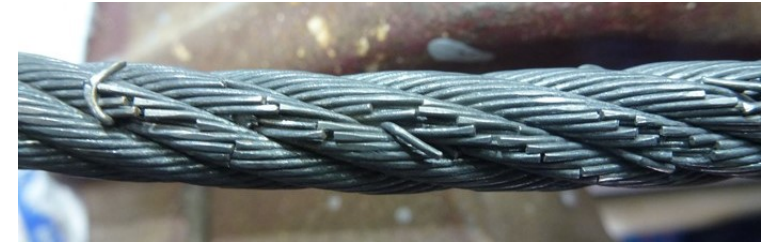
Multiple broken wires were identified after the incident, as seen in the picture.

The monthly inspections did not identify the broken wires which met the discard criteria. The discard criteria was three or more adjacent broken wires in a strand.

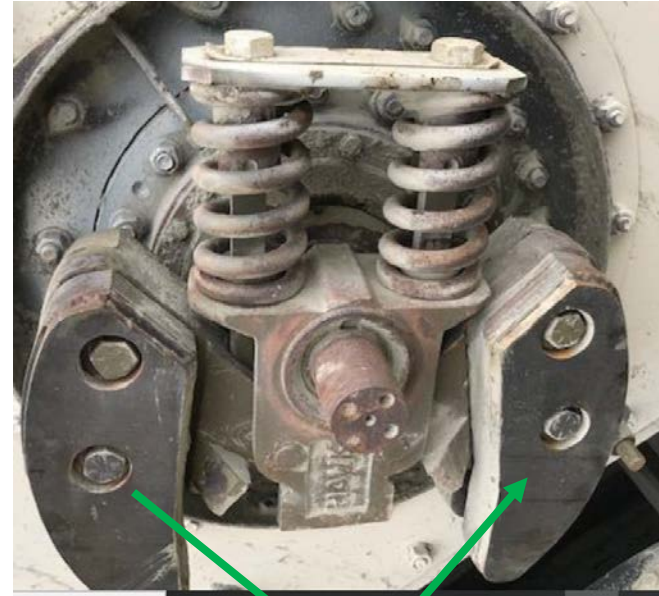
The two bob weights in place on the non-drive side

On 10 November 2020, the attachment of a counterweight, which is part of the Spring Controlled Mechanism, failed on the drive side of a triple deck vibrating screen. One of the two bob weights, on the drive side of the screen, broke away from the pin holding it onto the hub attached to the screen shaft

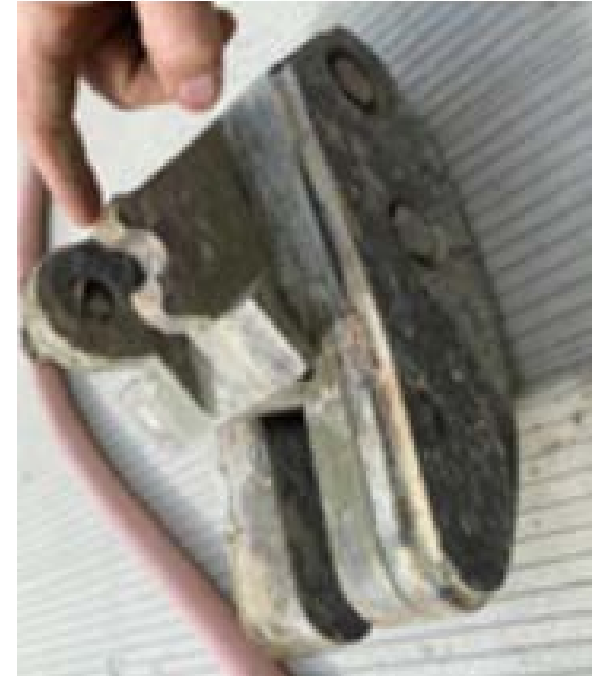
It was known that during the time of the previous ownership before 2005, that there had been failures of the attachment of the bob weights to the hub mounted on the shaft. Subsequently an updated design was introduced. The problem had been that the castings were uneven and the bob weights were not opening an equal distance.

Note: After 1999 the screens were fitted with fixed counterweights fitted directly onto the shaft.

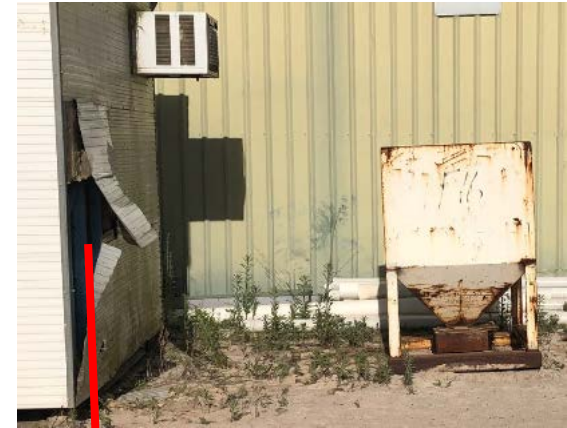
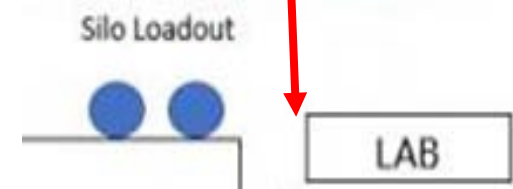
A worker who was inside the laboratory and on break moved away from the wall and was not injured.

On arrival at the quarry the truck driver tared off but failed to communicate with the office or sales despatch and drove straight under the silo to load.

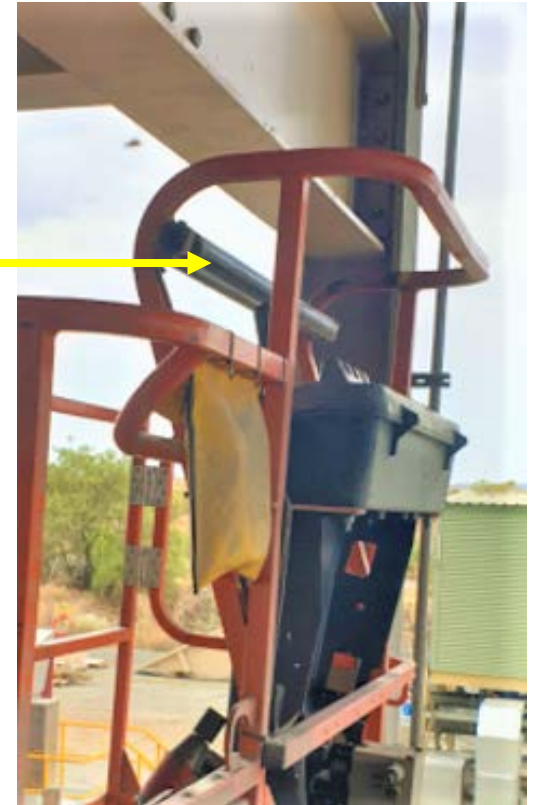
Note: The investigation should include all safety features that may also have the potential to play a part in lessening the consequences when the safety bar is activated.

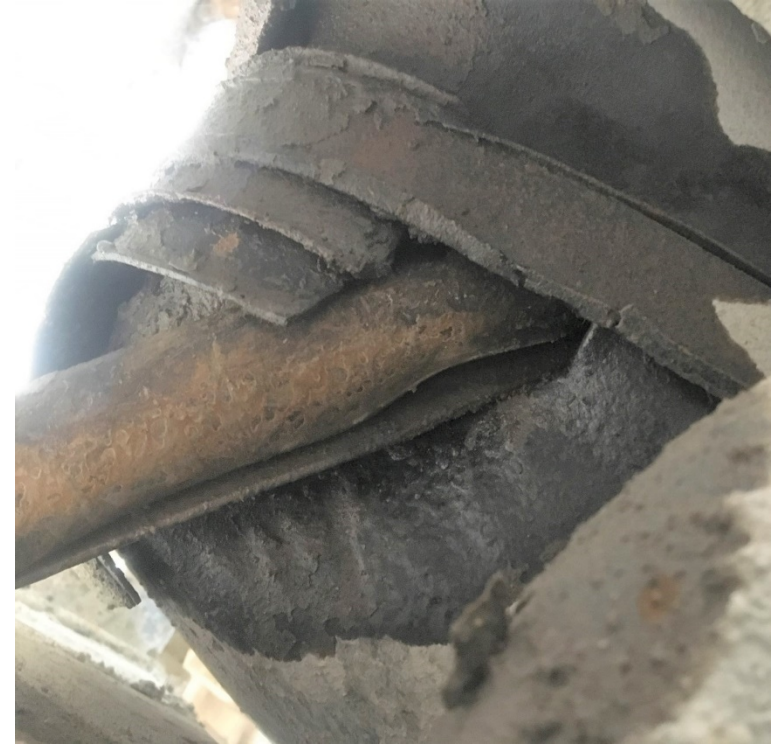
On 26 December 2020, a service crew worker drove through a puddle and heard a noise coming from underneath the light vehicle. The worker stopped to look for the cause of the noise and found that a 900 mm split set had punctured the fuel tank.

- Cease using development waste that could contain split sets to sheet the floor as the mine has done.  
[Elimination]
- Look into why the corrective action from similar incidents failed to prevent it happening again. In the previous incident one of the contributing factors was that muddy conditions on the decline potentially limiting visibility of materials such as a short split set. The relevant recommendation was awareness to crews of the event and the importance of housekeeping and always checking for hazards.  
[Administrative]
