# **SIMULATION OF SPRAY PAINTING INCIDENT INSIDE A CONFINED SPACE ON A DRAGLINE: CRITICAL LEARNINGS FOR MULTIPLE INDUSTRIES**

This paper covers the investigation and subsequent re-enactment testing of an incident that occurred while spray painting inside a confined space on a dragline, as conducted by Resource Safety and Health Queensland (RSHQ) to provide further learnings to industry.

While working on a dragline shutdown and performing spray painting activities under a Confined Space Entry Permit, two Coal Mine Workers became unresponsive and were rescued from inside the dragline revolving frame.

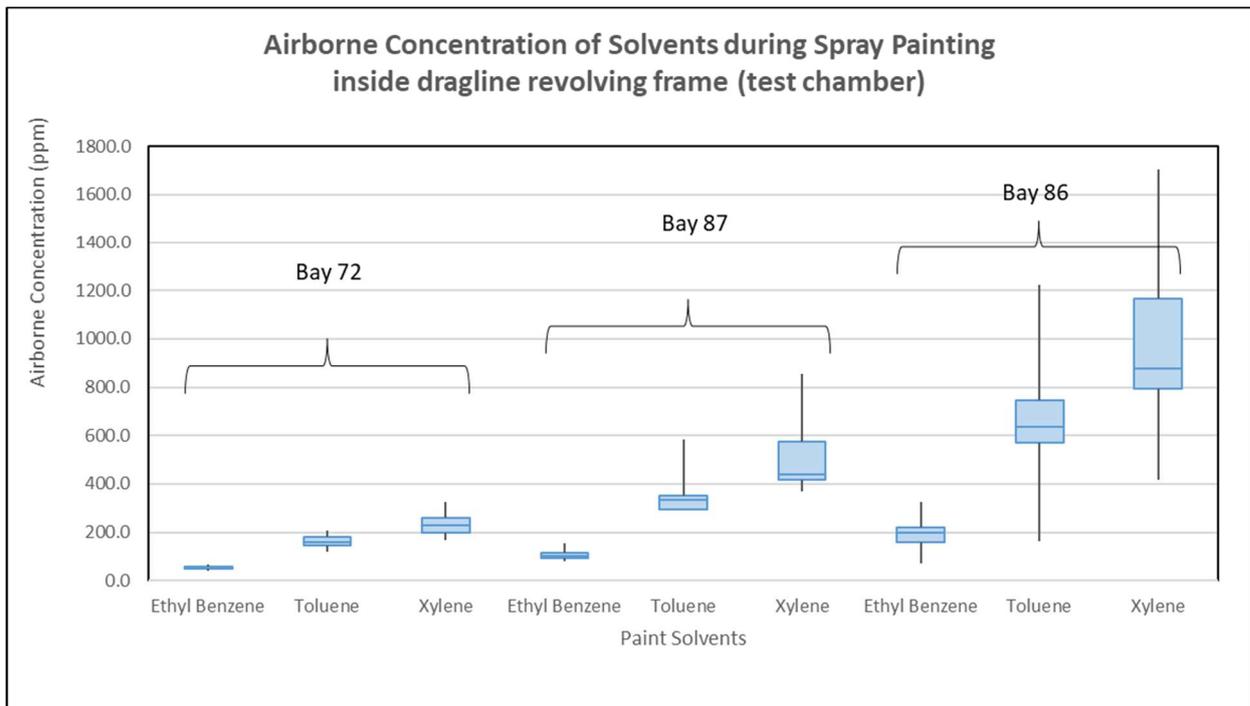
Figure f: Airborne concentration of individual organic solvent compounds measured in re-enactment

The results of charcoal tube analysis (Figure f) indicated that the ratio of organic solvent concentrations between different compounds measured in air, was consistent within each bay and approximated the relative maximum composition (% wt/wt) of individual compounds reported in the product safety data sheet (SDS)(Table 3). The airborne composition of solvents was directly proportional to their composition within the paint and this indicated that the direct discharge of paint into the atmosphere through the spray gun was the primary source of solvent emission. The ratio of airborne concentrations measured did not reflect the relative vapour pressures of individual compounds and this indicated that the emission from surface areas painted through evaporation was less significant.

The concentration of organic solvents were higher in bays 86 & 87 where the paint front was located and highest in the bay 86 which the largest volume of paint sprayed onto adjoining walls and compartments. The range and variability of measured concentrations for all solvent compounds, increased with concentration.

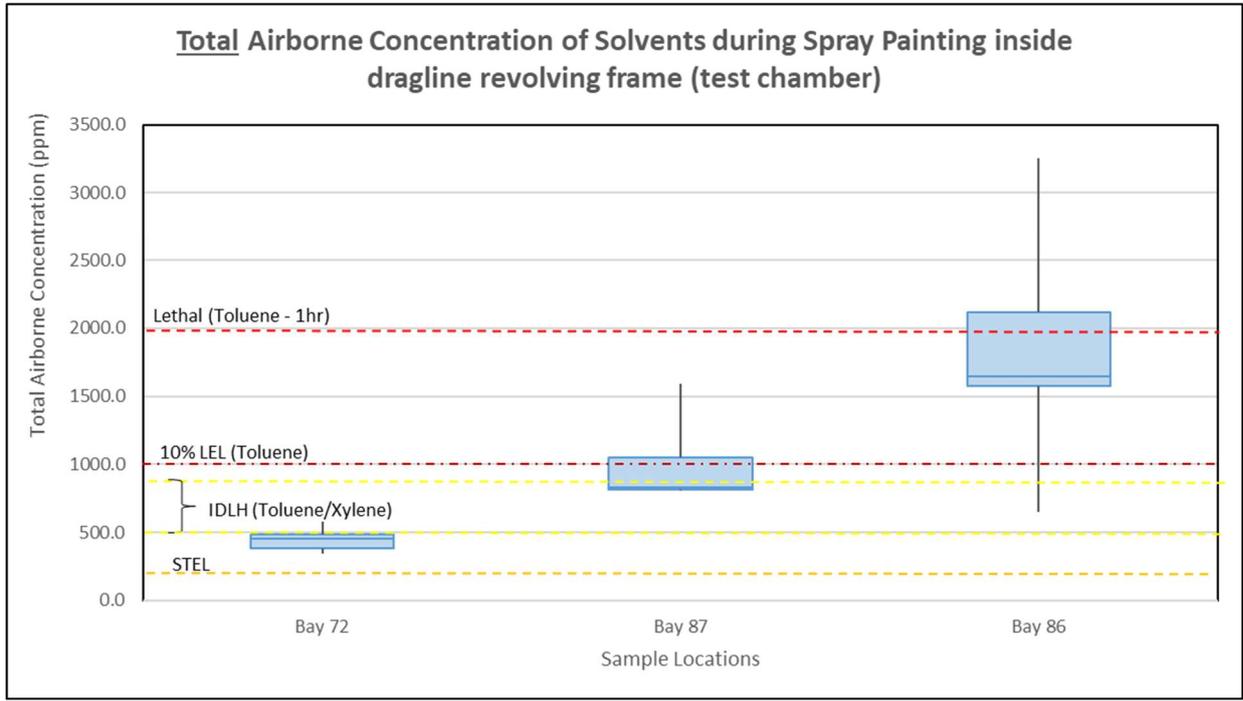
Figure g: Total airborne concentration of organic solvents (additive effects) measured in re-enactment

Given that the individual organic solvent compounds have similar health impacts and target organs, the separate concentrations of individual solvent compounds were added together to estimate the total concentration (Figure g) of solvents. The total airborne concentration of organic solvents measured were above the Short Term Exposure Limit (STEL) in all three bays sampled, above the IDLH and 10% LEL values in bays 87 and 86, and above the reported lethal 1-hour exposure concentration for Toluene, in Bay 86 (6; 7; 8; 9). Given that the fifteen minute sample durations exceeded the ten minute spray paint duration, the measured airborne solvent concentrations are likely to have underestimated the actual concentration generated during spray painting.

Measured concentrations in areas normally occupied by painters and occasionally by hose assistants, exceeded the immediately dangerous to life and health (IDLH) concentrations and potential lethal concentration for humans, for all three compounds and toluene, respectively. The relative ratio of individual organic solvent concentrations measured in the air, was generally consistent with the compositional ratio (% wt/wt) of solvent ingredients reported in the product safety data sheet and did not reflect the relative vapour pressure of these compounds.

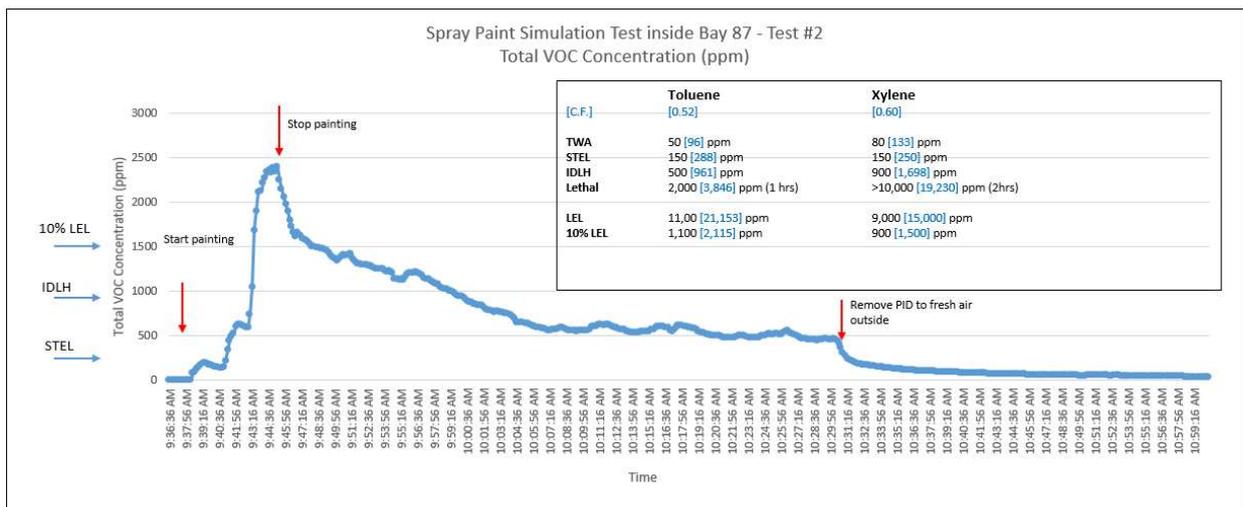
Figure h: Real time solvent LEL concentration in air (PID measurement in Bay 87 – Valid Test #1 (6; 7; 8; 9)) measured in re-enactment

The results of PID measurements are presented in Figure h & i below and these indicated that the maximum airborne solvent concentrations occurred as a direct result of spray painting and solvent being discharge through the spray gun nozzle. The maximum concentration was proportional to the spray paint duration and volume of paint discharged. A prolonged secondary plateau occurred after a short duration from when spray painting stopped, and this was attributed to the emissions from painted surface areas.

The PID measurements indicated that the instantaneous airborne concentrations exceeded the 10% LEL and IDLH values for the solvent compounds during spray painting and for a further 5 minutes and 20-30 minutes, respectively, after painting stopped. The STEL values were exceeded for a further 45-60 minutes after spray painting stopped.

- Continuous monitoring of airborne solvent concentrations should be conducted inside the space, in addition to routine confined space monitoring (O<sub>2</sub>, CO, % LEL, Tox), to verify the effectiveness and adequacy of controls being implemented. These controls include ventilation, respiratory protection, and confined space entry and withdrawal restrictions at 5-10% LEL. The use of extension sampling tubes to facilitate remote monitoring should be avoided when monitoring for organic paint solvents, to prevent the loss of sample and underestimating the true concentration at the point of sampling.
- Clearance monitoring should be conducted to ensure airborne concentrations are suitable for occupancy, prior to re-entering the space after spray painting has stopped.

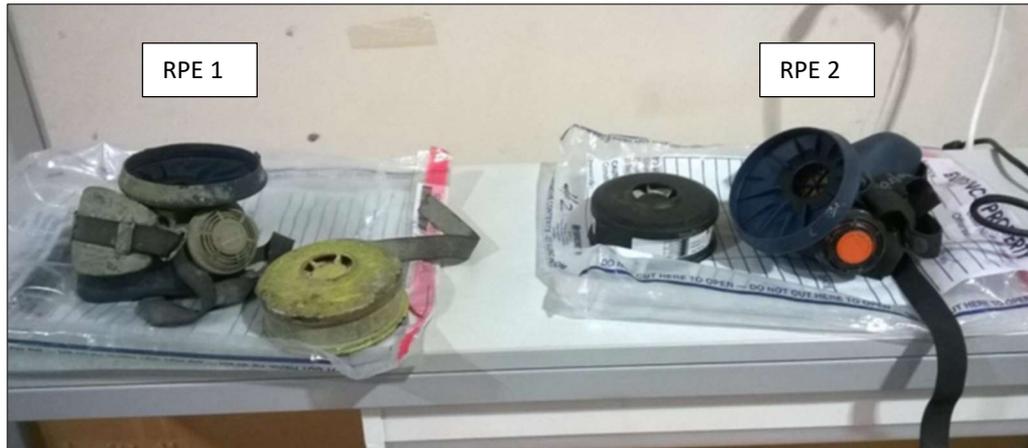
Figure j) Image of respirators worn by the two hose assistants

Testing of the two half face respirator and filter assemblies worn by the hose assistants (Figure j) indicated that the devices had not been adequately cleaned and maintained and the capacity of A1 and A2 class organic filters were limited and not suitable for the concentrations of solvents present during the incident.

The respirator worn by the CMW who was found unresponsive after performing hose assistant duties, had not been cleaned and maintained (Figure j, RPE 1), there was no residual capacity remaining in the A2 class filter, and inward leakage ( $\approx 577\text{cc/min}$ ) was measured in the facepiece under negative pressure (25 mm water column). This leakage was significantly higher compared with a new unused respirator (48cc/min) and was attributed to leaking exhalation valves and valve seats from being contaminated with paint. These findings were consistent with evidence provided by the CMW during interview, that they had not replaced the filter for approximately six months and had not participated in facial fit testing of their personal issued respirator.

The respirator worn by the other CMW performing hose assistant duties and unaffected by exposure, had been cleaned and maintained and the filter replaced at the start of shift. There was only 30% residual capacity remaining in the A1 class filter, and similar inward leakage ( $\approx 697\text{cc/min}$ ) was measured for this facepiece, also attributed to leaking valves and valve seats from paint contamination.

The leakage contribution from valves and valve seats on both respirators was verified by systematically cleaning and replacing individual components and repeating the leakage testing. Final testing after cleaning a replacement of components indicated inward leakage measured for each facepiece (48 and 96 ml/min, respectively), was significantly reduced and approached that of a new unused respirator.

- Air-Supplied respirators should be selected in preference to powered air purifying (PAPR) and/or negative pressure respirators, which rely on regular cleaning, maintenance, facial fit testing and particularly filtration performance and capacity, in order to provide an adequate level of protection.
