Monthly periodical

Queensland Mineral Mines & Quarries Inspectorate
January 2021

Mineral Mines & Quarries Inspectorate

Resources Safety & Health
Queensland

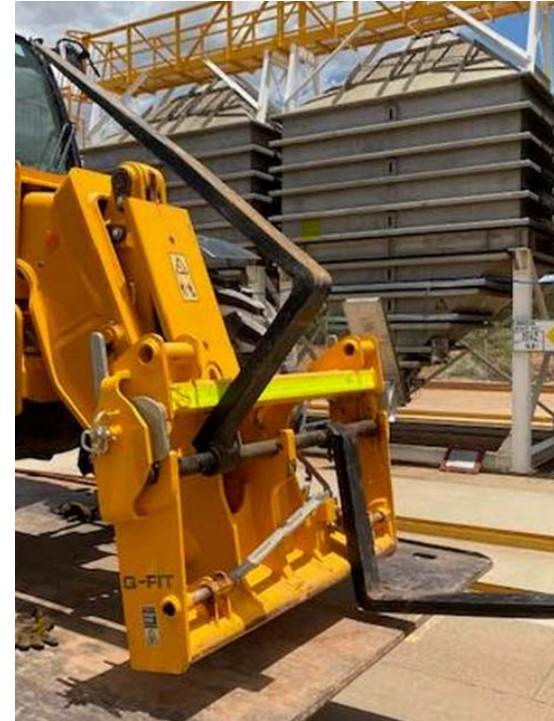
Re-enactment

Falling fork on telehandler strikes worker on the side of the head.

On 9 January 2021, a fork on the telehandler fell after the strap securing it, was released. The telehandler had been loaded onto the rear of the truck at another mine.

The float operator received laceration to ear and bruising to shoulder. The location of the injuries was fortunate because they were not wearing a safety helmet.

A loader had been placed on the front half of the truck.

Once the telehandler was loaded onto the rear half of the truck it became apparent that the forks were projecting beyond the back of the truck.

The float operator wanted to transport the telehandler with the forks down but a representative of the mine persuaded the float operator to secure them folded up.

As part of preparations to unload the telehandler, as the securing straps for the forks were being removed, one of the forks fell down under gravity.

- Arrange for transport that provides adequate space on trucks for telehandlers including their attachments, so that there is no reason to fold up the forks. (Engineering)
- In the event that there is inadequate space and the forks will project beyond the rear of the truck, the original equipment manufacturer in this instance, recommends that the fork carriage should be removed and placed on the truck elsewhere. (Elimination)
- Recognise that the float operator is ultimately responsible for securing the load. (Administration)
- Mandate the wearing of safety helmets in similar circumstances as the mine have now done. (Administration)

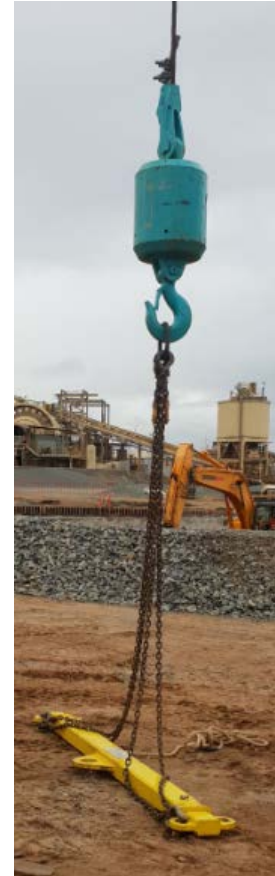
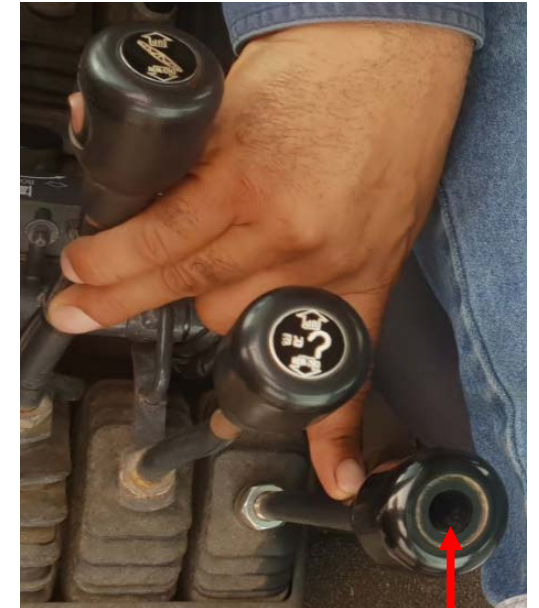
On 12 January 2021 a spreader bar was suspended by two pairs of chain slings on the auxiliary hook of a 250t crawler crane. The crane operator was booming up and lowering the hook simultaneously. The operator was looking around at where the spreader bar was going to be taken off the hook. The rigger was walking underneath the suspended load which brushed off the rigger's safety helmet, striking them on the shoulder and knocking them to the ground.

The rigger suffered minor injuries.

Rigger struck by 100 kg spreader bar.

The crew were working through their lunch break which led to haste rather than caution.

Although the verification of competency (VOC) was company and plant specific, it included items that were general in nature.

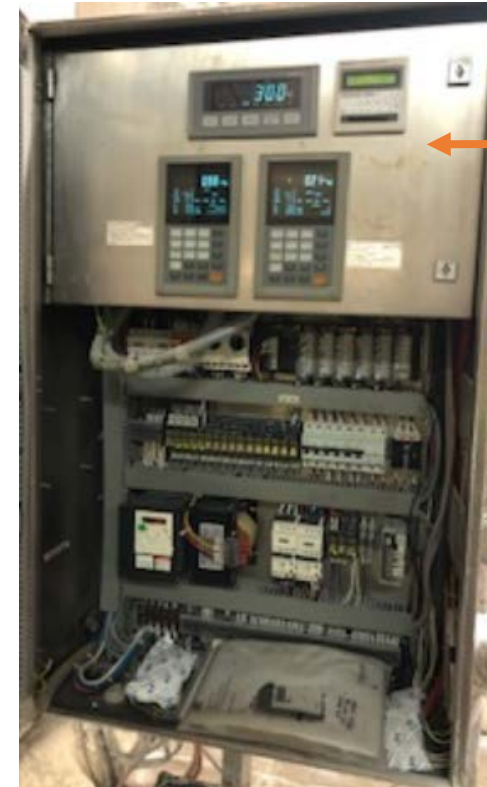
Operational controls.

Unauthorised access to 415 V control panel

On 30 January 2021 at 3.30 am a worker was using a broom to bang on the bottom of a hopper to bring down hung up material. During this activity the worker damaged a sensor cable and this tripped out the power. An unauthorised worker then opened the door of the electrical panel to see if they could fix the problem. The worker was not injured.

Unauthorised access to 415 V control panel.

The lock on the control panel door was damaged so that a key was not needed to open it.

- Operational controls should be separated from components above extra low voltage. (Separation)
- Keys needed to access control panels must be only available to authorised workers. (Administration)
- Locks on control panel doors must be maintained so that access can only be achieved by the use of a key. (Engineering)

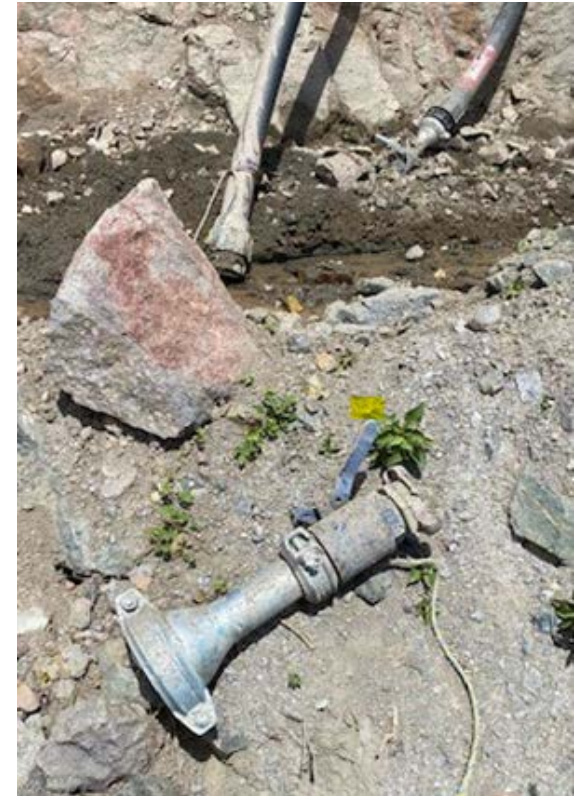
Uncontrolled release of compressed air.

During this activity the handle on the ball valve at the top of the pipe was knocked open allowing the air to discharge from a 100 m length of pipe all the way back to the compressor on top of the high wall. The pipe flayed around breaking off the discharge valve.

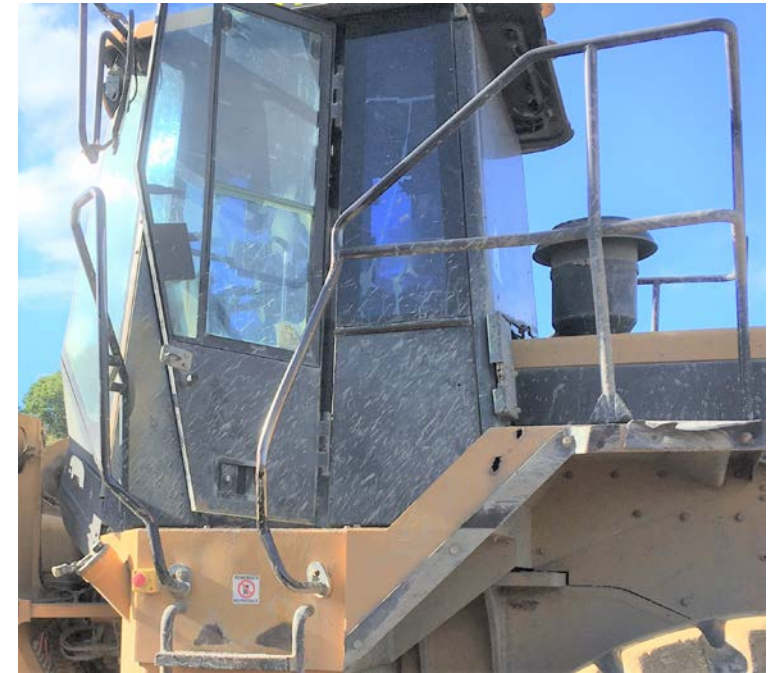
There was significant damage to the handrails on the loader and the truck had to be moved in order to get the operator out of the cab.

Rear dump truck backs into front end loader.

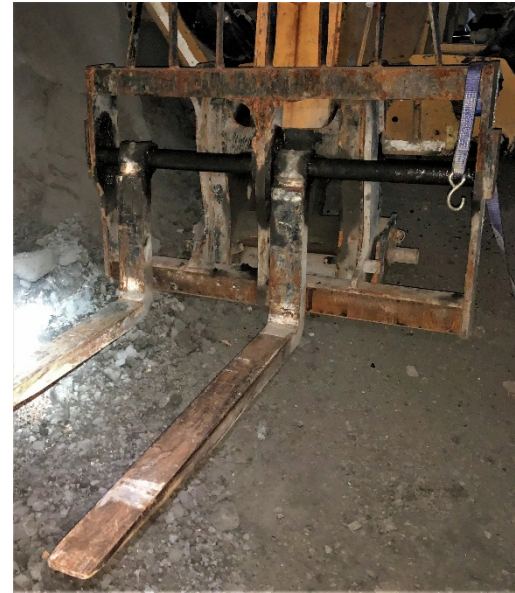
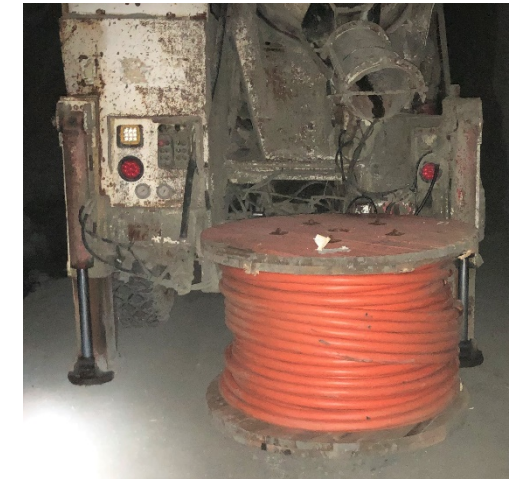
Telehandler strikes wall of decline and loses its load.

On 23 February 2021, a telehandler was transporting a 1.6 tonne reel of cable down a decline when it was steered into the wall due to a perceived loss of braking. On impact, the load was dislodged and travelled several metres into the back of an agitator truck also going down the decline. There were no injuries.

The Original Equipment Manufacturer (OEM) states that in avoiding a crush hazard, applying the park brake while travelling will cause unit to stop abruptly and could cause load loss. It also states that to stop the machine in an emergency, apply the park brake. After the incident the park brake failed the static test set out by the OEM in the Service Manual and at prestart.

- how loads are to be secured to the implements (Engineering)
- which way the load should be facing while tramming downhill. (Engineering)

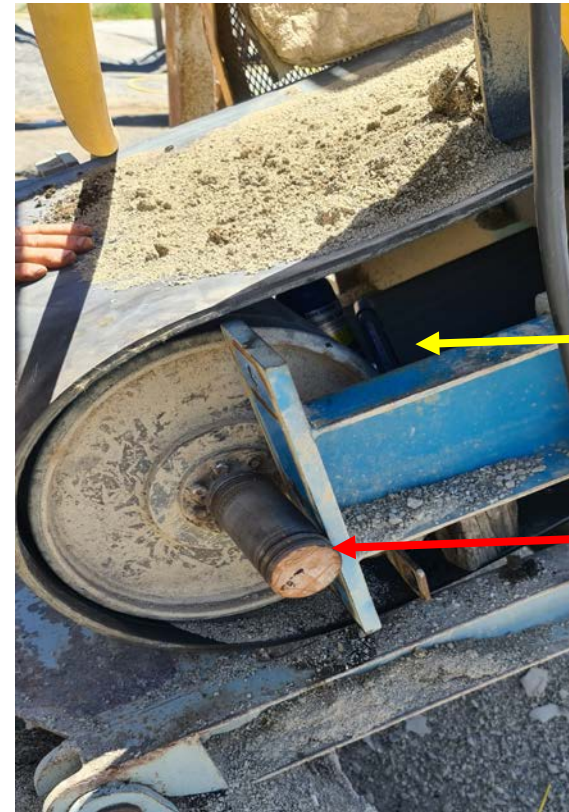
On 10 March 2021 a worker came over to assist with the changing of a bearing on a conveyor tail pulley. While they were inspecting progress, the shaft of the conveyor pulley moved unexpectedly trapping their hand against the mounting plate of the plummer block.

The worker sustained a broken finger.

Bottle Jack
in here

Fingers
crushed in
here

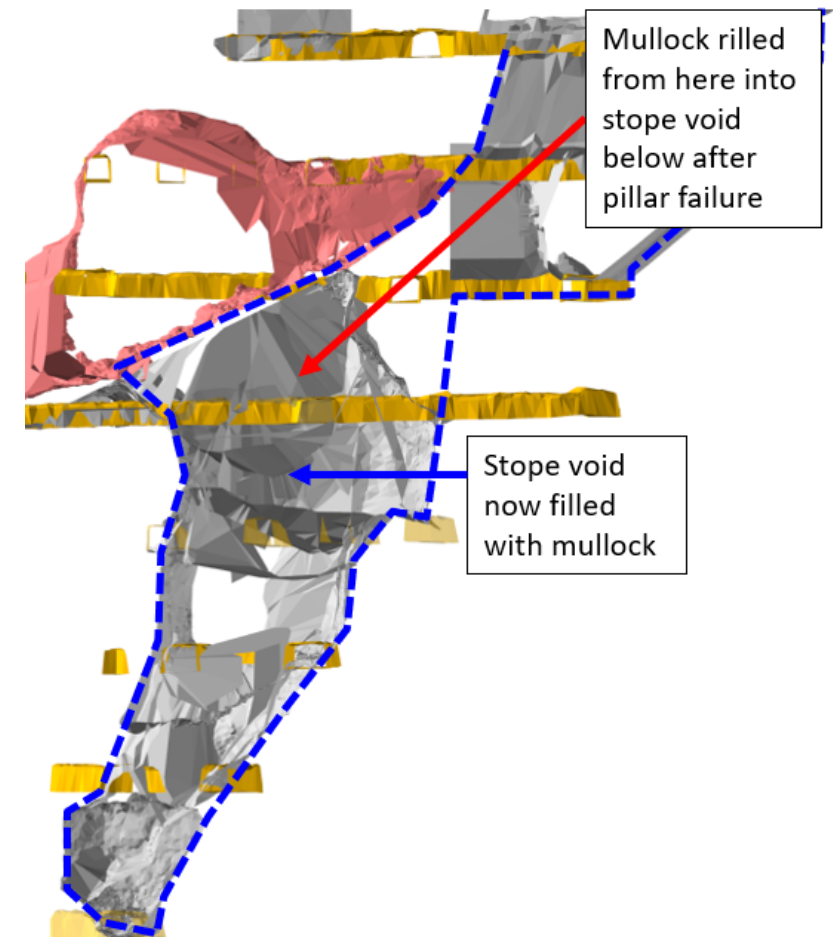
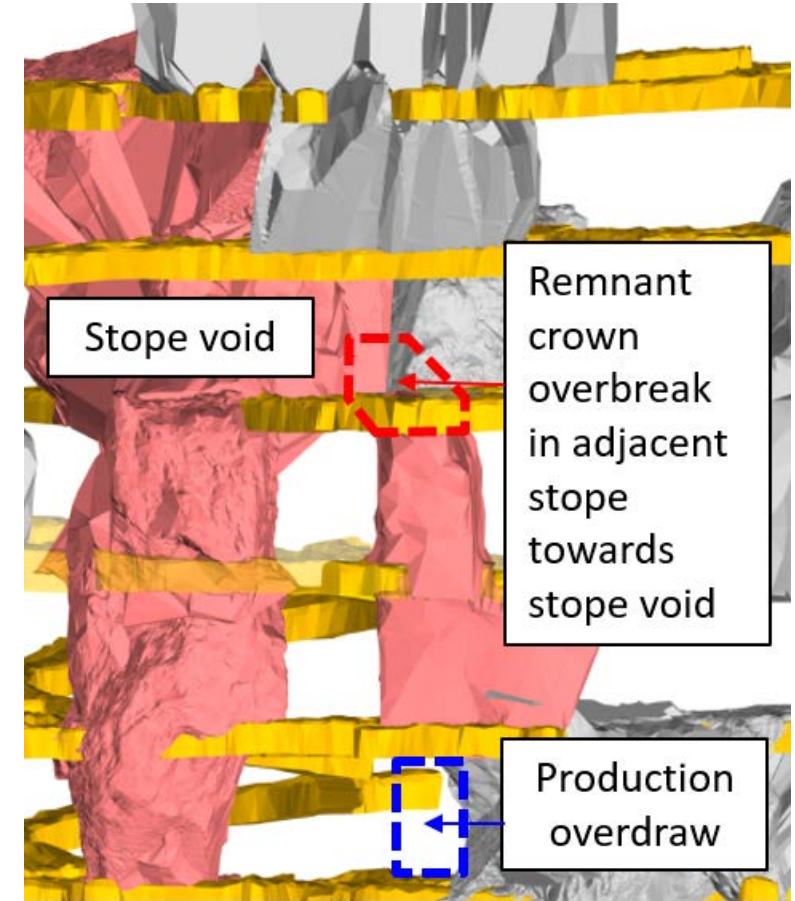
On 14 March 2021 mullock flowed into a stope void from an adjacent higher level stope. The movement of the mullock caused the reversal of the airflow in the decline and the FAR shaft.

150,000 t of mullock rills into remnant stope void.

The remnant stope void and the mullock filled stope were legacies from previous mine owners and the pillar between them failed. The failure was identified as being a slip along a sub-vertical structure.

Within the Ground Control Management Plan the hazard of associated with unfilled or partly filled voids was identified. This led to the creation of a Void Management Plan and Trigger Action Response Plans for the numerous stope open voids. Some of the requirements of these plans were not kept up to date.

Another potential contributing factor was that a neighbouring inactive production stope crown had been spalling towards the adjacent remnant stope.

- Avoid having a filled stope above and adjacent to a stope void below. If this cannot be achieved then take action to minimise the effect of a failure such as installing bulkheads that the mine is now doing. (Elimination or Engineering)
- Geotechnical input from the principal must be integrated into the mine plans being carried out by the mining contractor. (Administration)
- In-house geotechnical expertise may need to be supported by external advice. (Administration)
- Overbreak should be minimized by strictly adhering to drill and blast plans. If tonnes bogged out of a stope exceeds the expected amount, this must trigger a response to determine if there is any potential to impact on other adjacent areas. (Engineering)

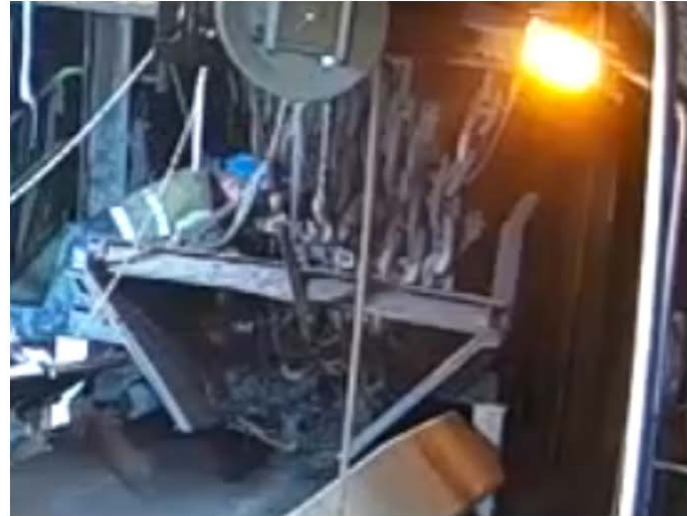
Image 1 – Operator preparing to enter chute with conveyor running

The worker did not identify the hazard of removing tramp material from the chute with the conveyor still running and did not isolate conveyor.

The worker has failed to follow site procedures by leaning over the swing chute to attach the hooks to remove a blockage whilst conveyor was operating.

The system at that time was running waste material from the mine. This has caused the chute to block. The chute can be easily unblocked when the belt is isolated.

- Investigate an engineering solution to further restrict access to the area. (Engineering)
- Provide coaching and mentoring to supervisors to work with their workforce about reinforcing safety controls and the importance of recognising hazards in the workplace.(Administration)
- Conduct a Safety Reset to reinforce expectations of safety interactions conducted by leaders in the workplace. Safety interactions must identify improvements to workplace and task completion.
(Administration)
- All operators have been refreshed on the requirements for unblocking chutes and picking material from the picking belts as per the requirements in the training package. (Administration)
- Review organisational structure to ensure adequate supervisory coverage on night shift and weekend.
(Administration)

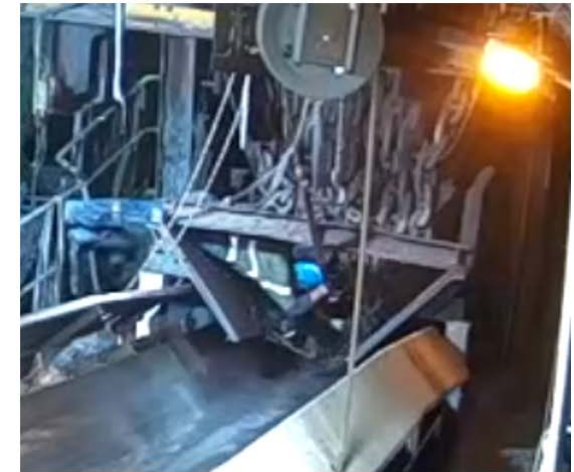
Image 2 - Operator in chute with conveyor running

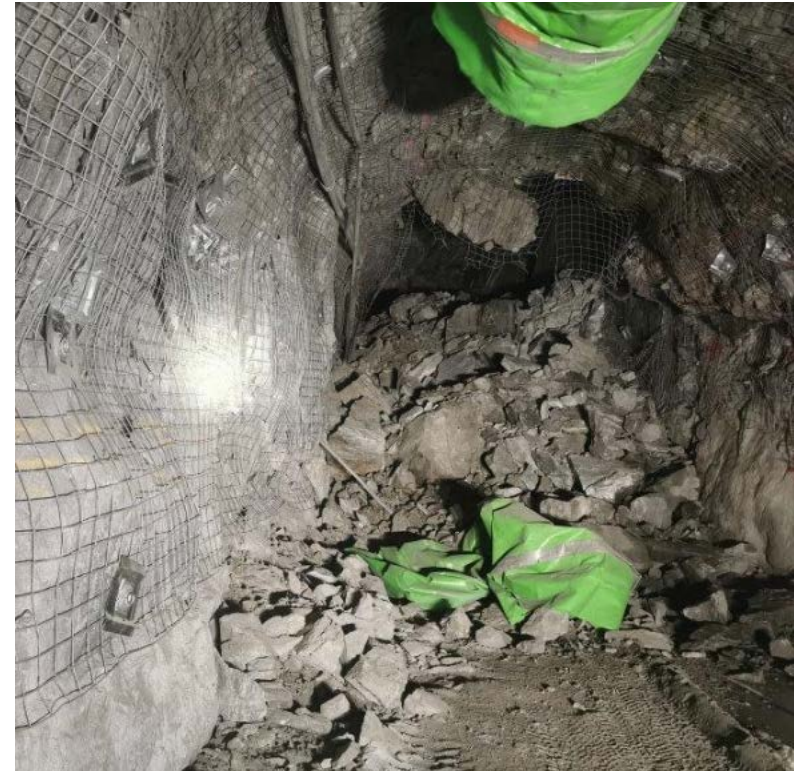
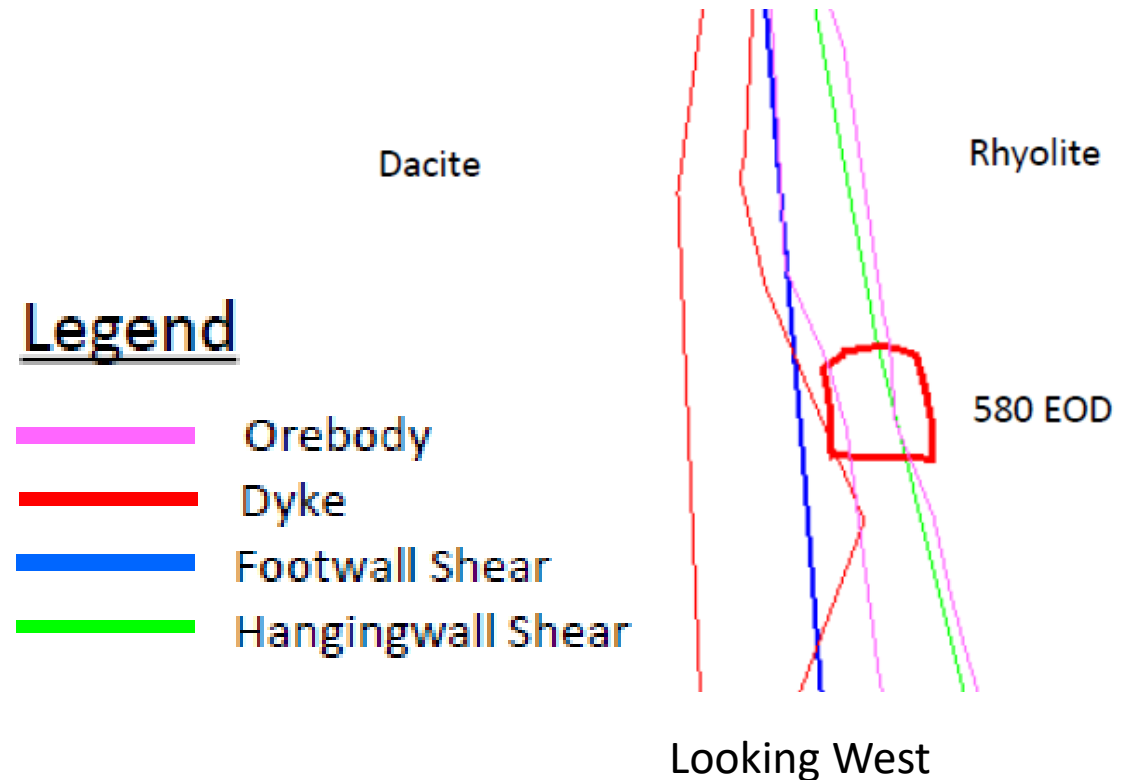
Looking East

Fall of ground into ore drive.

On 16 April 2021 there was a fall of ground from the hanging wall of an ore drive. The initial dimension was 4 m high X 8 m long X 4 m thick.

The failure has occurred along the shear and the dyke contact and a flat dipping joint structure in the backs. The failure also propagated up to the floor of the drive above

The location of the dyke relative to the drive was not mapped. There was a change in the position of the dyke comparative to the levels above. The dyke moved from being on the hanging wall side to the footwall side of the ore. This change did not trigger or identify an additional hazard regarding the interaction of underground stresses on the dyke.

The movement in the footwall dyke had been identified and two rehab plans were issued to mitigate the deteriorating ground. The first plan was to shotcrete the southern wall where the ground failure started, proceeding towards the east, followed by the meshing of the sprayed shotcrete. The second plan contained cable bolt instructions to be installed after the shotcrete.

- Geological features that may have an impact of ground stability should be mapped and ground controls installed during the development cycle or very close behind it to ensure ground conditions do not relax and joints start to open up because of lack of cohesion forces. (Engineering)
- Geological information gained as mining progresses should be incorporated into the planning of the levels below. (Administration)
- Ensure that appropriate resources required for ground control are available which would prevent potentially unstable situations escalating - for instance shotcreting resources. (Administration)

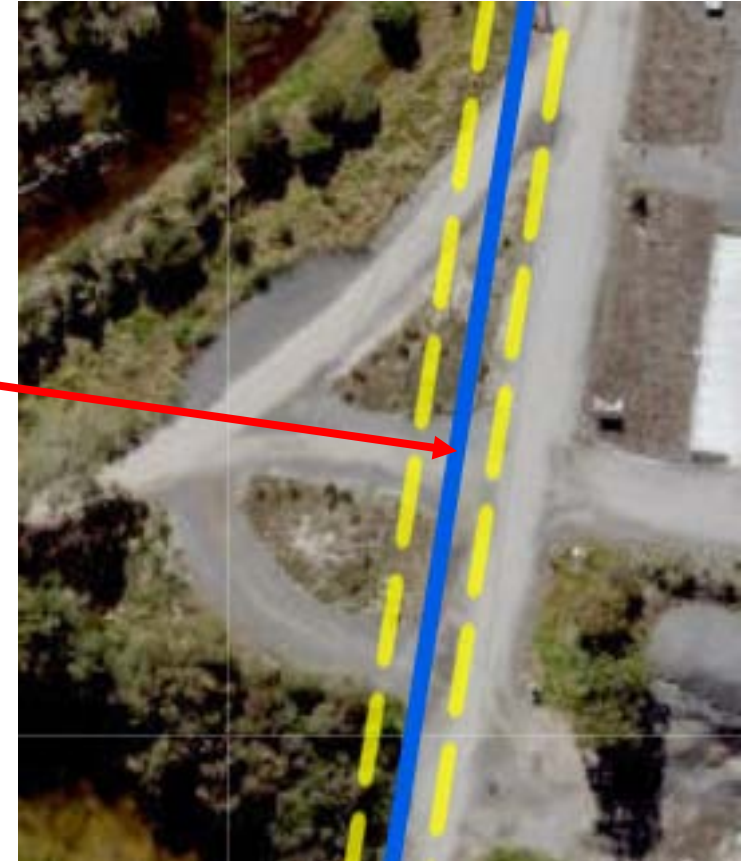
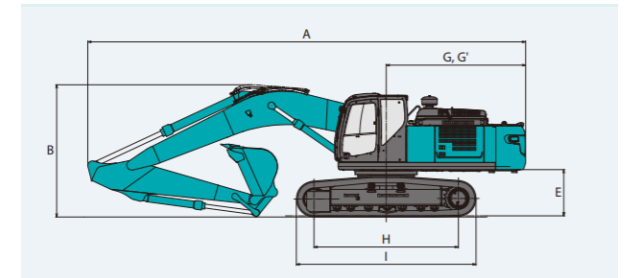
OHL struck here

Excavator strikes overhead power line.

The operator failed to fold the excavator boom into the travel position when moving from one task to the next.

- Eliminate the need to travel under the OHL. (Elimination)
- Determine if any mobile plant on site or coming to site is capable of breaching the minimum clearances required below the OHL. If the mobile plant cannot avoid breaching the minimum clearance, the power must be disconnected to allow the plant to travel under it. (Engineering)
- Mandate that mobile plant must travel around the site in the original equipment manufacturer's recommended travel position at all times. (Administration)
- Create designated travelways and install effective barriers to prevent alternate travelways being used. (Engineering)
- Implement and maintain specific effective controls at every designated travelways under OHLs.
- Use the link below to access guidance on preventing contact with OHLs.

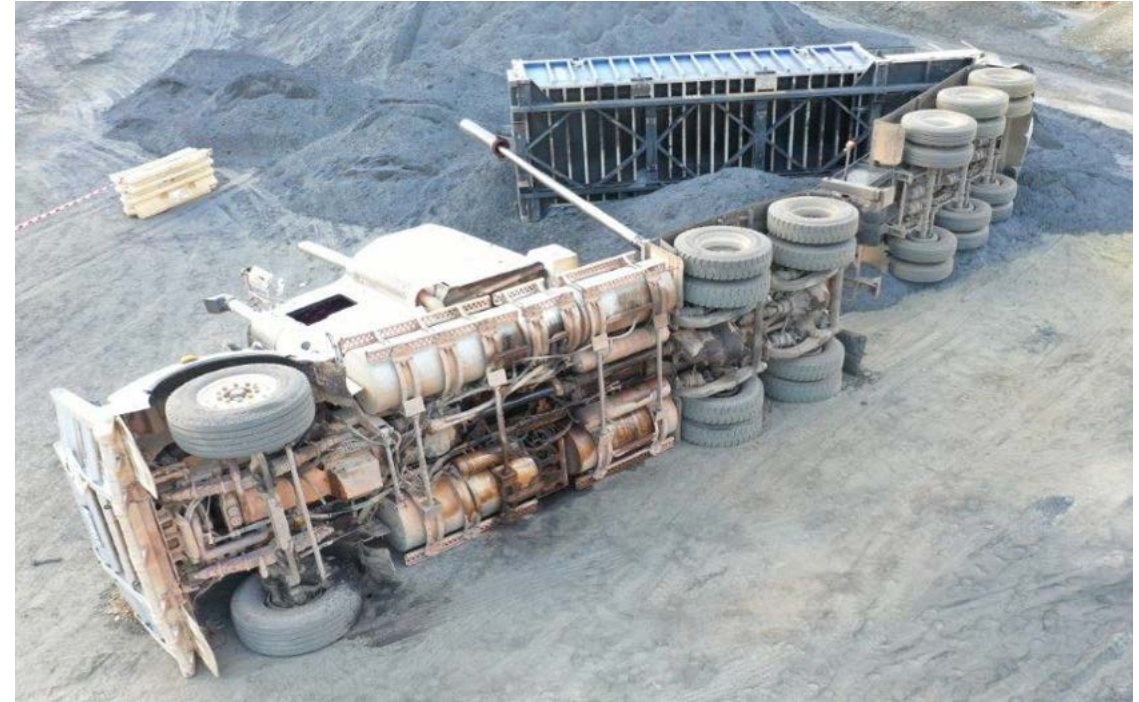
Semi-tipper rolls over.

Hang up on one side of the container, as a result of partial material tip, caused a change to centre of gravity of the vehicle when the hoist was fully extended.

Factors contributing to hang up were material compaction during load and transit, material moisture, material tackiness and container floor material/condition.

The material moisture content varied within the material due to the application of dust suppression prior to loading but was within the permissible transport limit.

- Ensure that the method of transport is appropriate for the nature of the material. (Engineering)
- Install dust controls systems that do not create isolated pockets of excessive moisture. (Engineering)
- When material handling does not perform as expected, identify any potential unintended consequences and take action before they occur. (Administration)

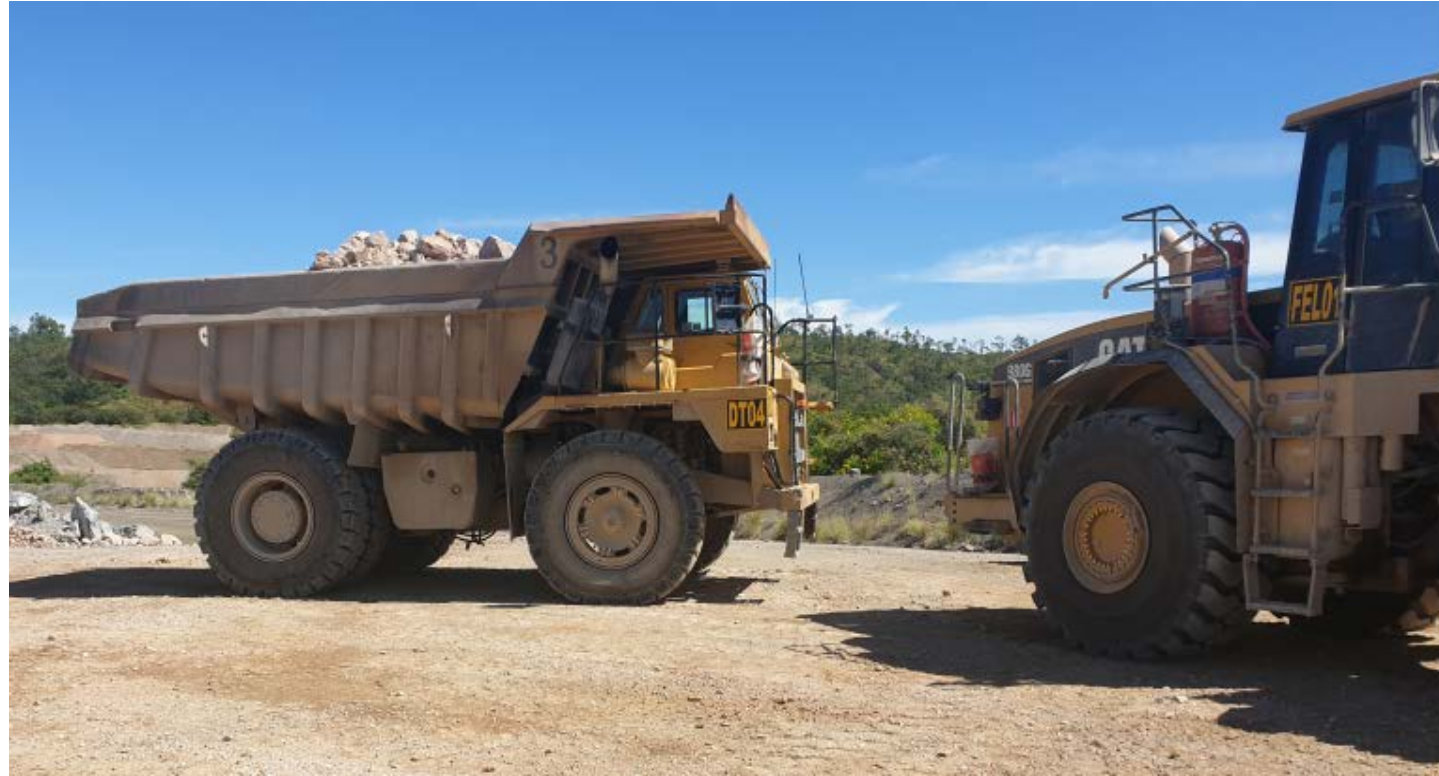
This was a slow speed event and the damage was minimal. There were no injuries.

Loader reverses into dump truck.

At the time of the incident later in the day complacency had set in and the dump truck operator failed to let the loader operator know that they had entered the ROM.

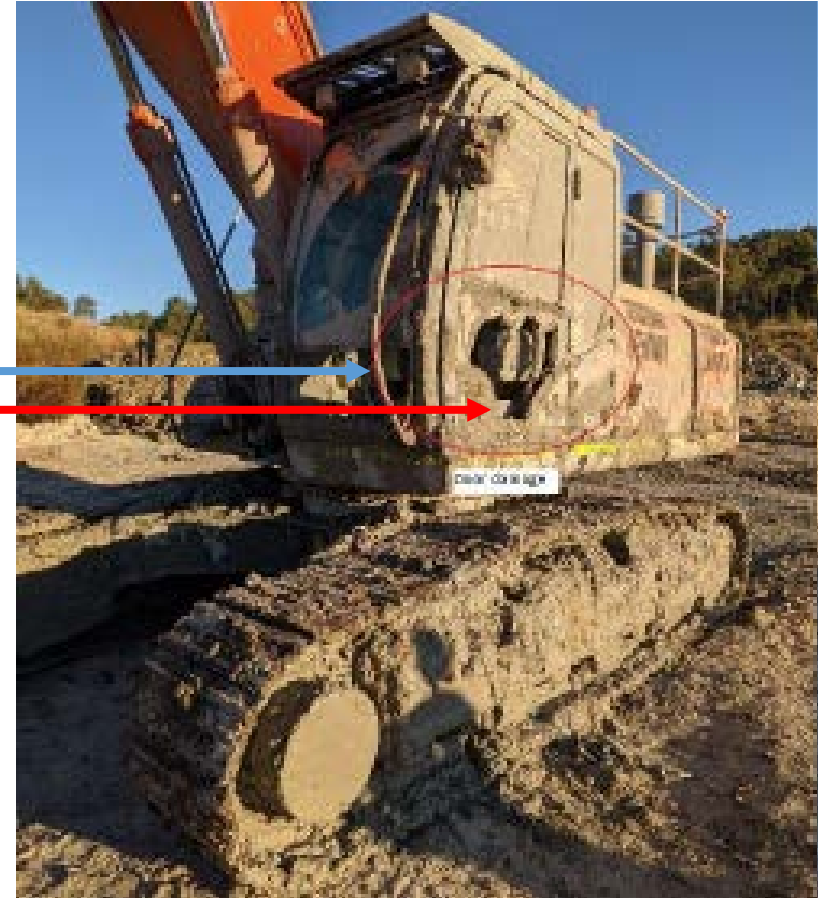
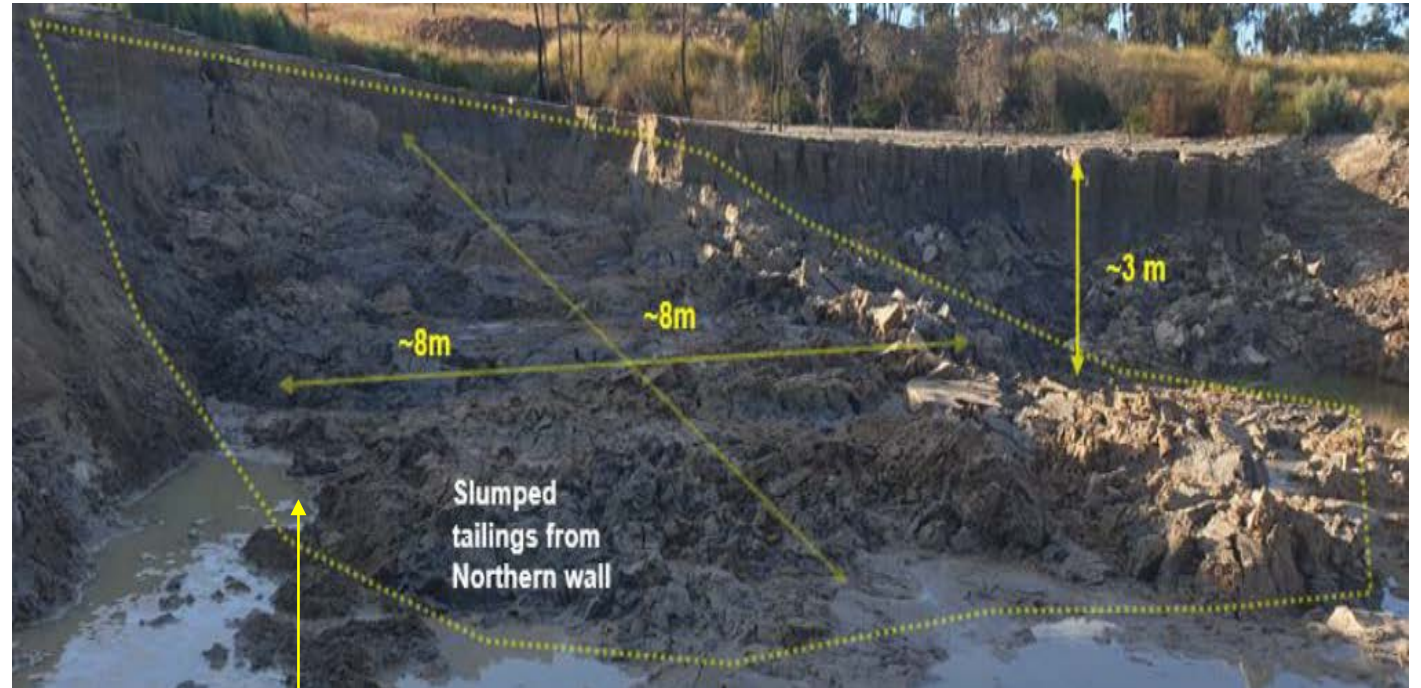
Excavator was here

On 8 May 2021 an excavator was removing tailings from an inactive decant pond when a slump of tailings struck the excavator. The operator managed to travel the excavator out of the area despite damage to the **cab door** and **front window**.

Tailings slumps against excavator.

As the excavation progressed, the stability of the wall of tailings was diminished until the point when the toe could no longer hold it back.

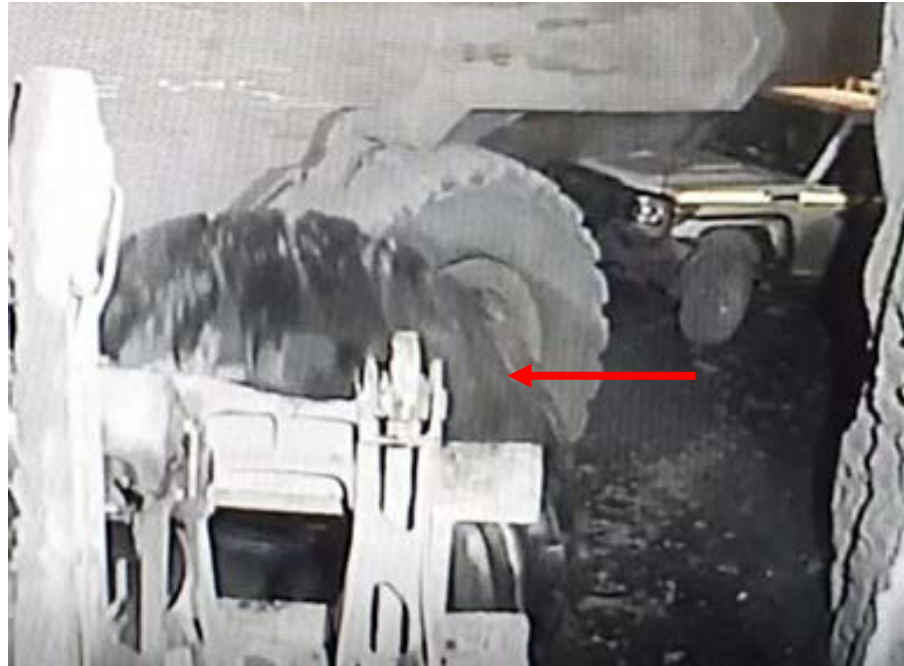
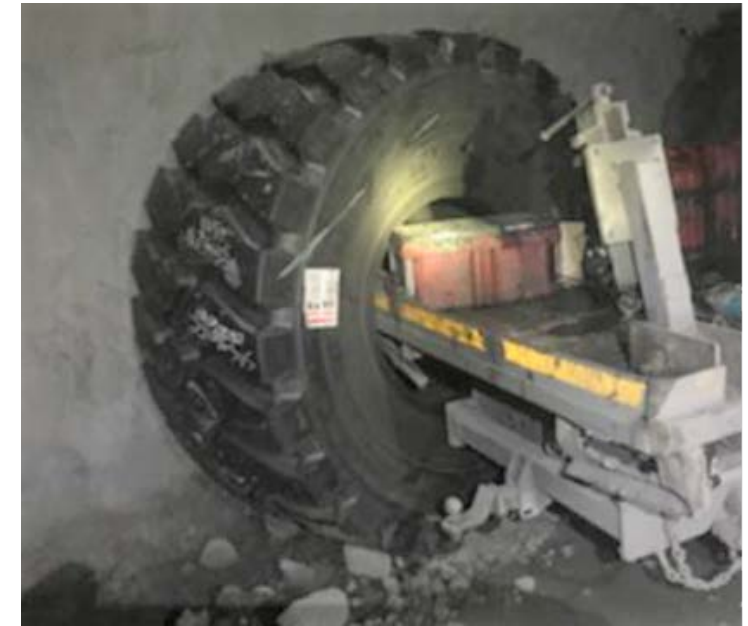
On 9 May 2021 a **new truck tyre** that was being handled by an integrated tool carrier when it rolled away from the right hand tyne 13 metres down the decline. The tyre came to rest wedged between a light vehicle and the wall of the decline.

Truck tyre rolls down decline.

The Task Hazard Analysis (THA) used was for changing a tyre on level ground not on a decline.

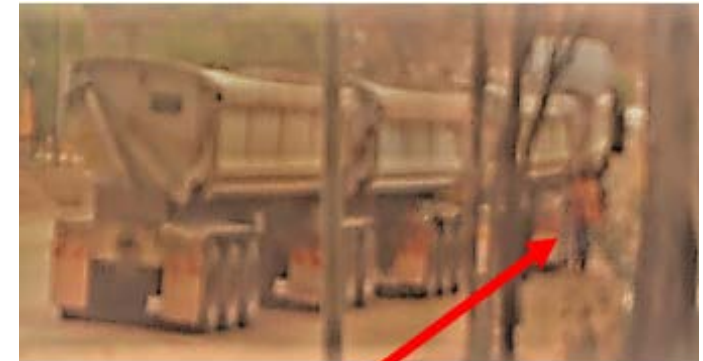
Driver is out of cab with brakes off.

After the driver had changed a leaking brake valve, they exited the cab with the park brake off to go and have a look to see if they had fixed the problem. Air had to be supplied to the valve, so the park brake had to be off.

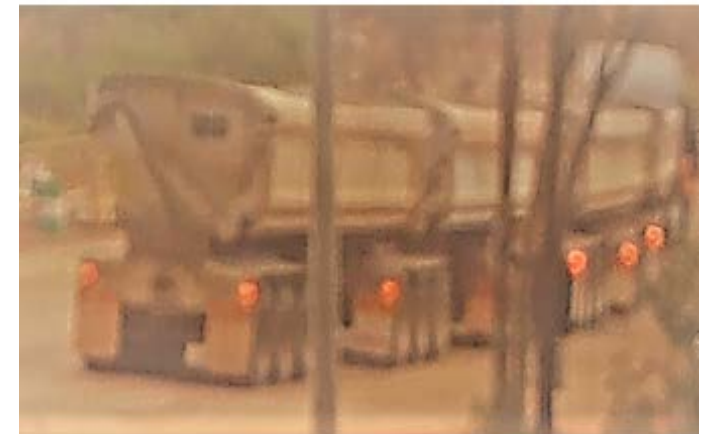
Road train has rolled five metres and driver is applying brakes

Road train rolls away.

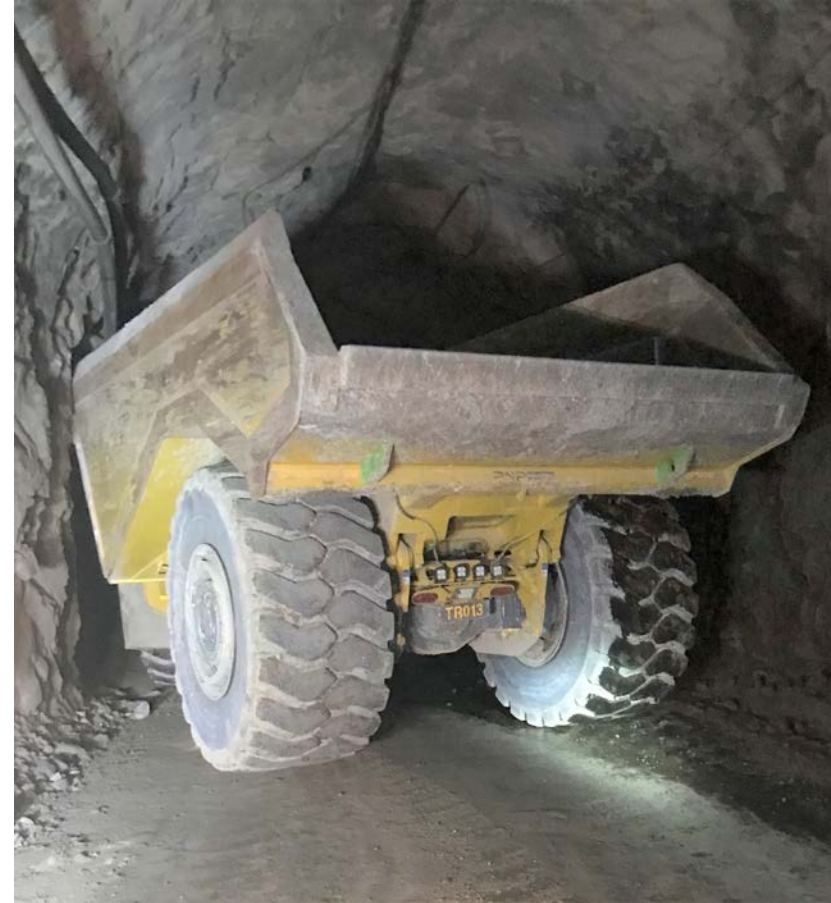
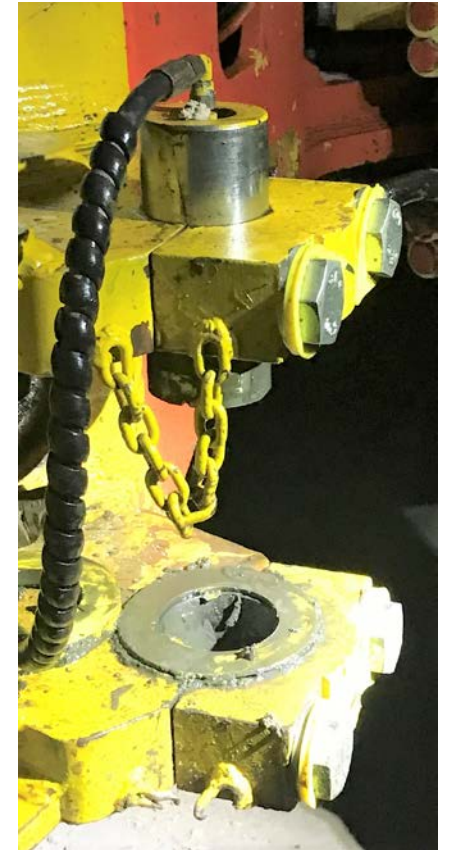
Truck loses steering travelling down decline.

The steering pin had broken in half and the trunnion caps did not secure the two halves. One half was found on the ROM and the other half had worked its way out of the trunnion allowing the ram to detach.

The mine's trucks had been fitted with a latched alarm that is triggered by a spike in hydraulic pressure in the steering circuit but the contractor was waiting on the parts for this. Also the mine's trucks had been fitted with keeper plates that would show if the pin was broken and stop the broken halves from falling out.

- Relevant critical safety information must be shared with their contractors – For instance the installation of the latched alarm. (Administration)
- The SSE should advise the original equipment manufacturer (OEM) when critical safety features fail and the OEM should rectify design and/or maintenance problems.
- The OEM should broadcast any remedial action to all known owners of affected plant and to relevant industries. The remedial action recommended by the OEM should be available on their website and implemented by the SSE.

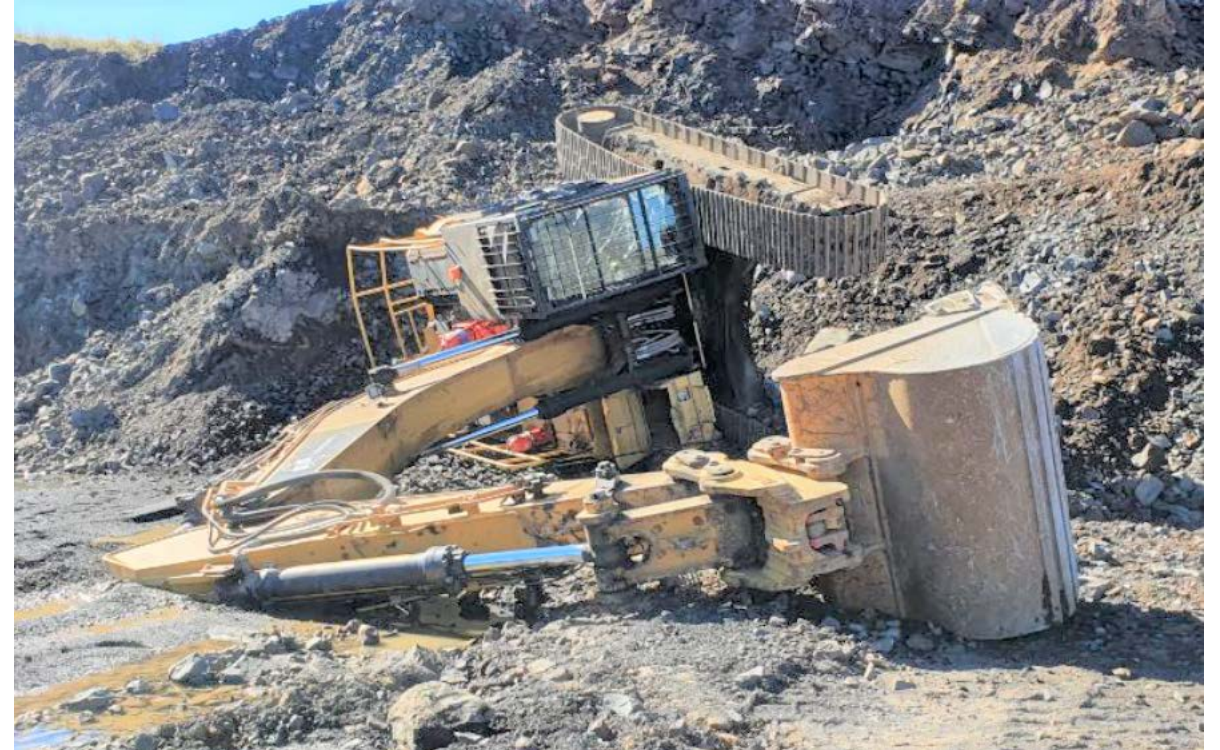
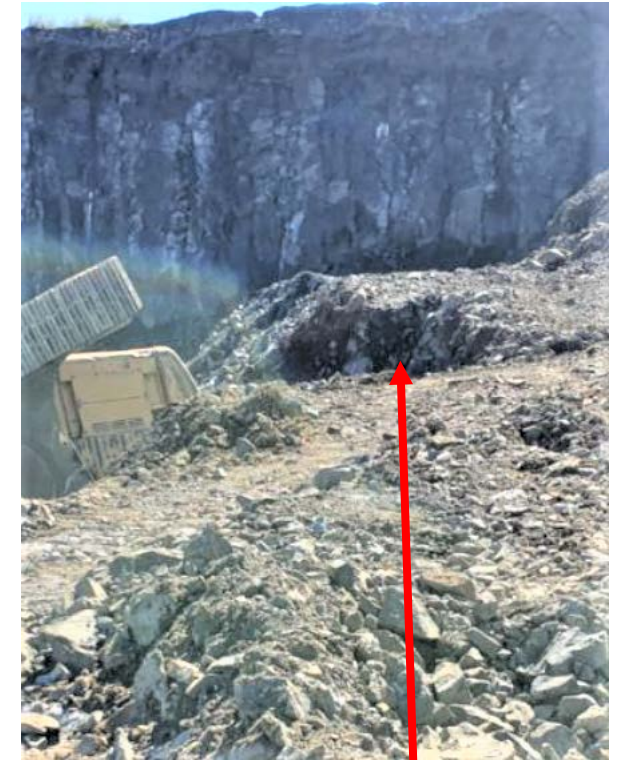
Other undermined area

Excavator falls off bench.

The bench has been undermined at this location and at other locations along this particular bench but was not recognised as a problem by supervisors.

- Issue a Safety Bulletin as the quarry has done in this case. (Administration)
- Standard batter angles and bench width should be determined, recorded and monitored to ensure they are adhered to. (Engineering)
- Ensure training and assessment includes understanding why the task should be done in any particular way with the intention of combating complacency. For instance always face the direction of travel. (Administration)
- Make it clear to everyone that it is a collaborative responsibility to take into account the hazards that are present in any given situation. (Administration)

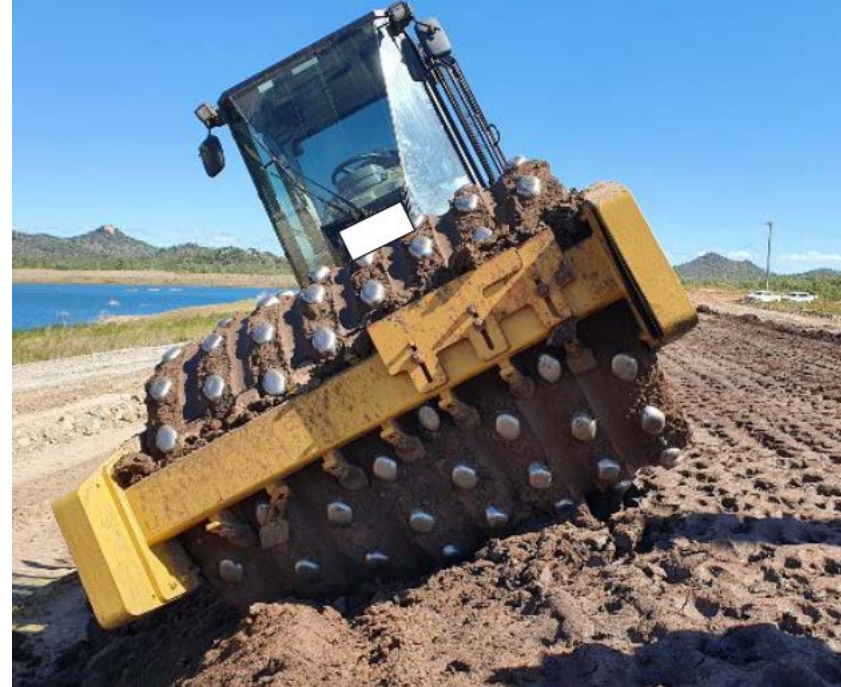
Uncontrolled movement of roller

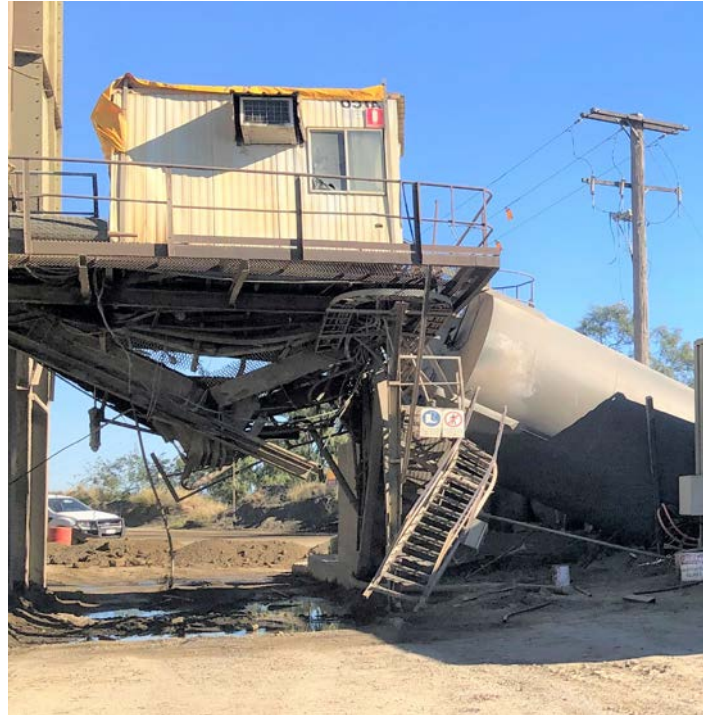
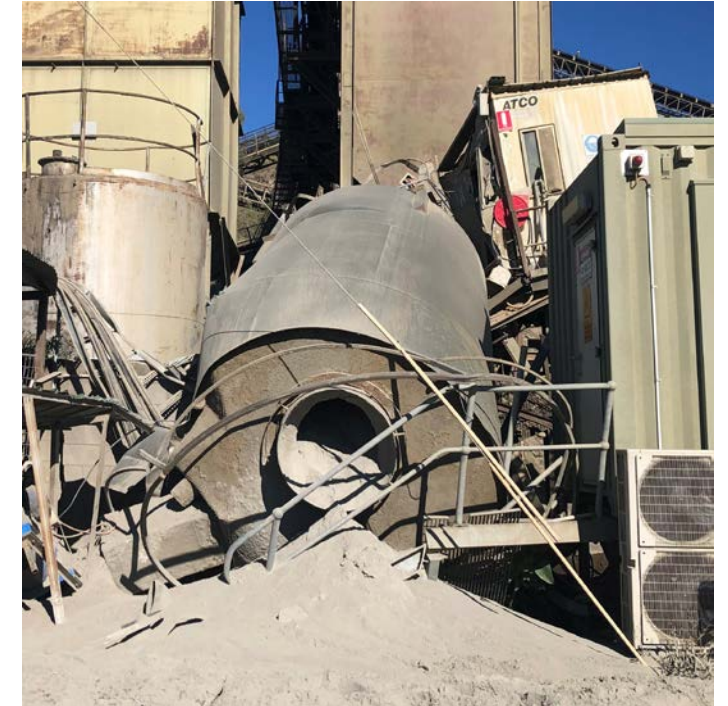
Structure supporting cement silo fails.

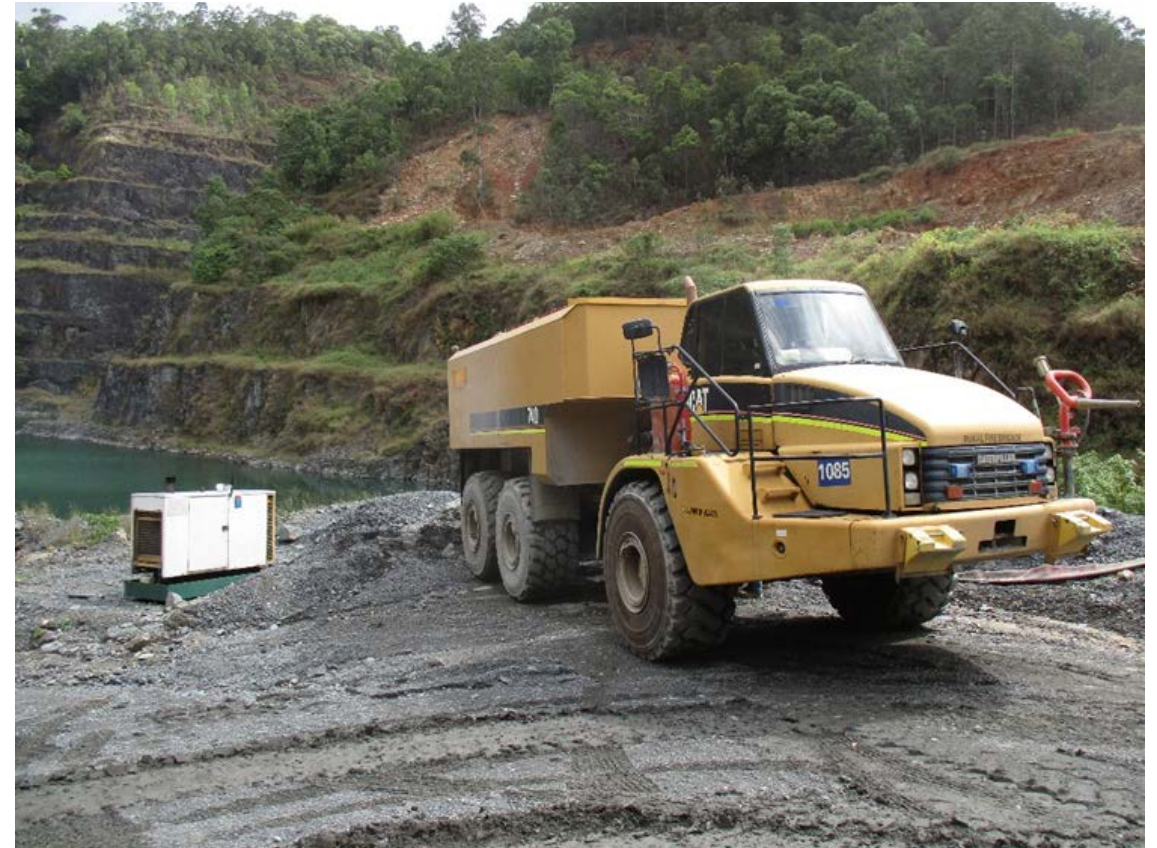
The worker was outside the water cart cab at the time of the shot.

Person within blast exclusion zone

- All blast guards and barricades must be in place prior to the final check and clearance of blast exclusion zone. (Administrative control)
- All persons who undertake the role and function of blast guards must be trained. (Administrative control)
- All persons working at the quarry must be notified of the intended date and time of the blast. (Administrative control)
- Site Senior Executive must ensure that the activities of blast contractors are monitored to ensure they follow the agreed safety management plan. (Administrative control)
