Monthly periodical

Queensland Mineral Mines & Quarries Inspectorate
January 2021

Mineral Mines & Quarries Inspectorate

Resources Safety & Health
Queensland

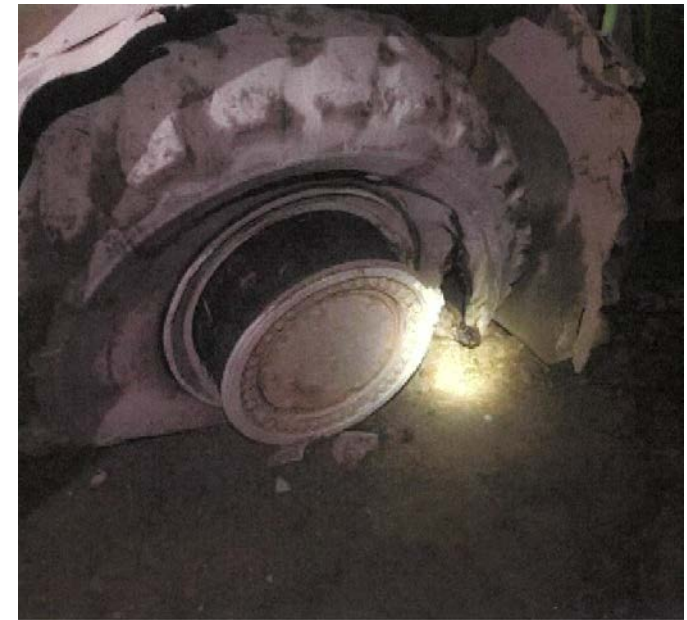
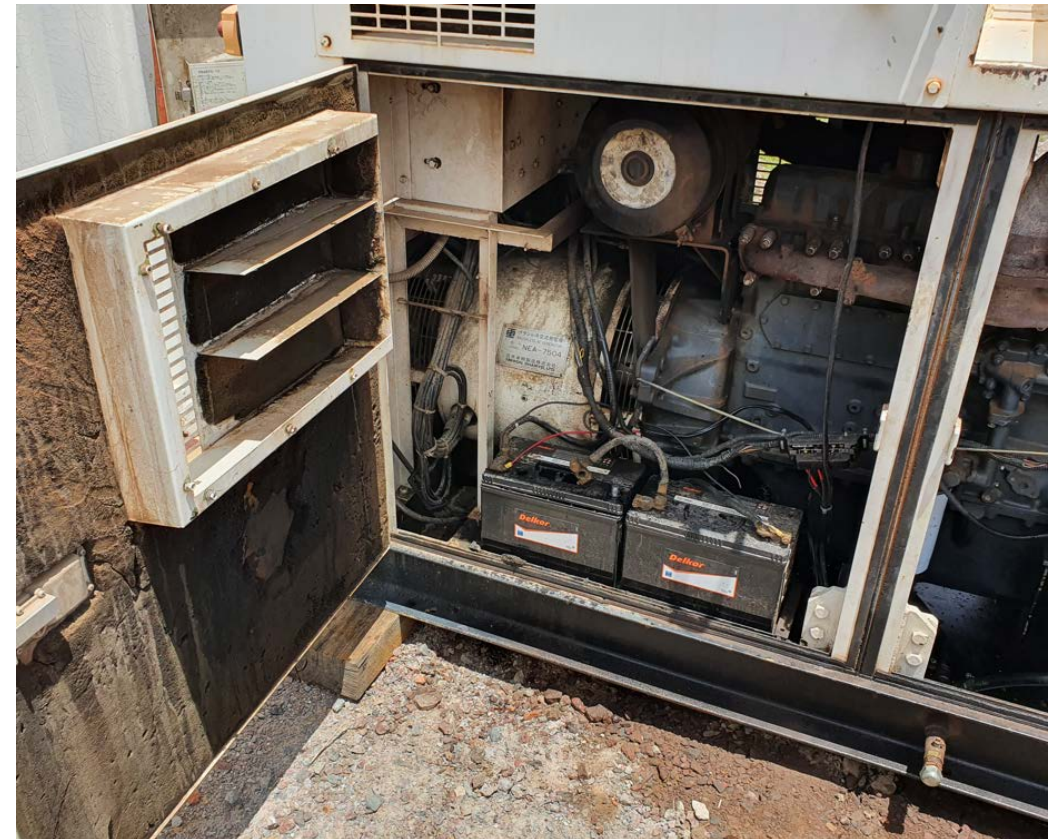
Generator battery explosion

The sparks ignited hydrogen sulphide gas, causing the battery to explode.

- Battery terminals must be maintained in good condition and routinely checked to ensure they are tight. (Administrative control)
- Battery covers should always be in place and secure before equipment is started. (Engineering control)
