MMQ Quarterly Report

High Potential Incidents and Serious Accident Summary Queensland Mineral Mines and Quarries Inspectorate January – March 2023 quarter

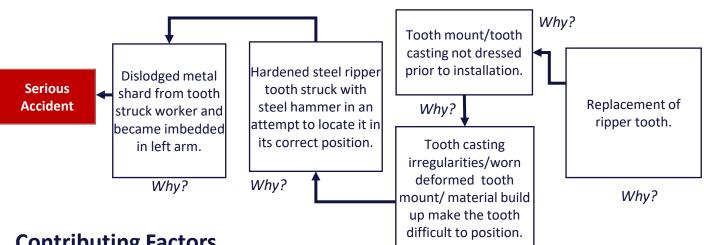
A contractor was changing the ripper boot on a ripper attachment when he struck the boot with a steel hammer in an effort to locate it in its correct position. Striking the boot with the hammer caused a shard of steel to snap off the boot and penetrate the workers forearm. The shard required surgical removal.

- Contractor changed the style of ripper boot being used, which incorporated a different locking system that the contractor was not familiar with (Change management process, lack of experience, unfamiliarity of task).
- The finish of the Ripper Boot was poor which led to the Ripper boot not allowing for proper install -Radius required buffing to install.
- No visual inspection of Ripper Boot prior to the task being completed.
- Contractor hit boot with hammer (steel on steel).
- Contact was made on the edge of the boot the weakest part of the boot.
- Soft hammer (copper) not used

- · Clean and deburr component housings and mounts prior to installing the component.
- Avoid striking components to set them in their correct position. Where an interference fit exists, consider the use of a hydraulic press to assist. Other fitting techniques such as heating or cooling to reduce component interference fits temporarily during the installation process may be appropriate(when fitting bearings for example). Remember to consult with the component manufacturer before extreme heating or cooling, as these activities may introduce additional hazards if not performed correctly.

- If there is no alternative other than to strike a hardened steel component, always use a soft faced hammer (copper or nylon insert) to do SO.
- Repeated striking of a component in order to correctly position it will likely indicate a problem. Take the time to investigate reasons for the component not fitting easily or correctly.

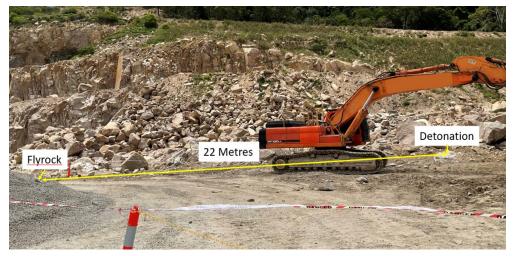
An unplanned detonation of explosives occurred while using an excavator fitted with a rock-breaker attachment, to break rock in the floor of a quarry.

Drill and blast activities were conducted by a contractor. The Contractor's drill and blast records were not adequate to ensure the requirements of AS 2187.2

- No procedure for secondary blasting of oversize material.
- No procedure for hydraulic breaking of oversize material.
- No procedure for identifying misfires.
- SSE failed to ensure the blasting records were adequate as per AS2187.2.

Lack of explosives awareness and identification of misfires training for workers.

- Ensure all blasts are cleared for misfires prior to work recommencing in the area.
- Ensure the blast management plan meets or exceeds the requirements under AS 2187.2.
- Never work on top of blasted ground that has not been cleared.

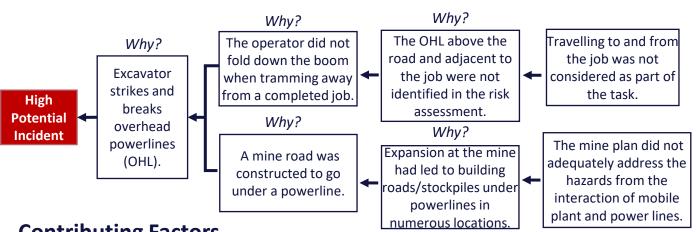
While leaving a completed job and travelling on a mine road, an excavator struck High Voltage overhead power lines (OHL), breaking the power lines and causing a fire from the lines arcing on the ground.

OHL visibility – There was no signs on the road identifying powerlines above and there were no markers on the lines to highlight the difficult to see lines.

Mine Planning – The Mine planning and design process did not adequately address keeping Mobile plant operations separated from powerlines.

Safety and Health Management System – The SHMS relied on administrative controls. Higher level controls such as elimination, separation or engineering should have been used to keep plant away from powerlines. Reliance on operator competency as a control – Recent incidents show that to expect trained and experienced operators to remember the presence of power lines is an unreliable way of preventing further similar incidents.

- Eliminate the need to travel/work under OHL's.
- Determine if any mobile plant is capable of breaching the minimum clearances required below the OHL. If the mobile plant cannot avoid breaching the minimum clearance, the power must be disconnected to allow the plant to travel under it safely.
- Mandate that mobile plant must travel around the site in the travel position at all times.
- Create designated travel-ways away from OHL and install effective barriers to prevent alternate travel-ways being used.
- Separation of mobile plant from OHL must form a part of Mine Planning and be incorporated into the Safety and Health Management System.

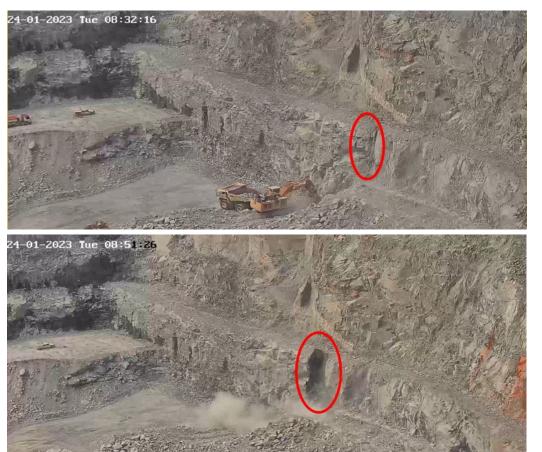
Mining activity was occurring in the open cut pit involving a double bench mining technique using a 250t backhoe excavator. A phone call was received from the remote geotechnical monitoring team notifying the Mining Supervisor of a progressive deformation pattern developing in the radar monitoring data.

The Mining Supervisor notified the mining crew and instructed the area to be evacuated and barricaded. Twenty minutes after the call a small wedge failure occurred whereby ~61 tonne of material fell from 18 metres above onto the area where mining activities were recently active.
