Highwall Failure & Misfire

Neil Reynoldson
Mines Inspectorate
August 2015

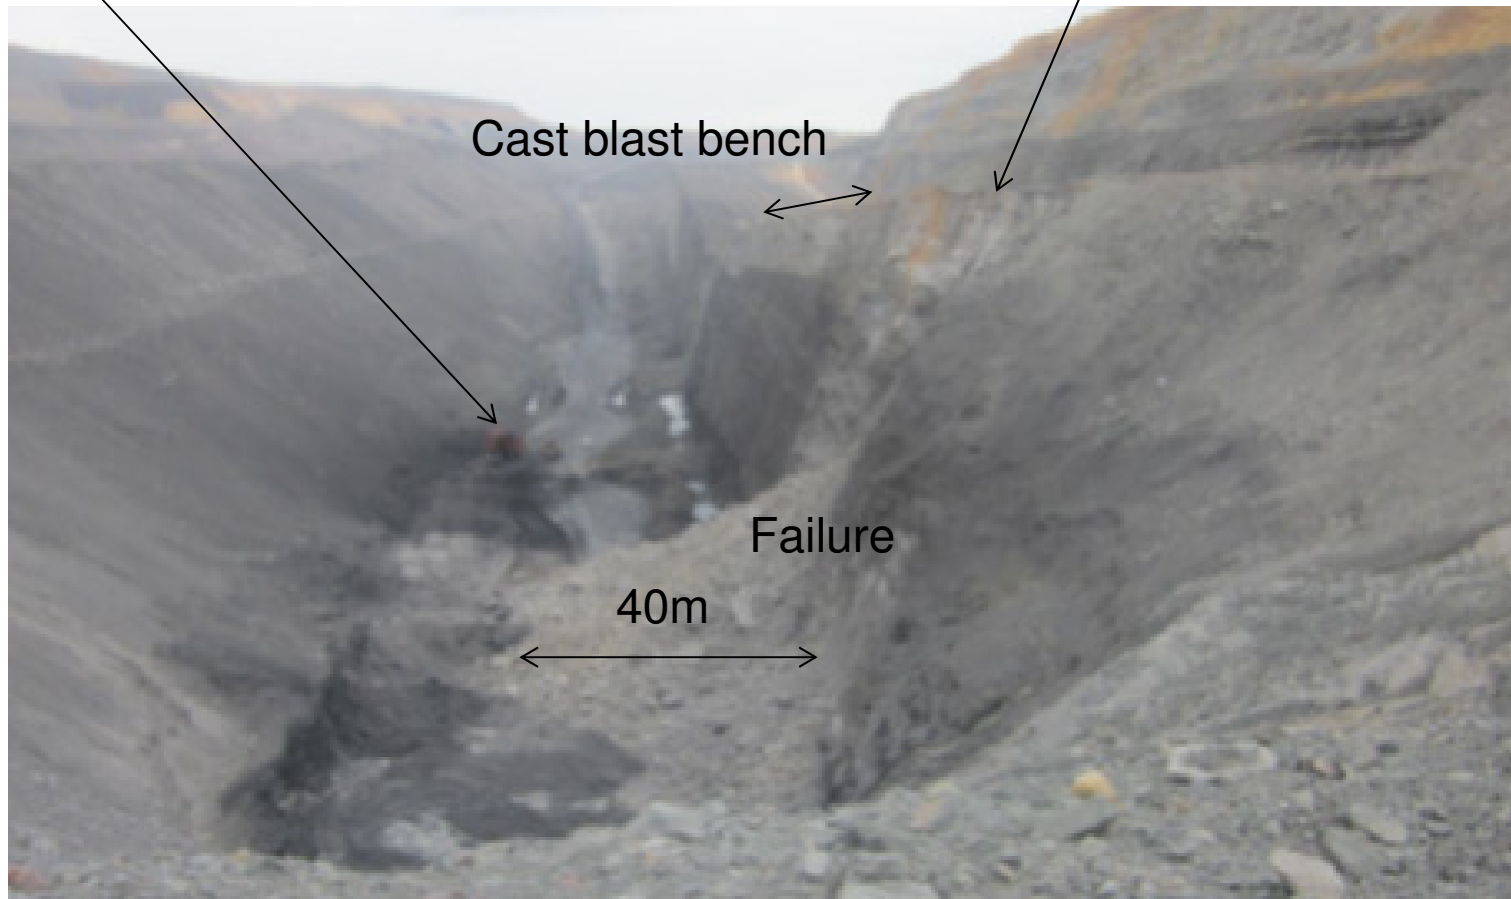
Highwall Failure- 19/12/14

8.45hrs- Highwall collapse

- Material breached bunding, and extended approx 40mts across the pit floor.
- Loaded shot for a scheduled cast blast and loaded holes were part of the collapsed material

Equipment pulled back

Loaded holes on top bench lost

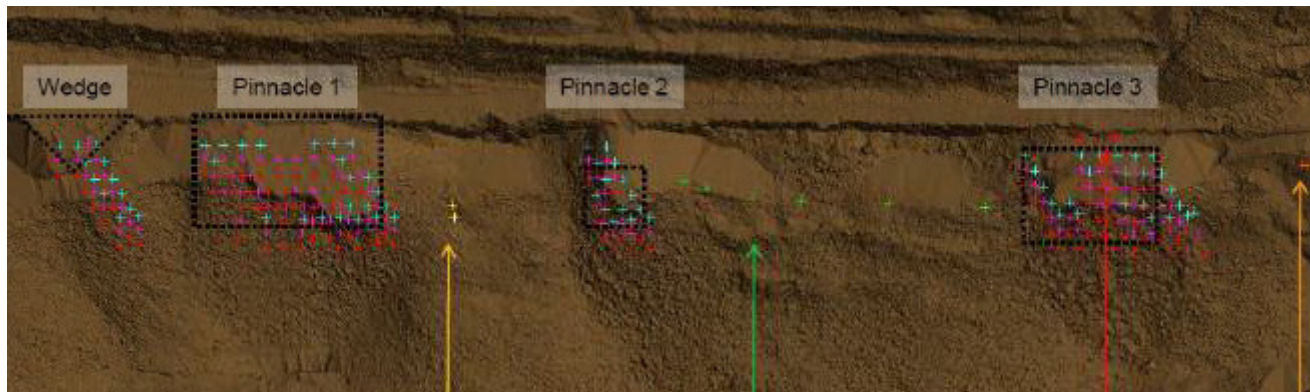
Floor shot and cast blast – Fired 22/12/14

Fired with Ikon 2

Misfire had 4 zones (wedge , pinnacle 1 , 2 & 3)

- Failure to recognise risk of fly rock from floor shot impacting on cast blast during first det - last det -fire command
- Change (to fire with two separate blasters) was not managed through a Risk Assessment to use two separate blasters
- No Procedure for this particular task (Multi blast), supported by a Risk Assessment
