# Truck Breaches Tip Head Due to Dump Failure

2<sup>nd</sup> December 2025

Hail Creek Open Cut

## Summary - Truck Breaches Tip Head Due to Dump Failure

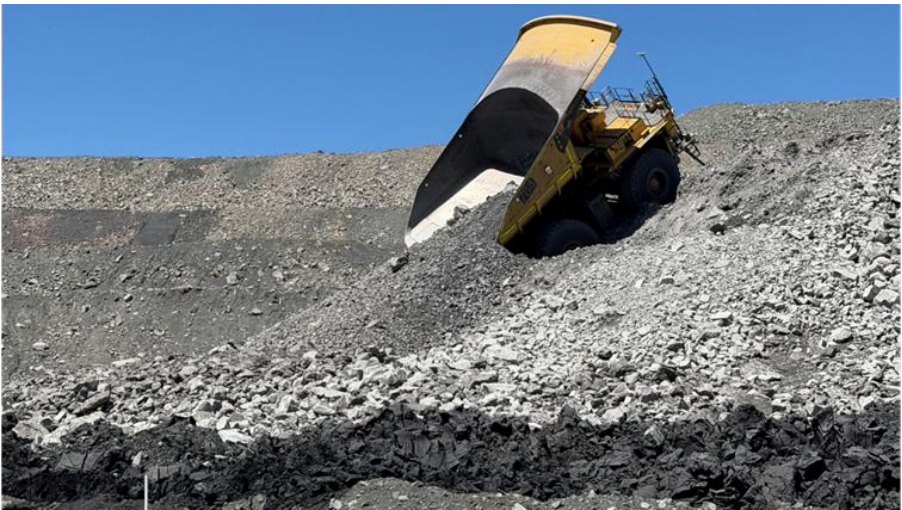
TR784 a Komatsu 960E haul truck was discharging a load of waste at the corner of the RL180 dump. As the truck tray was raised and weight transferred to the rear wheels, a localised circular bench scale failure of the dump face occurred. As the material gave way underneath the rear of the truck, it began to slide backwards and downwards in a slow but uncontrolled manner. The truck came to rest at an approximate angle of 45°.

At the failure location, the RL180 dump was 19m high, comprising a ~15m lift of CAT 3 rock spoil being placed over a ~4m thick layer of CAT 1 CDA2 Ultrafine Clay. The CDA2 Ultrafine Clay was dumped at the location without approval and the hazard that this created was not identified during the dump design process nor during any inspections leading up to the incident. In the week prior to the incident, the site received 143mm of rainfall.

The weight that was applied by directly tipping at the dump corner crest, which was overlying the saturated, weak CDA2 Ultrafine Clay layer is what caused the dump to fail.

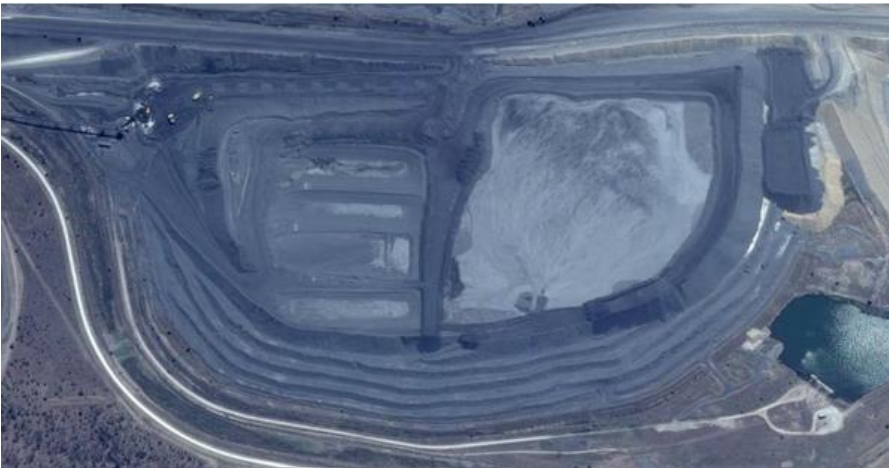
2011 - CDA2 facility exhausted

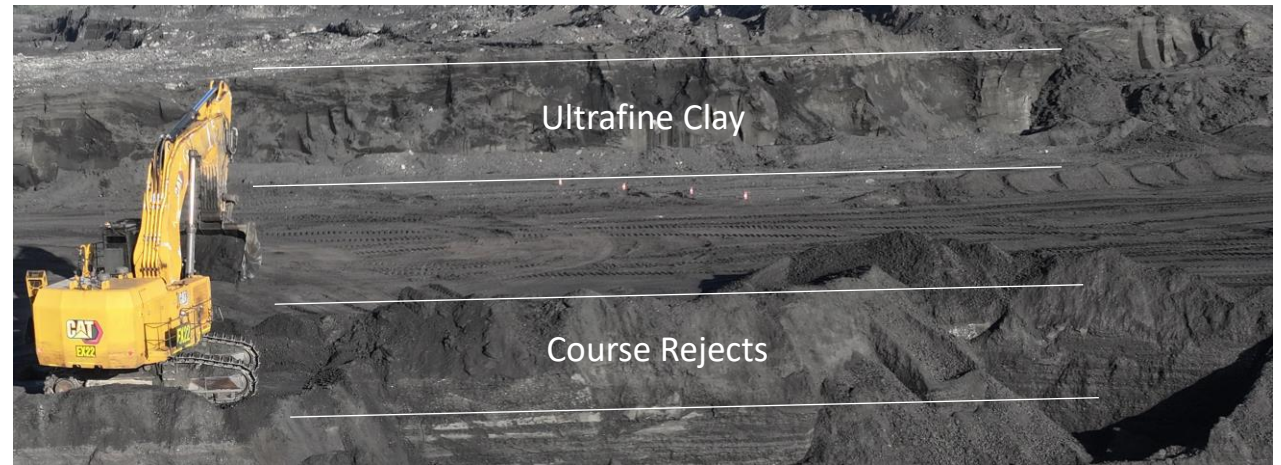
2025 - Course and clay material from current stockpile

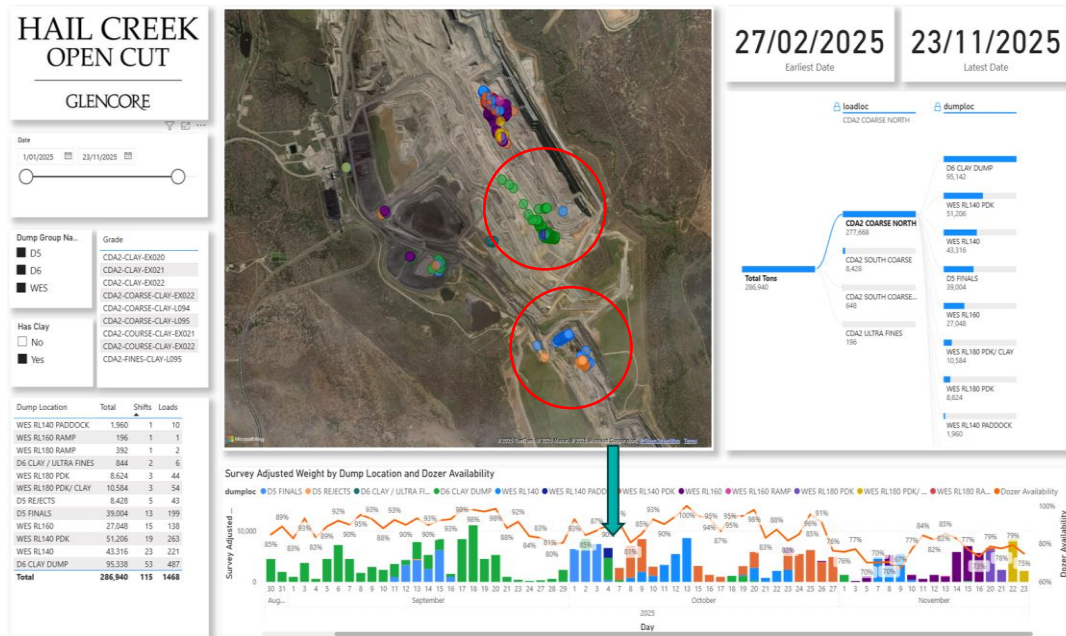
- CDA2 Ultrafine Clay ‘ALL’ dumping locations (*note that the background photo is old*)
- The ‘Red Circles’ represent the dedicated storage cells

- CDA2 Ultrafine Clay material dump locations 27/02/25 to 23/11/25 (702 loads in Dump 5&6, 706 loads in WES)
- All material went to Dump 5 & 6 storage cells up until early October, from 7<sup>th</sup> October majority (apart from 21 loads), went in-pit

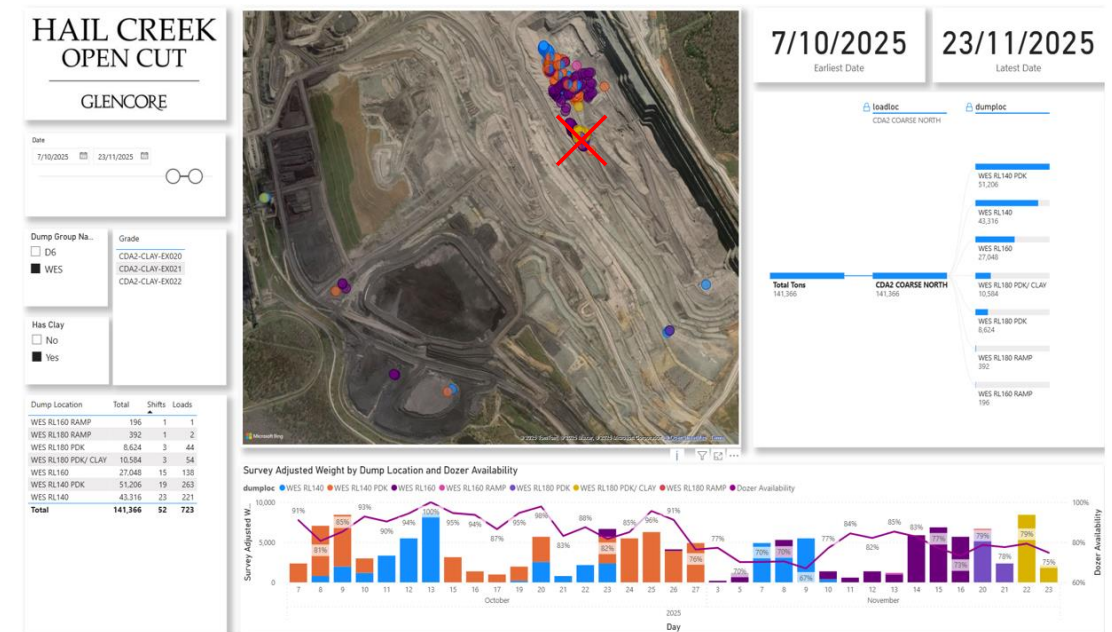
- CDA2 Ultrafine Clay ‘WES Pit’ dumping locations (*note that the background photo is old*)
- The ‘X’ represents the incident location

- Loads dumped in WES Pit = 706
  - 17 loads counted out of WES and subtracted from the data set
- Data from 7<sup>th</sup> Oct

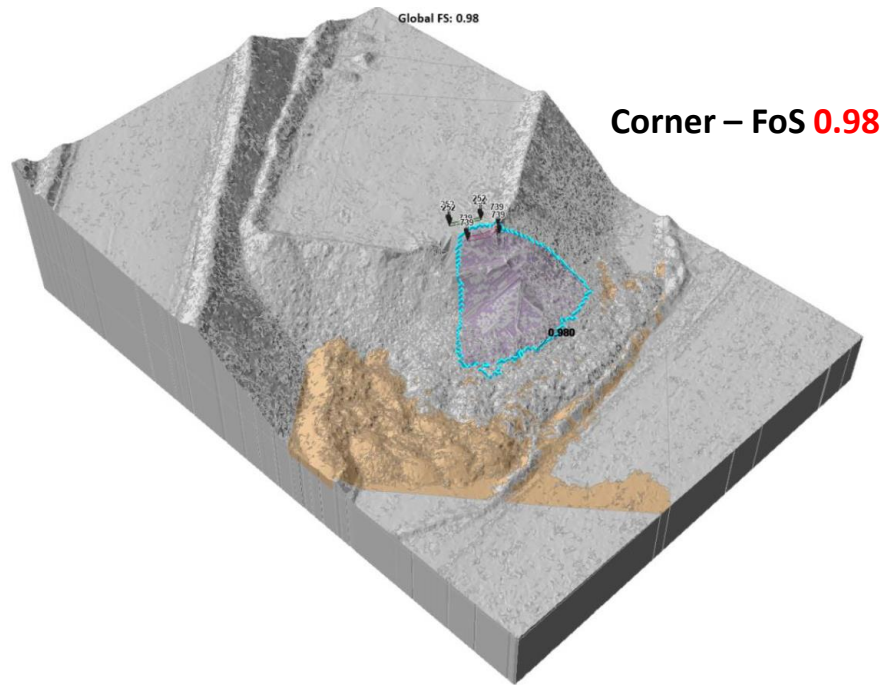
3D geometry modelling of the dump corner

- The material strength parameters for the CDA2 Ultrafine Clay material has reduced the FoS and significantly weakened the dump structure
- **143mm** of rain was recorded in the days leading up to the event
- **What is a circular base failure?** The slip surface passes below the toe, often when the **foundation material is weaker than the slope material.**
