Investigation findings and recommendations

Winder brake failure at Osborne Mine on 1 March 2015

9 November 2018

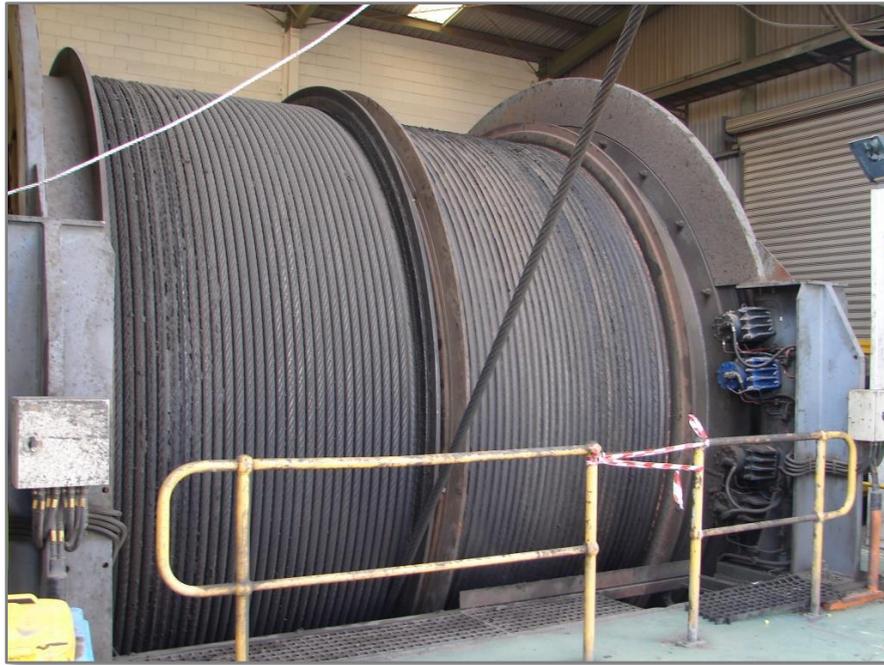
Following this incident, on 1 March 2015, the brakes on the clutched drum failed to hold the counterweight which ended up at the bottom of the shaft. The remaining five or six turns of rope came off the drum and the rope broke at the anchor point on the drum. As the end of the rope came out of the winder house it caused considerable damage to the front window and the guard railing at the top of the head frame. One piece of the railing was found 105 m away on an internal mine road.

The winder without the counterweight rope

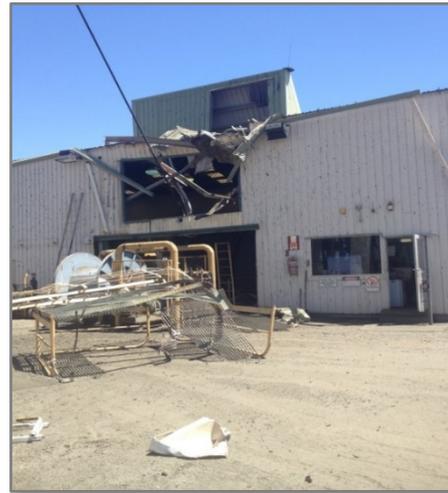
Following this incident, on 1 March 2015, the brakes on the clutched drum failed to hold the counterweight which ended up at the bottom of the shaft. The remaining five or six turns of rope came off the drum until the rope broke. As the end of the rope came out of the winder house it caused considerable damage to the front window and the guardrailing at the top of the head frame. One piece of the guardrailing was found 105 m away on an internal mine road.

Damage to the front of the winder house after the second incident

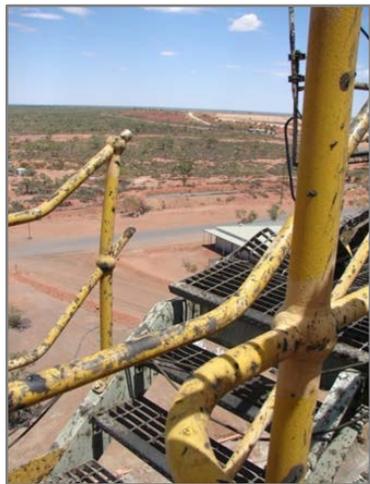
Damage to the guardrailing at the top of the headframe

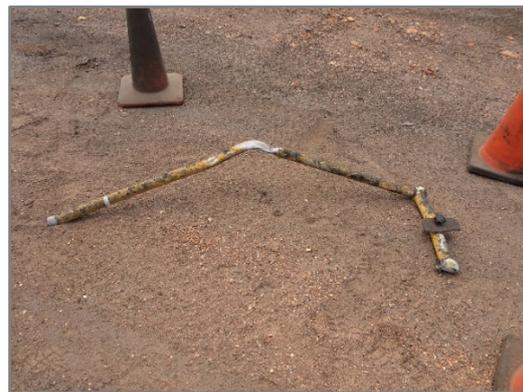
Piece of guardrailing found 105 m from headframe

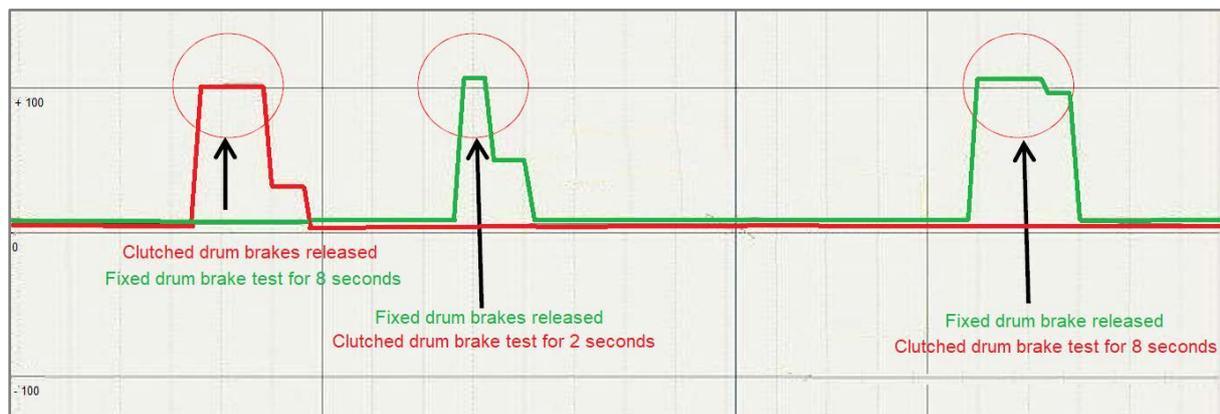
Static brake hold tests on day of incident

The last of these four SBHTs was done on the morning of the incident and the Citect screen shot of the chart is shown below. The timeline goes from left to right. The green trend lines show the fixed drum brake is released while the clutched drum brake is being tested.

The first SBHT on the clutched drum appears to have failed because it lasts only 2 seconds instead of 8 seconds. The second SBHT shows a pass result but no TR is recorded. When asked during a record of interview whether it was possible that the first SBHT on the clutch drum had failed and the test had been redone, the winder driver replied: "We've redone it..... Yep, yep. That's possible."

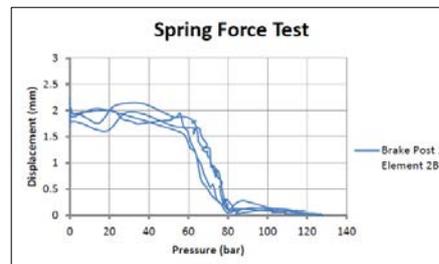
The chart on the right displays spring force tests conducted in January 2012. It shows a caliper on the clutched drum brake with an unknown problem. Four calipers on this drum had a similar problem and were listed for immediate attention.

Unknown problem – January 2012

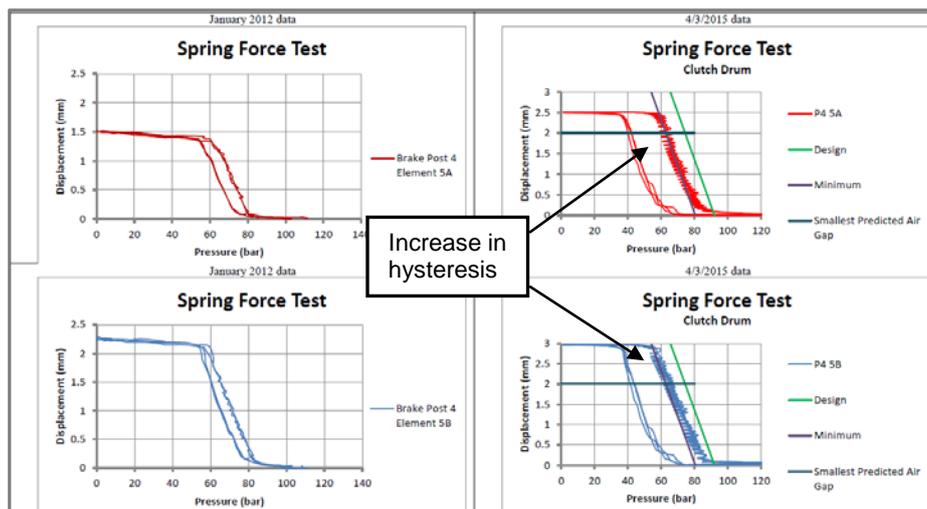
Comparison of results of spring force tests between 2012 and 2015 show an increase in hysteresis to about 30%. This could result in a significant reduction in the pad to disc forces and brake holding capacity. In addition, the air gap settings on the brakes were greater than specifications which contributed to lowering the braking force.

Spring Force Tests comparison of caliper on clutched

In relation to the brake calipers, consider spring force testing, monitoring of the air gap and a system that can identify leakage from individual calipers.

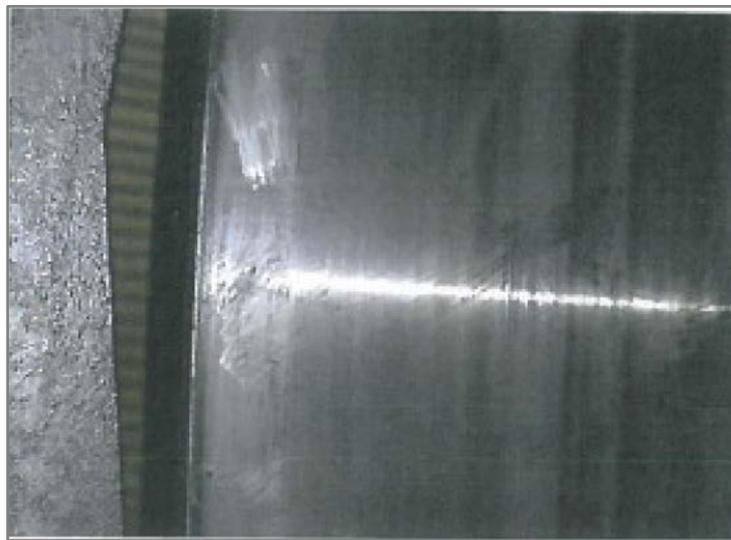
On two occasions consultants observed contamination on the inside of the clutched drum disc brake, once in 2012 and again in 2014. The consultant's May 2014 report stated that the brake disc surface on the inner side of the clutched drum appeared to be contaminated by oil and recommended cleaning the disc surface with a suitable cleaning fluid and to remove and clean the pads one by one.

The consultant's reports did not make reference to finding the source of the contamination and gave advice that was contrary to the manufacturer's maintenance instructions for the brake calipers that states "If friction pads become fouled with fluid they must be replaced after curing the leak and the disc(s) wiped clean".

From May 2014 until the incident on 10 February 2015, no evidence was found that the brake calipers were changed out and no new brake pads were installed. The practice of cleaning the contaminated brake disc when the SBHT failed became normal and was endorsed by consultants.

Clutched drum brake disc contaminated with oil

In the event that the brake path becomes contaminated, the manufacturer's instructions should be followed and should include cleaning the brake path and replacing all the brake linings and identifying the source of the contamination to prevent further contamination.
