Incident periodical

Recent High Potential Incidents
Learnings and Recommendations
Communications

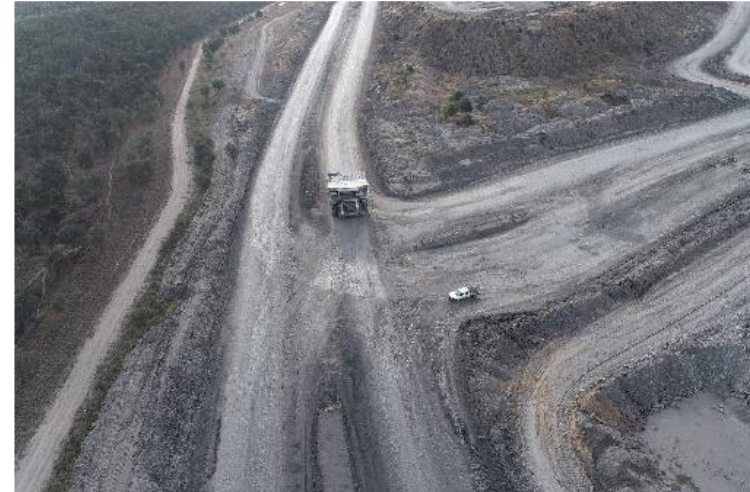
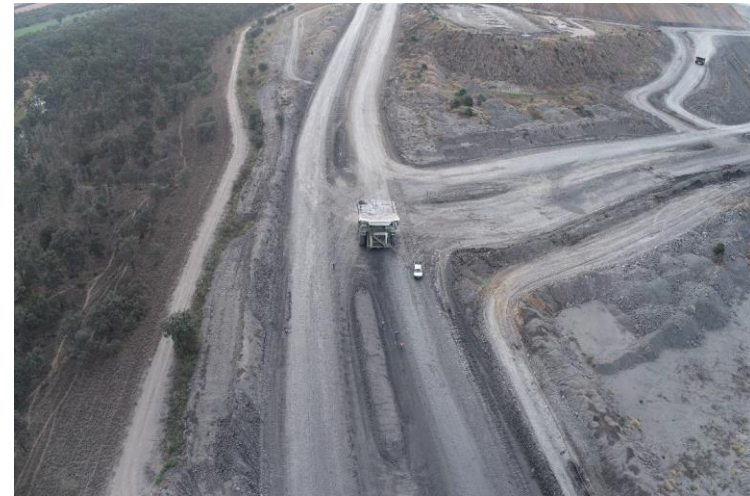
- A light vehicle (LV) turned left after stopping at a T-intersection and entered a haul road in front of an empty rear dump truck (RDT) travelling in the same direction.
- The RDT took evasive action to avoid a collision, stopping 10 to 15m from the LV.
- No injury or damage was reported, however, the potential existed for a serious incident to occur.
- Investigation findings included:
 - LV operator mistook the flashing blue light on the haul truck as an indicator that the truck was turning left at the intersection.
 - The LV operator was distracted at the time, talking to a vehicle passenger.
 - Prior to the incident the RDT was travelling faster than permitted.

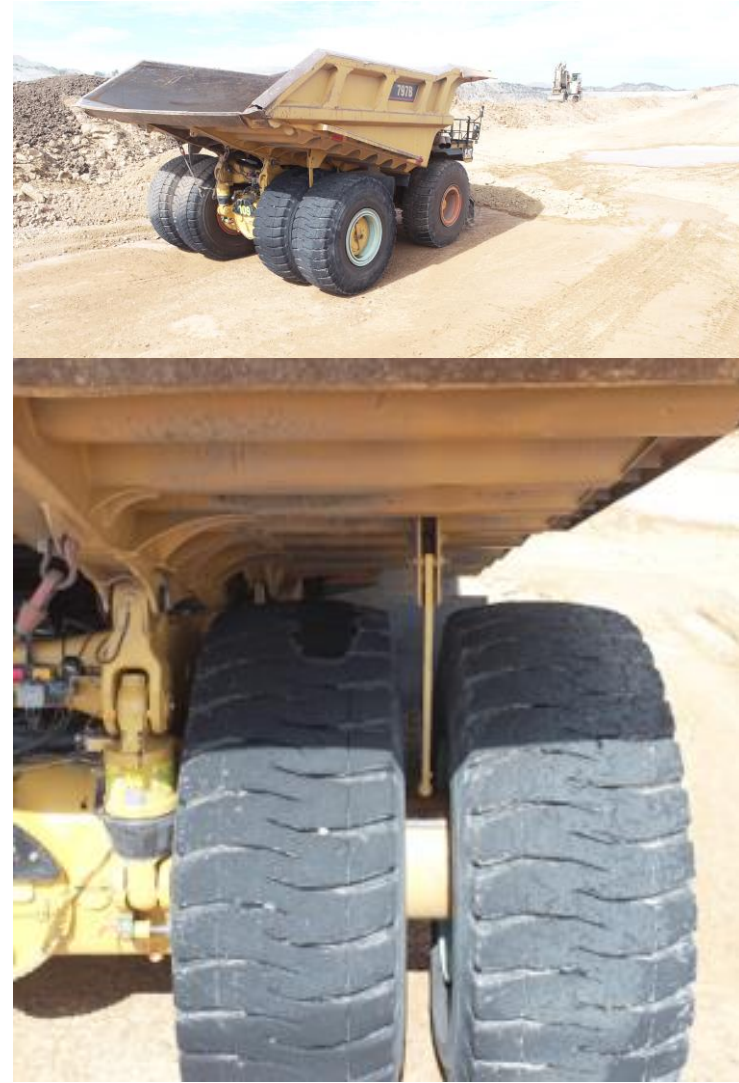
- An excavator operator observed a small flame coming from pos 5 tyre tread on a rear dump truck during loading.
- The truck operator exited without incident, ERT responded and extinguished the fire using a water truck. An exclusion zone was established.
- Investigation findings included:
 - that the external tyre fire was likely caused by tread separation due to a rock cut from road debris or unfavourable ground conditions.
 - inadequacies in site procedures & communications for dealing with suspected tyres incidents.

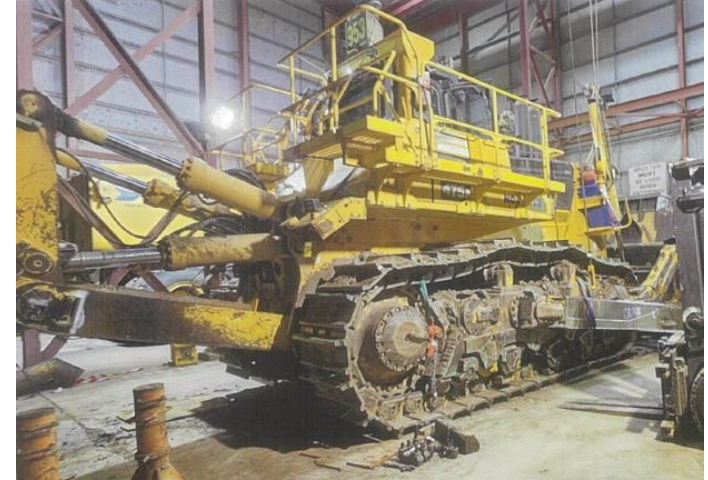
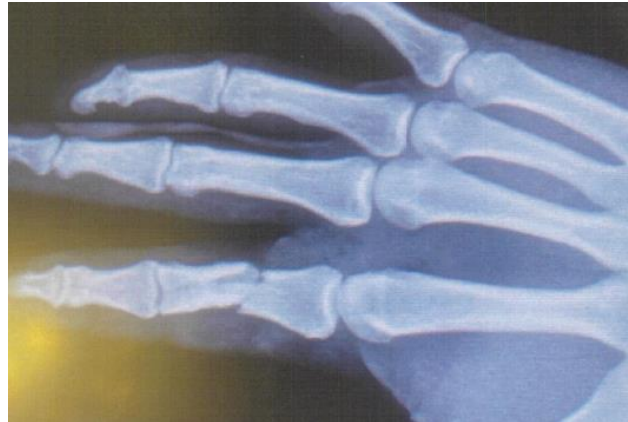
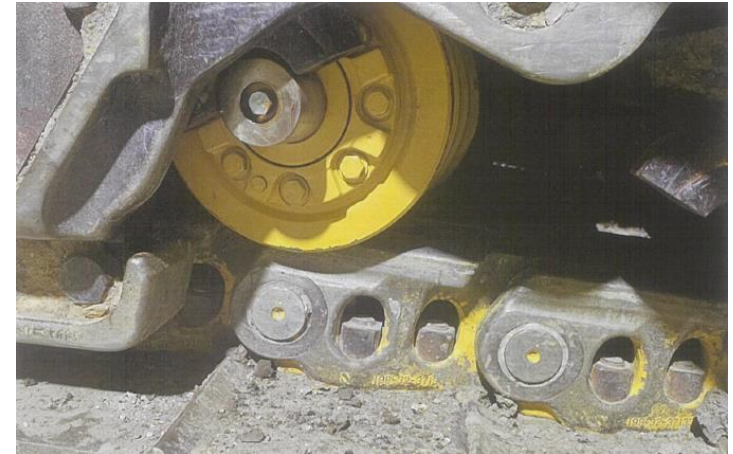
- A CMW suffered a serious hand injury whilst replacing a load roller on a dozer.
- The load roller moved unexpectedly, crushing the CMW's finger between the roller and track.
- Investigation findings included:
 - Supervision & planning inadequacies.
 - Communication issues.
 - Inadequate manning when spotter reallocated to another task.
 - Lack of risk management, JHA, SOP.
 - Lack of specialised tooling.

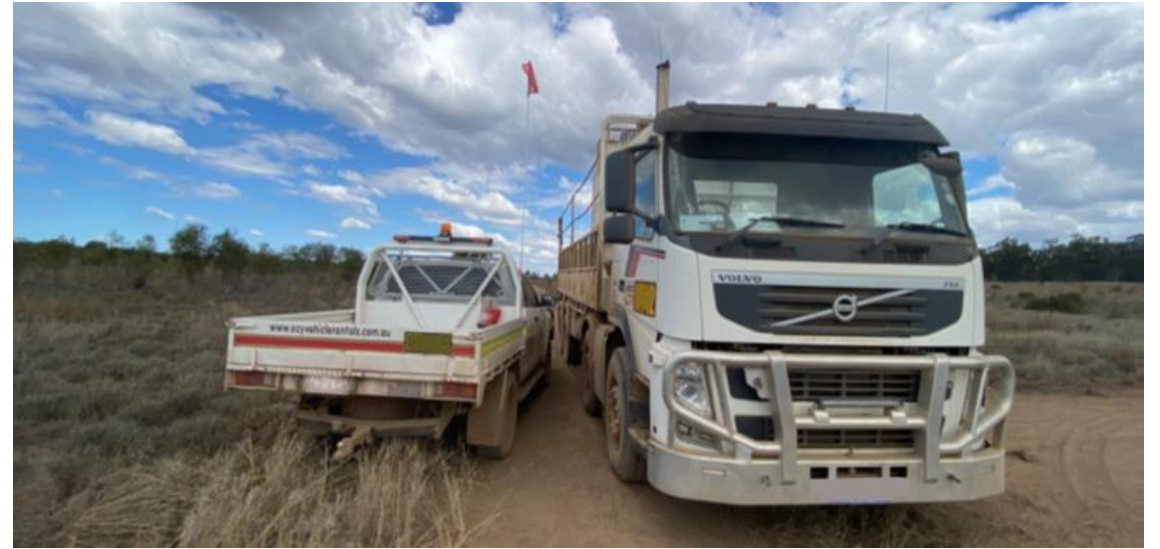
- A CMW was pinned between a slow-moving light vehicle (LV) and a stationary exploration driller's water truck.
- The CMW was able to extricate themselves from the small gap between the vehicles.
- Soft tissue injuries and bruising to the lower torso was suffered.
- Investigation findings included:
 - Mine transport rules were not followed.
 - The vehicle was not parked fundamentally stable before the CMW got out of the LV.
 - The LV was left with the engine running, in gear and the hand brake not engaged.

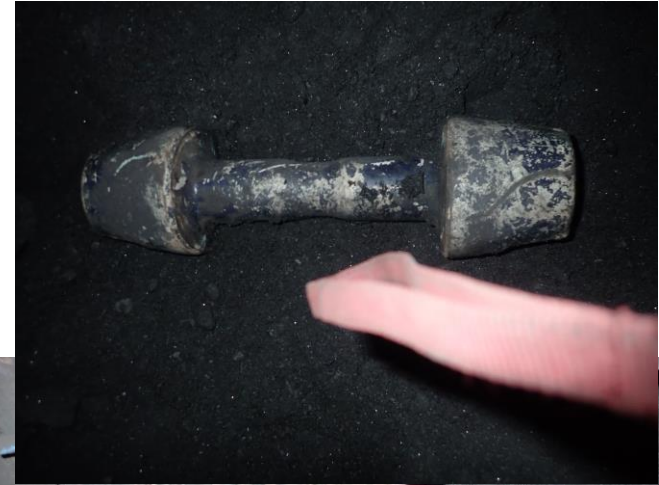
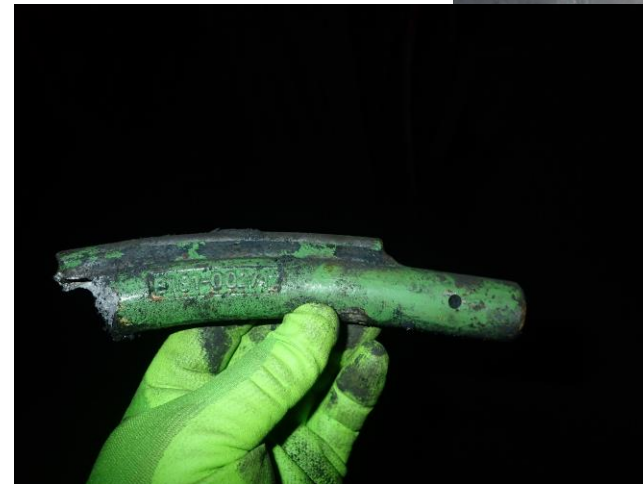
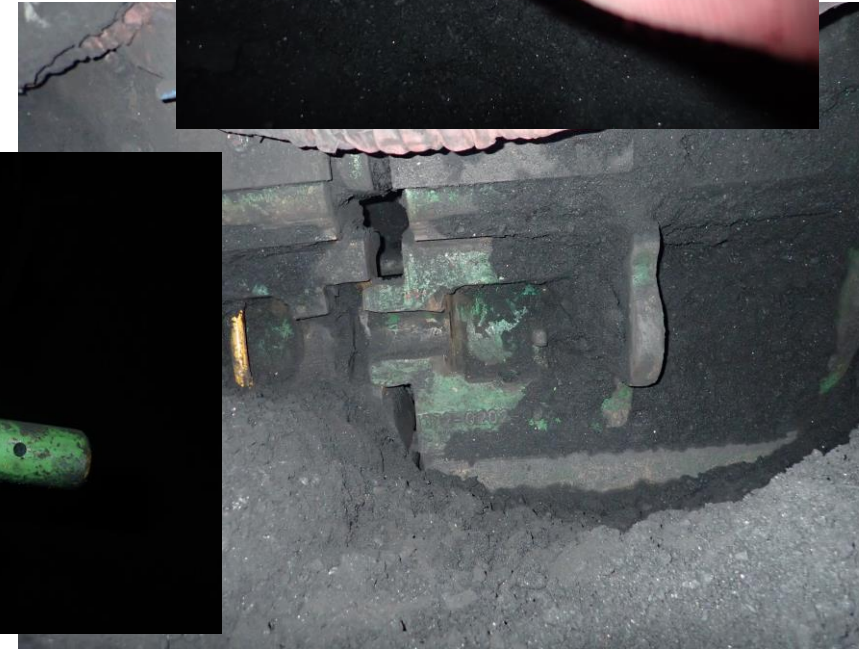
- A CMW was manually operating the longwall AFC push function at the TG end of the longwall.
- A dog bone dislodged under tension, a retaining hockey stick failed, and a piece of the hockey stick ejected striking the CMW in the back.
- The CMW was transported to hospital for assessment and treatment for soft tissue injuries to their back.
- Investigation findings included:
 - Manual operations were being used to push the AFC instead of the auto function. This placed additional strain on components.
 - Similar issues had occurred on previous shifts and had not been communicated.
 - Non-engineered components & inadequate instructions.

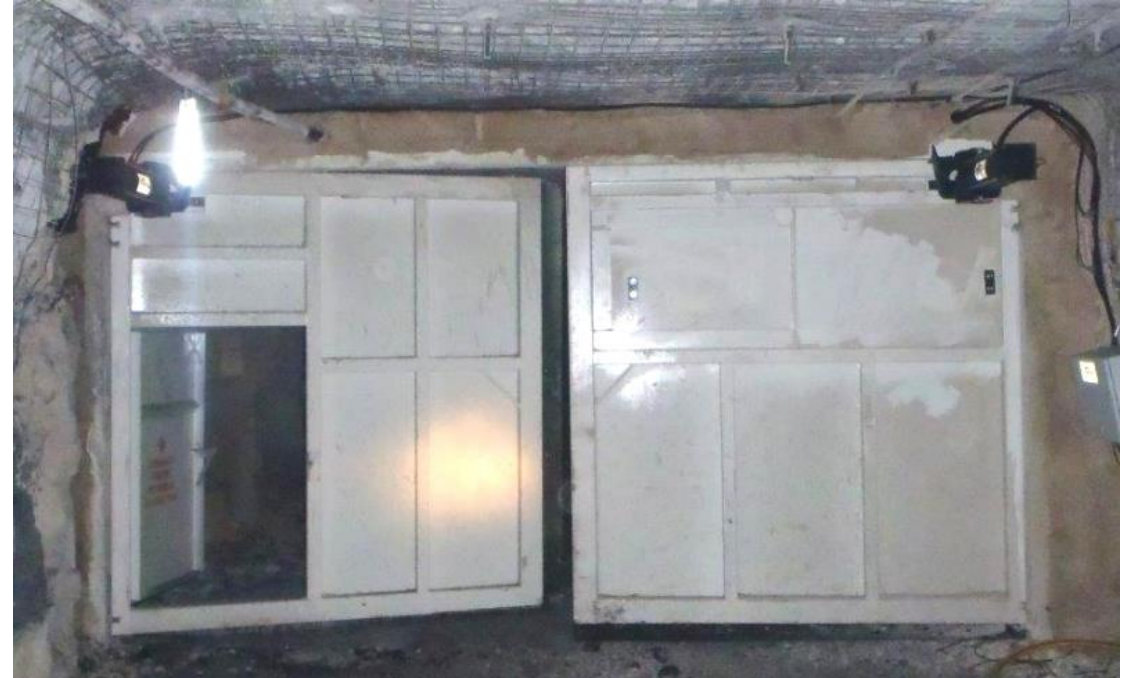
Typical machine door

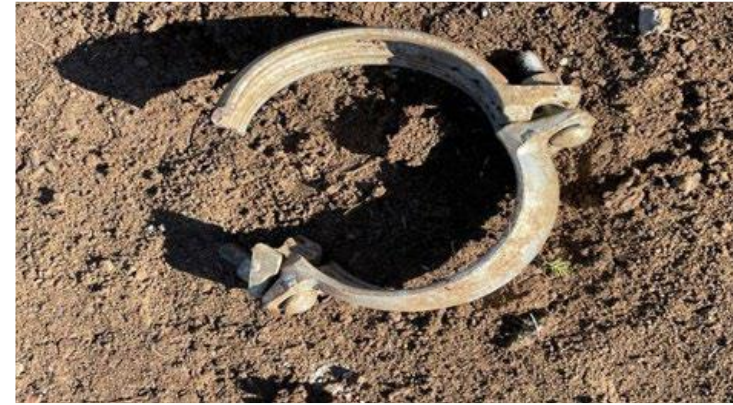
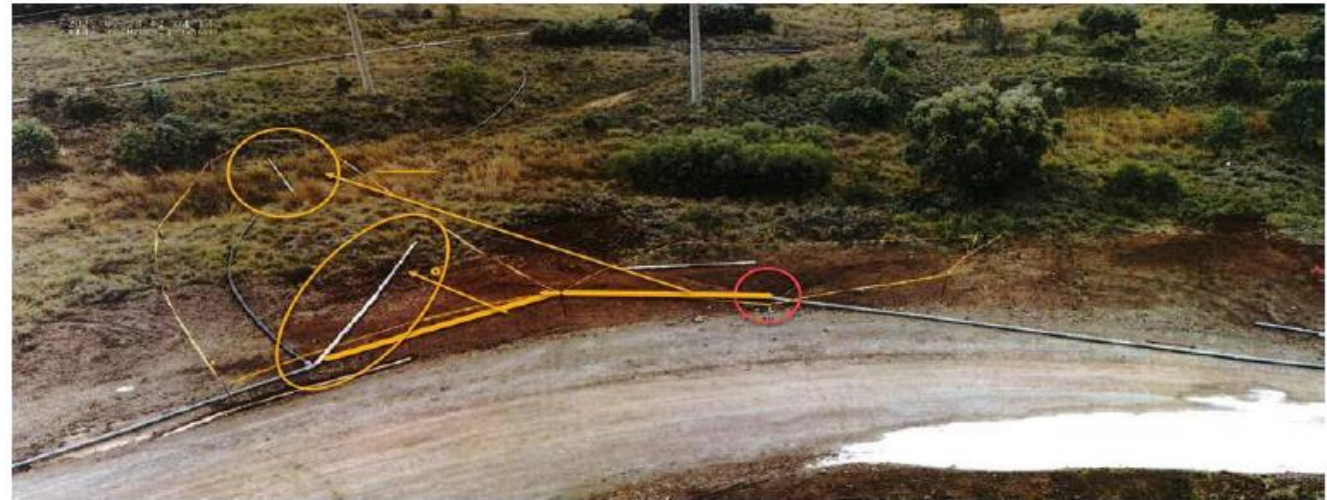
Red circle shows IW position yellow indicates pipe pre and post clamp failure
