# MMQ Quarterly Report

High Potential Incidents and Serious Accident Summary  
Queensland Mineral Mines and Quarries Inspectorate  
*July – September 2022 quarter*

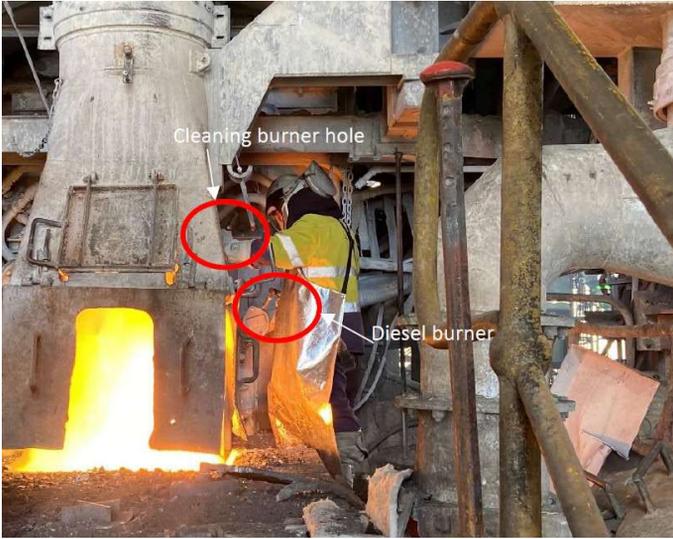
While cleaning the port for a diesel burner used for maintaining heat to the weir portion of a smelter furnace, radiant heat ignited the fuel spilled on the worker's PPE. After unsuccessfully attempting to extinguish the fire, the worker was moved to the safety shower by nearby colleagues.

**Safety & Health Management System (SHMS):**  
No documented procedure or SWI was in place for regular burner port cleaning.

**Organisational Culture:**  
Cleaning of the burner port without isolation of the fuel and air supply was the accepted practice.

**Equipment:**  
Isolation was only possible through control valve, which was located away from the burner port. Multiple trips to control the valve would be required for air and diesel adjustment.

**Emergency Response/Training:**  
An emergency response plan for fires in the area was not in place. Attempts were made to extinguish the fire using hands, then with a bucket of water before the worker was moved to the safety shower.

Photograph of a re-enactment of the incident

- Sites must identify fire hazards from fuel interaction with hot areas, and ensure appropriate controls are in place
- Always isolate and lock out energy sources before working on plant
- Always have emergency response plans in place for foreseeable emergencies on site

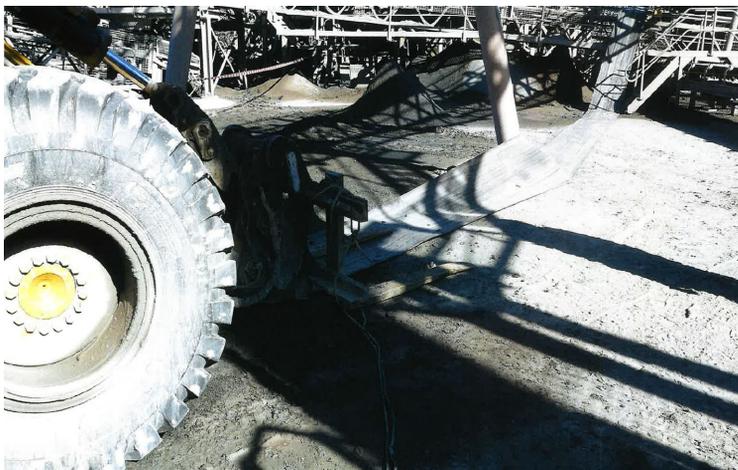
A loader was being used to pull an old conveyor belt from a conveyor structure. One end of a synthetic fibre rope was attached to a the loader and the other end was attached to a conveyor belt. During the process of removing the old conveyor belt, a gravity take up unit pulley jammed. Force needed to move the conveyor belt, resulting in the rope failing .

**Hazard Identification** – The hazard of rope failure and whiplash was not identified during the risk assessment process and as a consequence, controls such as an exclusion zone of suitable size were not considered.

**Plant and equipment** – Purpose built equipment such as winches and winders fitted with load cells were not utilised.

**Slinging of load** – Poor load slinging techniques caused the conveyor component to jam, increasing tension on the rope, resulting in rope failure.

**Personal protective equipment** – Eye protection was not being worn by the injured person at the time of the accident.

Photographs showing incident scene

- Equipment failure during hauling and loading type operations can occur at any stage. Workers need to be aware of this and stay well clear of items such as cables, ropes, and chains when they are under tension.
- Preference should be given to purpose-built equipment such as winches, winders and reeler when installing or replacing conveyor belts.
- Monitor loads to ensure equipment load limits are not exceeded.
- Plant design should include designated lifting points where necessary.
- The most critical control in this instance is separation from the hazard.
- An exclusion zone should account for any rope or cable stretch under load, plus a significant allowance as a margin of safety, particularly when using synthetic fibre ropes.
- An exclusion zone must be clearly defined and where possible physically prevent entry into the exclusion zone.

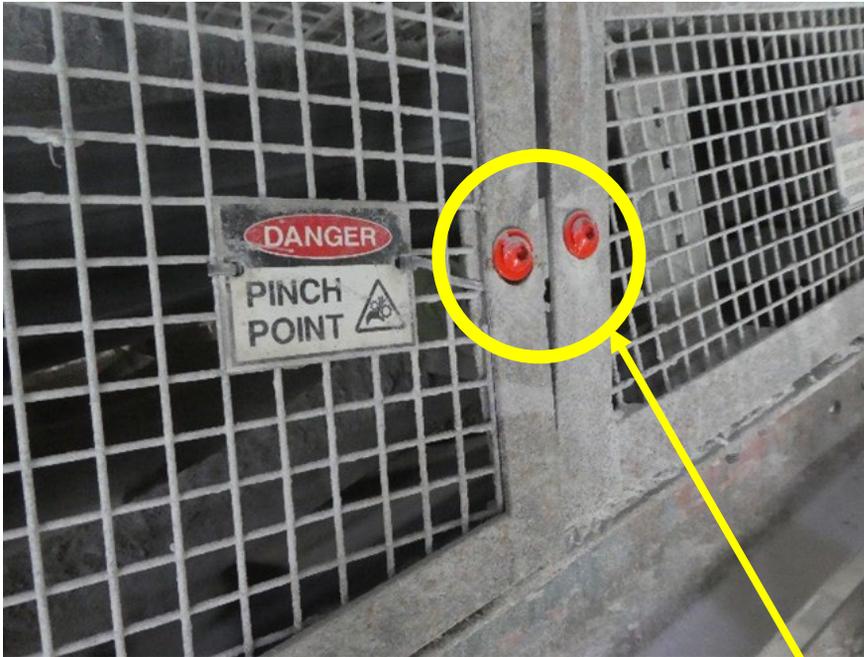
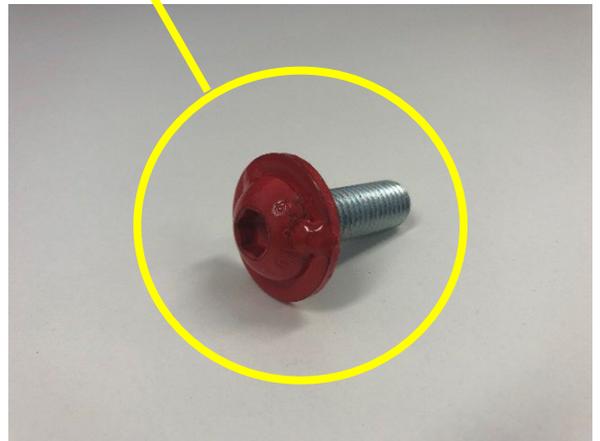
A local quarry has installed specialised fasteners to ensure machinery guarding remains in place and effective. The idea was formulated by the quarry manager, and the fasteners are manufactured by maintenance workers on site. It's a simple, effective and low-cost initiative. At least one tamper proof fastener is used on each guard panel, ensuring only suitably competent workers with access to special tools can remove the guards.
