# MMQ Quarterly Report

High Potential Incidents and Serious Accident Summary  
Queensland Mineral Mines and Quarries Inspectorate  
*January- March 2022 quarter*

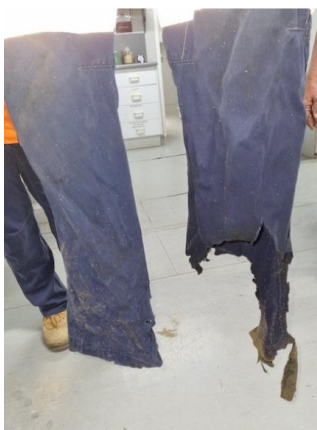
## Inching drive motor fan disintegrated

During a mill inching task to reposition mill and balancing mill charge, the motor fan of the inching drive disintegrated, ejecting fragments of the fan into the immediate area.

Photos showing fan fragment ejection damage

This hazard has been present for a period, thought to be longer than a decade. Engineering a solution that removes the excessive energy being directed through the inching drive motor and ensuring effective change management will prevent such future incidents. To assist hazard perception and recognition we need to challenge the status quo and acknowledge we are all influenced by our biases - what are the potential hidden hazards and what could go wrong?

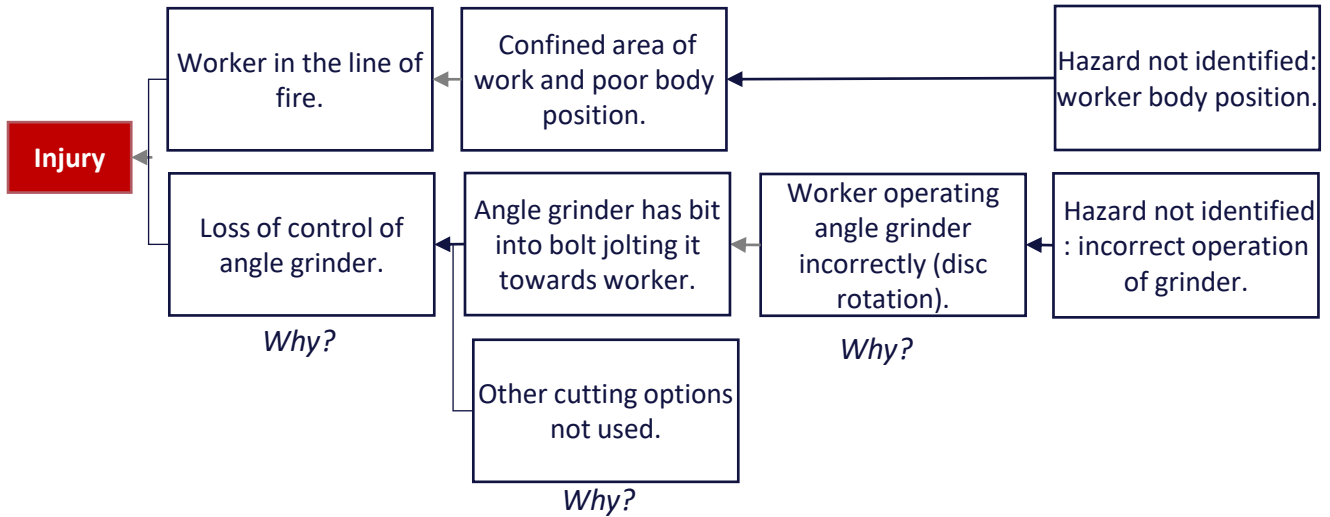
A worker was using a 5" angle grinder to cut off bolts from a platform. The angle grinder has 'bit into' the bolt being cut, then kicked back into the workers abdomen causing a 20cm laceration.

- The SHMS didn't include procedures for outlining the requirements for small powered hand tools.
- The Standard Work Instruction (SWI) did not identify correct body position or safe operation requirements for the grinder.
- Training records management for the worker did not include training in the relevant SWI.
- The worker did not identify hazards associated with their body position or incorrect operation of the angle grinder.

- Workers must not be positioned in a hazards 'line of fire'.
- Angle grinders should be fitted with dead-man switches, guards and handles (OEM).
- Ensure that workers are trained and assessed as competent to perform tasks.
- Procedures should be sufficiently detailed to manage all hazards associated with the task.
