ANNEXURE 1 - SITE MANAGEMENT PLAN

SITE MANAGEMENT PLAN (SMP) – PARKHURST PLANT, ROCKHAMPTON

**Parkhurst Facility
Rockhampton**

Stage One Site Assessment

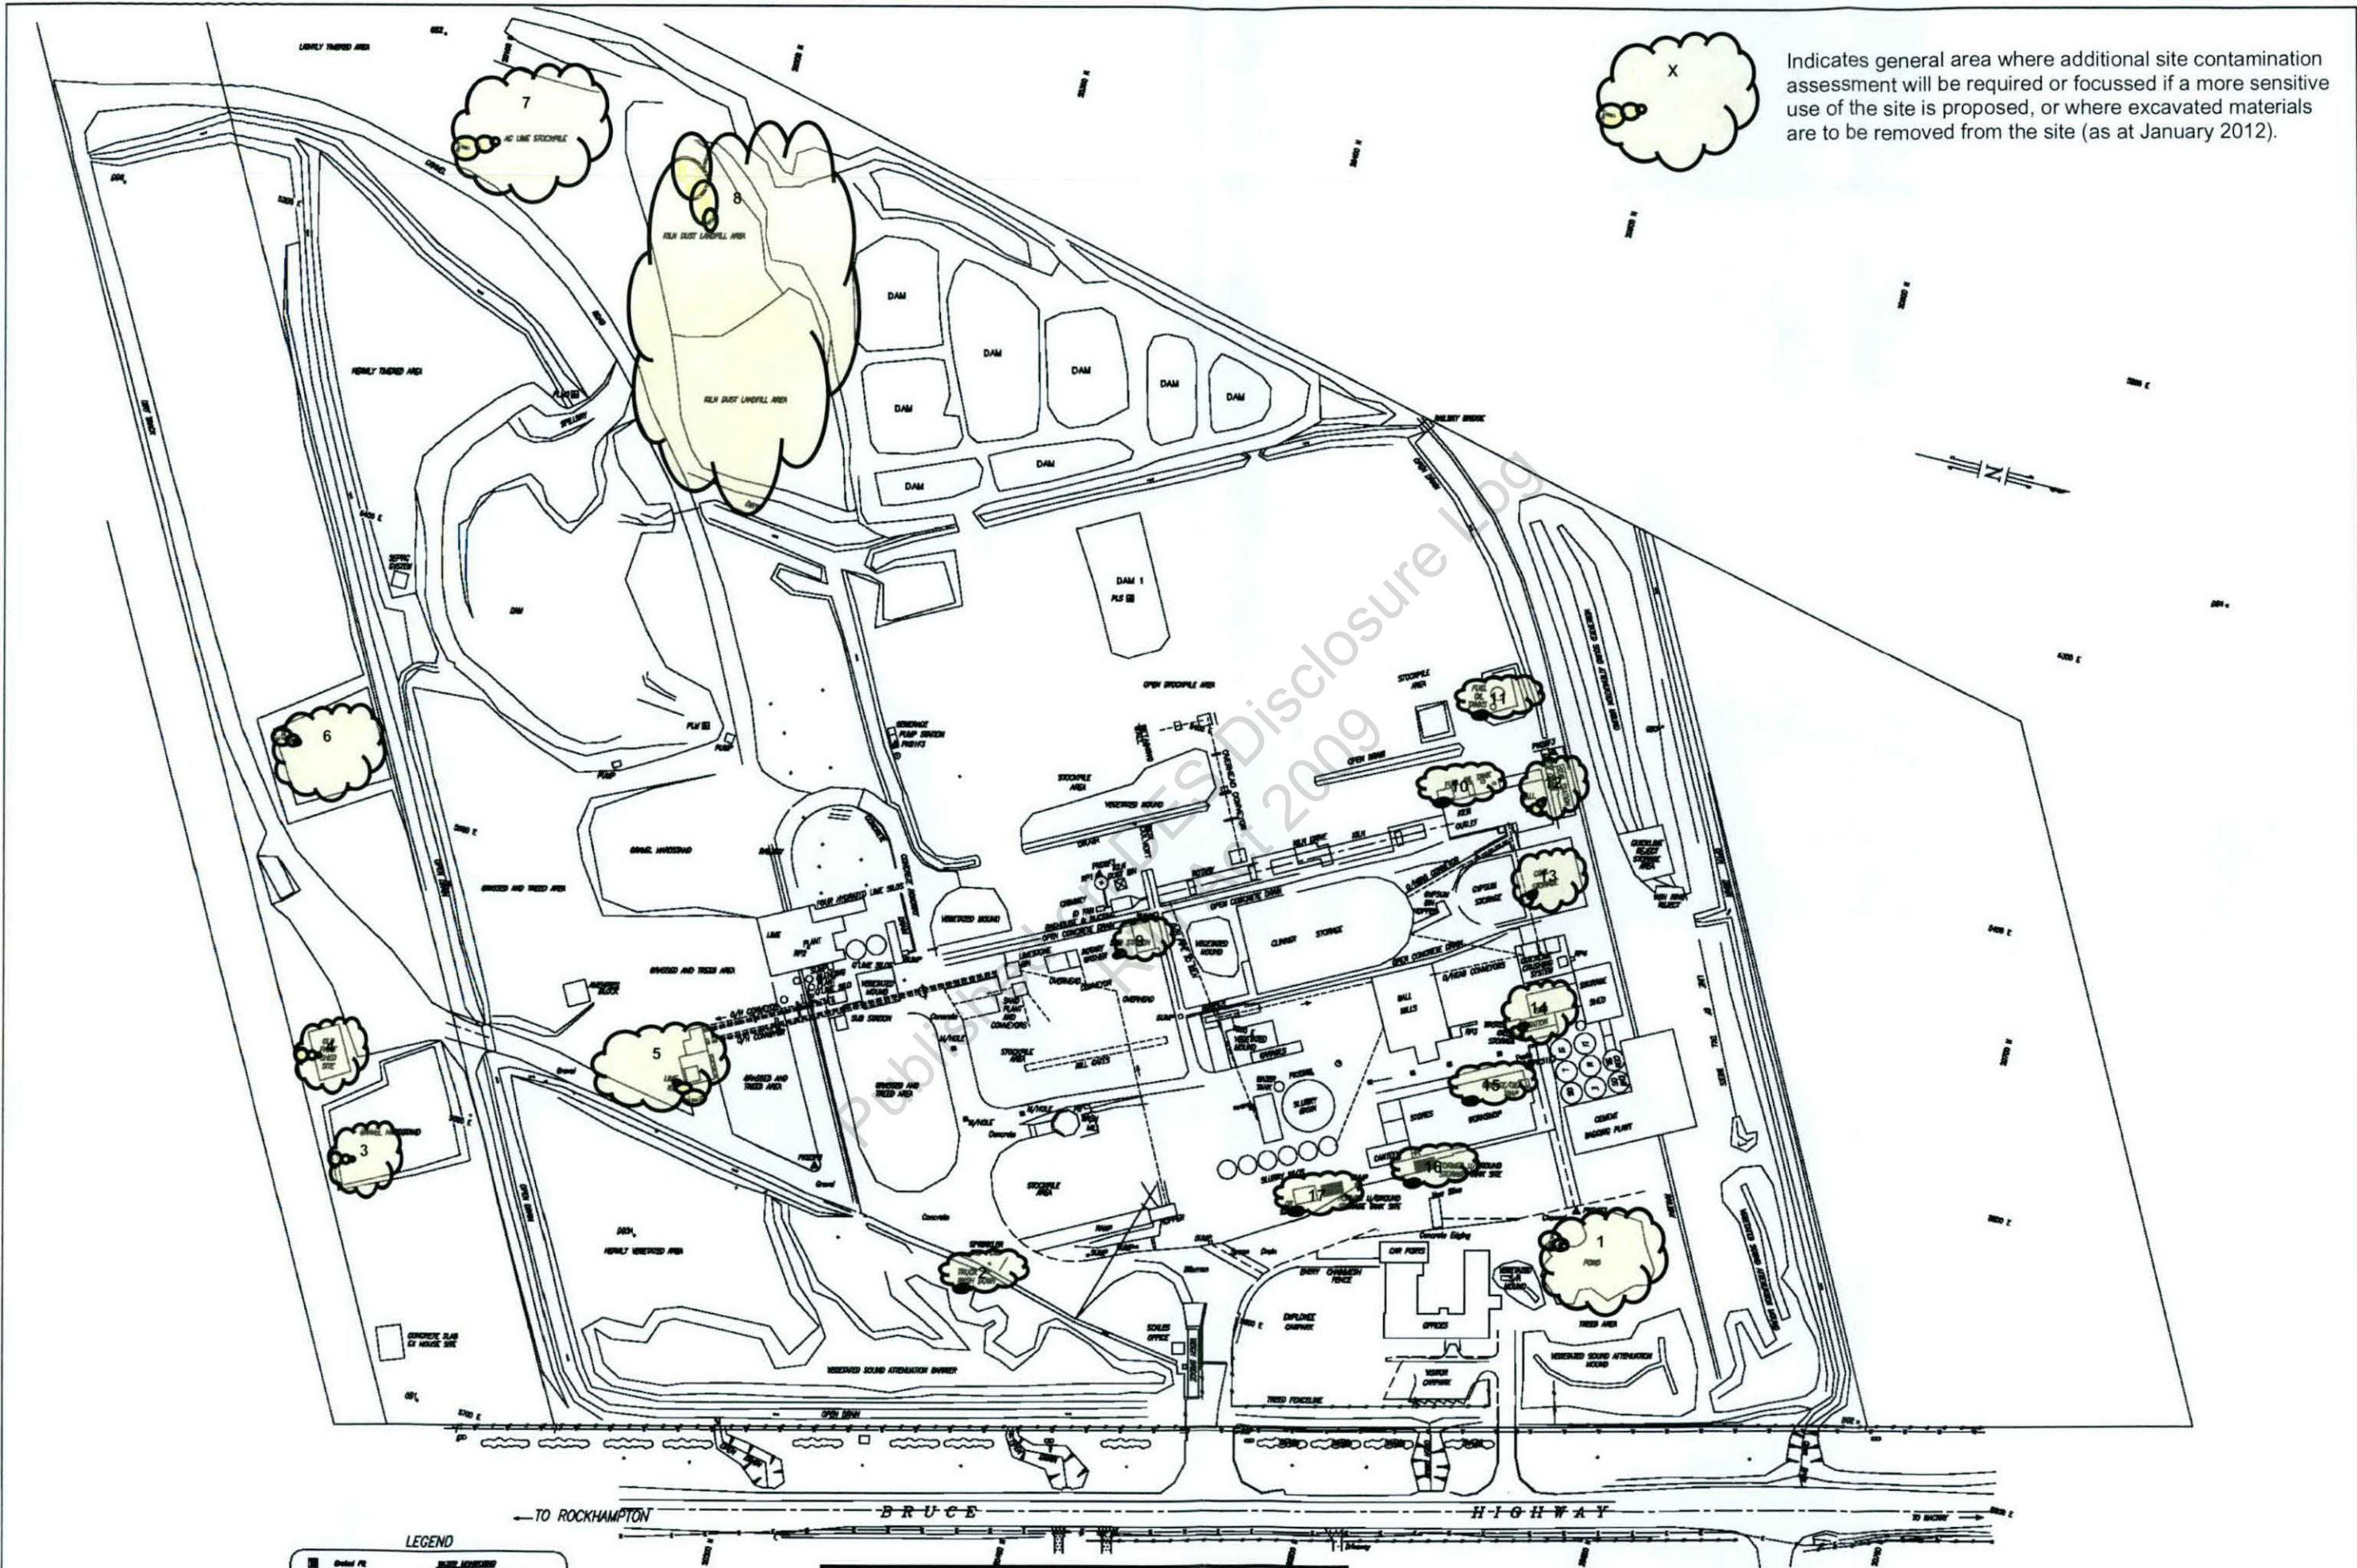
Site	Area of environmental concern	Contaminants or issues of concern
1	Former pond area is now filled with unknown quality fill (may have been sourced from the clay lease area on site).	Petroleum hydrocarbons, Heavy metals
2	Vehicle washdown area (concreted).	Petroleum hydrocarbons, Heavy metals
3	Laydown and storage area. Staining noted on hardstand, and hardstand broken in areas.	Petroleum hydrocarbons, Heavy metals
4	Storage shed (Generally paved, but some areas exposed).	Petroleum hydrocarbons, Heavy metals, OC/OP pesticides, herbicides
5	Redundant Vertical Kiln area and oil and waste oil storage. Staining identified in and outside former bunded areas.	Petroleum hydrocarbons. Asbestos significant in this area.
6	Laydown area for rotating spares and process equipment.	Petroleum hydrocarbons, Heavy metals
7	Temporary waste material storage. May also have contained other waste contaminants (drums, rags, etc).	Petroleum hydrocarbons, Heavy metals, pH

Indicates general area where additional site contamination assessment will be required or focussed if a more sensitive use of the site is proposed, or where excavated materials are to be removed from the site (as at January 2012).

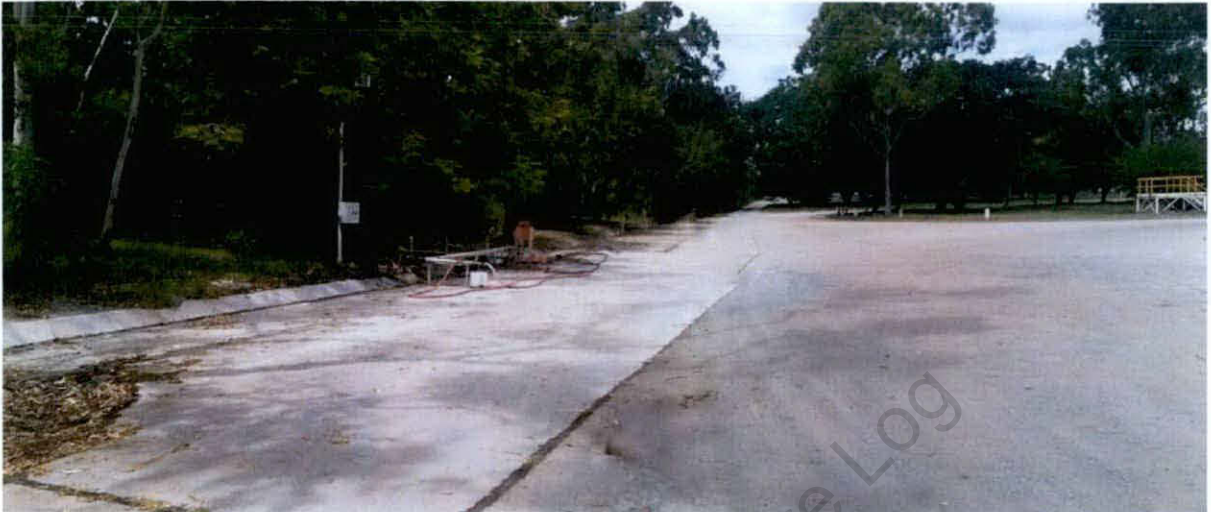
Figure 4-2 (2) Washdown area

3	Laydown and storage area. Minor staining noted on hardstand, and hardstand broken in areas	Petroleum hydrocarbons, Heavy metals	Human ingestion (acute exposure) Human dermal contact (acute exposure) Human inhalation (acute exposure) Human indirect (eg downstream resource use) Aquatic ecology Terrestrial ecology	<ul style="list-style-type: none"> • Low for site use due to cover/paving. Low-moderate for construction works. • Low for site use due to cover/paving. Low-moderate for construction works. • Low for site use due to cover/paving. Low-moderate for construction works. • Low for site use due to cover/paving. Low-moderate for construction works. • Low. Cover limits erosion and no groundwater issues identified. • Low. Cover limits erosion and no groundwater issues identified.
4	Storage shed (Generally paved, but some areas exposed).	Petroleum hydrocarbons, Heavy metals, OC/OP pesticides, herbicides	Human ingestion (acute exposure) Human dermal contact (acute exposure) Human inhalation (acute exposure) Human indirect (eg downstream resource use) Aquatic ecology Terrestrial ecology	<ul style="list-style-type: none"> • Low for site use due to cover/paving. Low-moderate for construction works. • Low for site use due to cover/paving. Low-moderate for construction works. • Low for site use due to cover/paving. Low-moderate for construction works. • Low for site use due to cover/paving. Low-moderate for construction works. • Low. Cover limits erosion and no groundwater issues identified. • Low. Cover limits erosion and no groundwater issues identified.

Site	Area of environmental concern	Site contamination assessment recommended
1	Former pond area is now filled with unknown quality fill.	No, if quality of fill can be confirmed.
2	Vehicle washdown area (concreted)	Review only (paved)
3	Laydown and storage area. Staining noted on hardstand, and hardstand broken in areas	Yes
4	Storage shed (Generally paved, but some areas exposed).	Yes
5	The redundant vertical kiln area and oil and waste oil storage. Staining identified in and outside former bunded areas.	Yes
6	Laydown area for rotating spares and process equipment (check location)	Yes
7	Waste material storage. May also have contained other waste contaminants (drums, rags, etc)	Yes
8	Kiln dust stockpile area	Yes
9	Electrical substation	Review only (no PCBs identified)
10	Fuel oil storage	Yes
11	Fuel oil / diesel storage	Yes
12	Electrical substation	Review only (no PCBs identified)
13	Coal storage	Yes
14	Electrical substation and waste oil storage	Review only (no PCBs identified) and paved

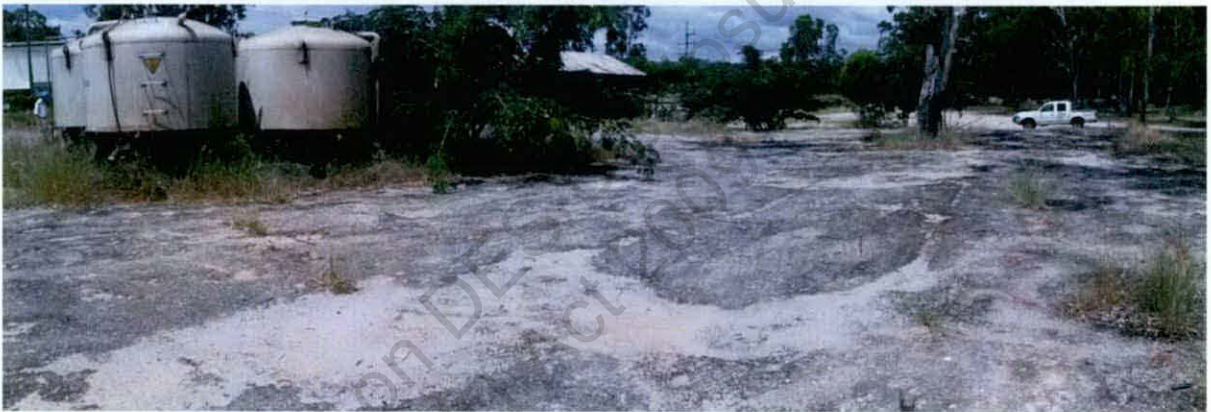
Figure 4-3 (3) Laydown and storage area

- Oil and waste oil storage areas show indication of spills or leaks in the general areas.
- Some of the laydown or storage areas show dark or black staining on the hardstand (sometimes broken) surface. This staining is likely generally due to storage of coal, burning of waste materials or vegetation, or waste oil. None of the stained areas were considered a significant issue based on a visual assessment.

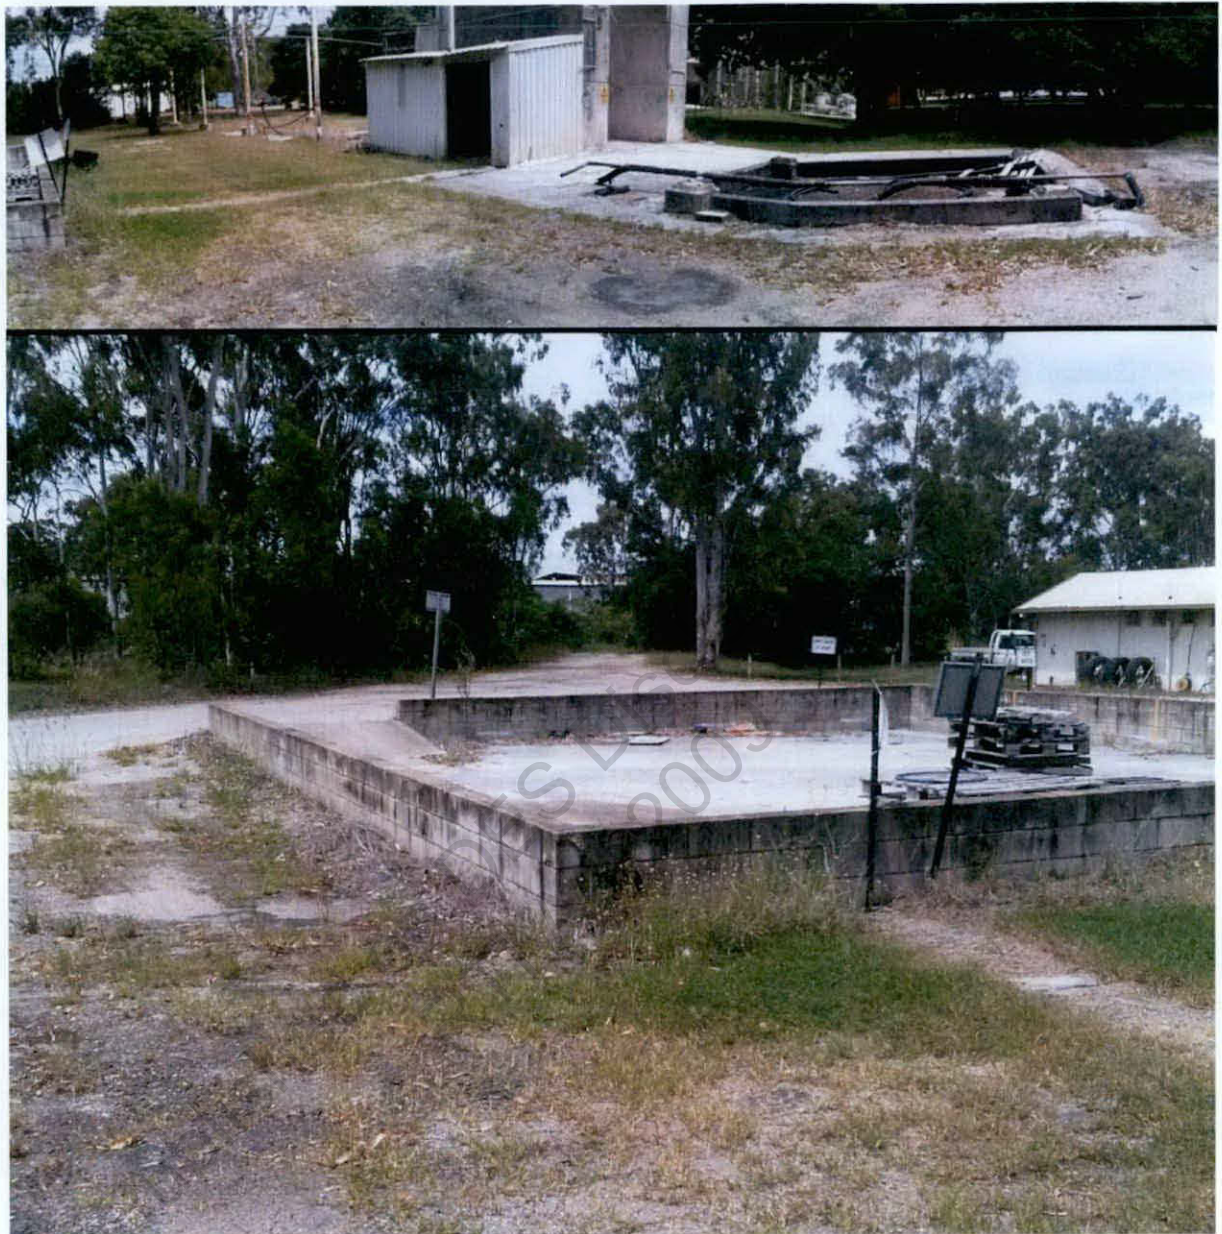
Figure 4-5 (5) Kiln and oil storage area

5	Kiln area and oil and waste oil storage. Significant staining identified in and outside former bunded areas.	Petroleum hydrocarbons. Asbestos significant in this area.	Human ingestion (acute exposure) Human dermal contact (acute exposure) Human inhalation (acute exposure) Human indirect (eg downstream resource use) Aquatic ecology Terrestrial ecology	<ul style="list-style-type: none"> • Low-moderate for site use due to cover/paving. Low-moderate for construction works. • Low-moderate for site use due to cover/paving. Low-moderate for construction works. • Low-moderate for site use due to cover/paving. Low-moderate for construction works. • Low-moderate for site use due to cover/paving. Low-moderate for construction works. • Low-moderate due to paving/cover and minor groundwater hydrocarbon issues. • Low-moderate due to paving/cover and minor groundwater hydrocarbon issues.
6	Laydown area for recycling (check location)	Petroleum hydrocarbons, Heavy metals	Human ingestion (acute exposure) Human dermal contact (acute exposure) Human inhalation (acute exposure) Human indirect (eg downstream resource use) Aquatic ecology Terrestrial ecology	<ul style="list-style-type: none"> • Low for site use due to cover/paving. Low-moderate for construction works. • Low for site use due to cover/paving. Low-moderate for construction works. • Low for site use due to cover/paving. Low-moderate for construction works. • Low for site use due to cover/paving. Low-moderate for construction works. • Low. Cover limits erosion and no groundwater issues identified. • Low. Cover limits erosion and no groundwater issues identified.

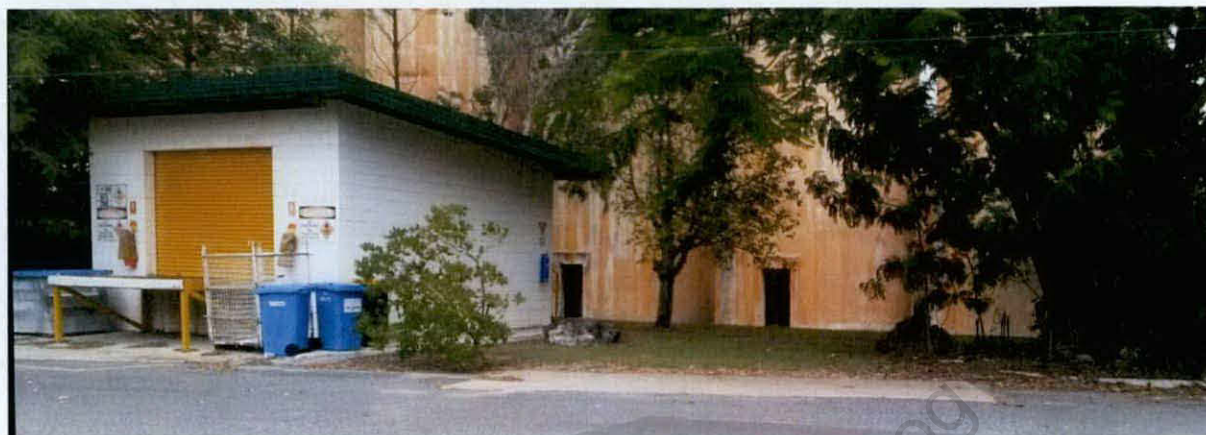
Figure 4-9 (17) Former UST site and oil store.

The USTs appeared to be in good condition on excavation and removal with no visible holes or corrosion noted. Upon removal of the tanks, water ponded within the remaining clay void in which the backfill sands were located. Following excavation of the backfill sands it became evident that the low permeability of the underlying clay was responsible for water ponding within the void. The low permeability of the
