# MMQ Quarterly Report

High Potential Incidents and Serious Accident Summary  
Queensland Mineral Mines and Quarries Inspectorate  
*January- March 2022 quarter*

**Resources Safety & Health**  
Queensland

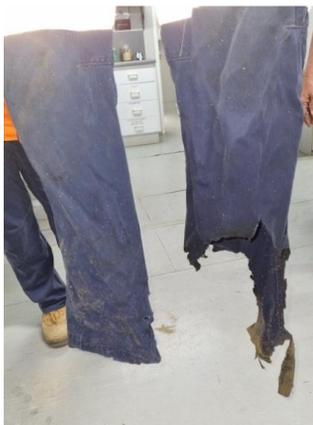
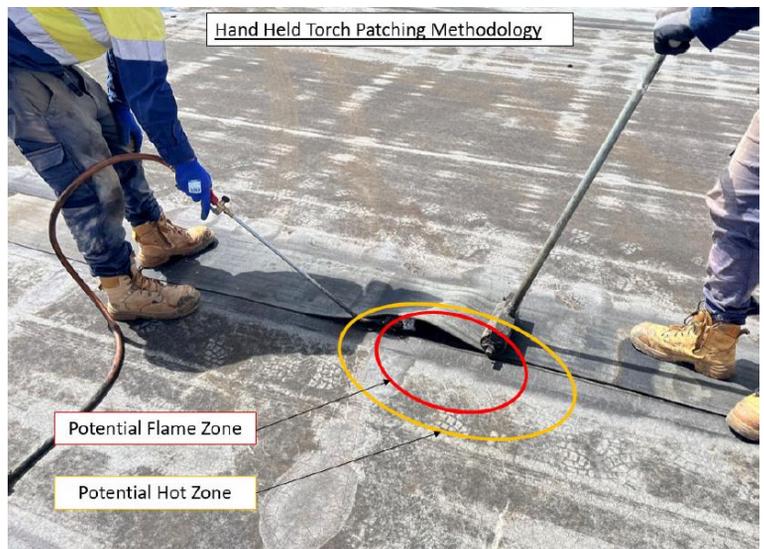
## Worker received burns while gas torch welding a tails dam liner

A worker involved with gas torch welding on the bituminous geomembrane liner in a tailings dam has sustained significant burns to his left leg. The worker was using a hand roller to seal a seam that had been heated with a hand-held LPG gas torch, when his left trouser leg caught on fire.

The SHMS did not include the requirement for specific PPE to be worn during liner ‘patching’ and ‘seaming’ activities.

- Never access a danger area during hot works.
- The use of a ‘spotter/fire watch’ should be used during hazardous activities.
- Always use fit for purpose equipment and PPE for the task.
- Ensure that workers are competent for the task that they are performing.

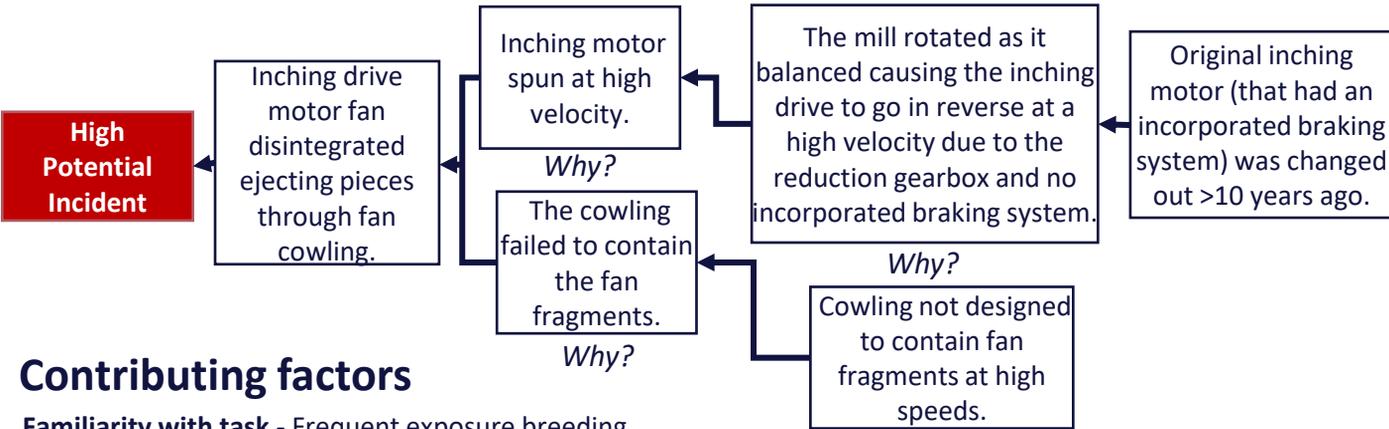
## Inching drive motor fan disintegrated

During a mill inching task to reposition mill and balancing mill charge, the motor fan of the inching drive disintegrated, ejecting fragments of the fan into the immediate area.

**Familiarity with task** - Frequent exposure breeding familiarity with the task resulting in a failure to recognise potential hazards.

**Hazard identification** - “nothing bad has happened before during the tasks” resulting in a failure to identify and control the dormant hazard.

**Change management** - initial management of change when motor was first changed out failed to identify and introduce compatible equipment

This hazard has been present for a period, thought to be longer than a decade. Engineering a solution that removes the excessive energy being directed through the inching drive motor and ensuring effective change management will prevent such future incidents. To assist hazard perception and recognition we need to challenge the status quo and acknowledge we are all influenced by our biases - what are the potential hidden hazards and what could go wrong?

Photos showing fan fragment ejection damage

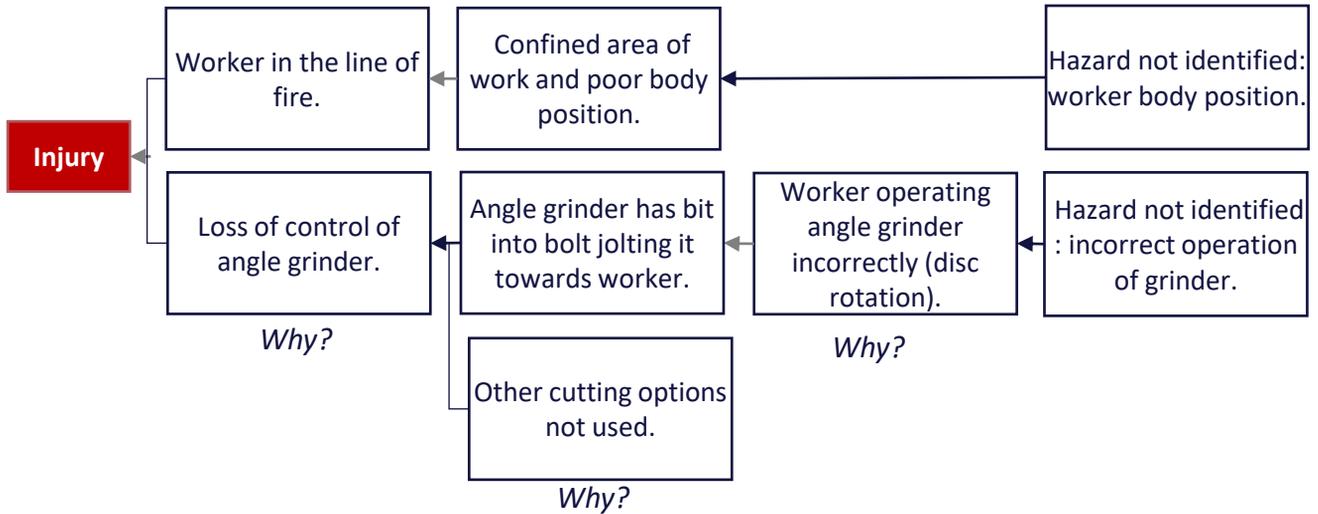
## 20cm Laceration to abdomen from 5" angle grinder

A worker was using a 5" angle grinder to cut off bolts from a platform. The angle grinder has 'bit into' the bolt being cut, then kicked back into the workers abdomen causing a 20cm laceration.

- The SHMS didn't include procedures for outlining the requirements for small powered hand tools.
- The Standard Work Instruction (SWI) did not identify correct body position or safe operation requirements for the grinder.
- Training records management for the worker did not include training in the relevant SWI.
- The worker did not identify hazards associated with their body position or incorrect operation of the angle grinder.

- Workers must not be positioned in a hazards 'line of fire'.
- Angle grinders should be fitted with dead-man switches, guards and handles (OEM).
- Ensure that workers are trained and assessed as competent to perform tasks.
- Procedures should be sufficiently detailed to manage all hazards associated with the task.
