Incident periodical

Recent High Potential Incidents
Learnings and Recommendations
Reporting + Communications

Queensland Coal Mines Inspectorate

October 2023

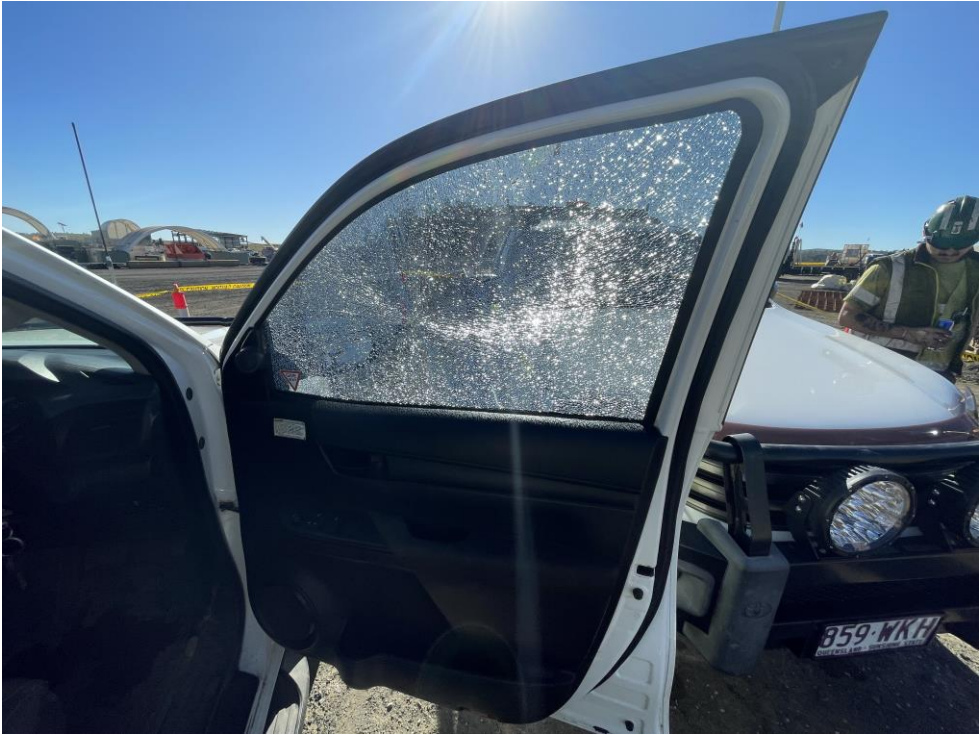
During August 2023 there were two high potential incidents (HPIs) reported that involved the failure of components on concrete boom delivery systems that resulted in the ejection of concrete material and damage to mobile plant.

On both occasions windows were struck and either shattered or breached. No personal injuries were sustained.

Light vehicle struck by concrete shattering passenger side window.

- Does your mine have a robust process for introduction of plant to site?
- Does this include all components of the plant including attachments and consumable components?

- Does this system include plant operated by short and long term contractors?
- Are records kept of maintenance and inspection history; especially of wearing components (i.e. pipes concrete is being pumped through)?

- Has site considered the impact rating of glass in various pieces of mobile plant?
- Do Coal Mine Workers (CMWs) consider park up position of mobile plant when conducting tasks that have the potential to impact nearby work areas?

- CMWs always need to have a plan A and B. Understand the line of fire and stay out of it. In case things go wrong always have in advance a safe path of retreat.

- Consideration should be given to referencing other industry codes of practice for guidance; e.g. Worksafe Queensland Concrete Pumping Code of Practice 2019.

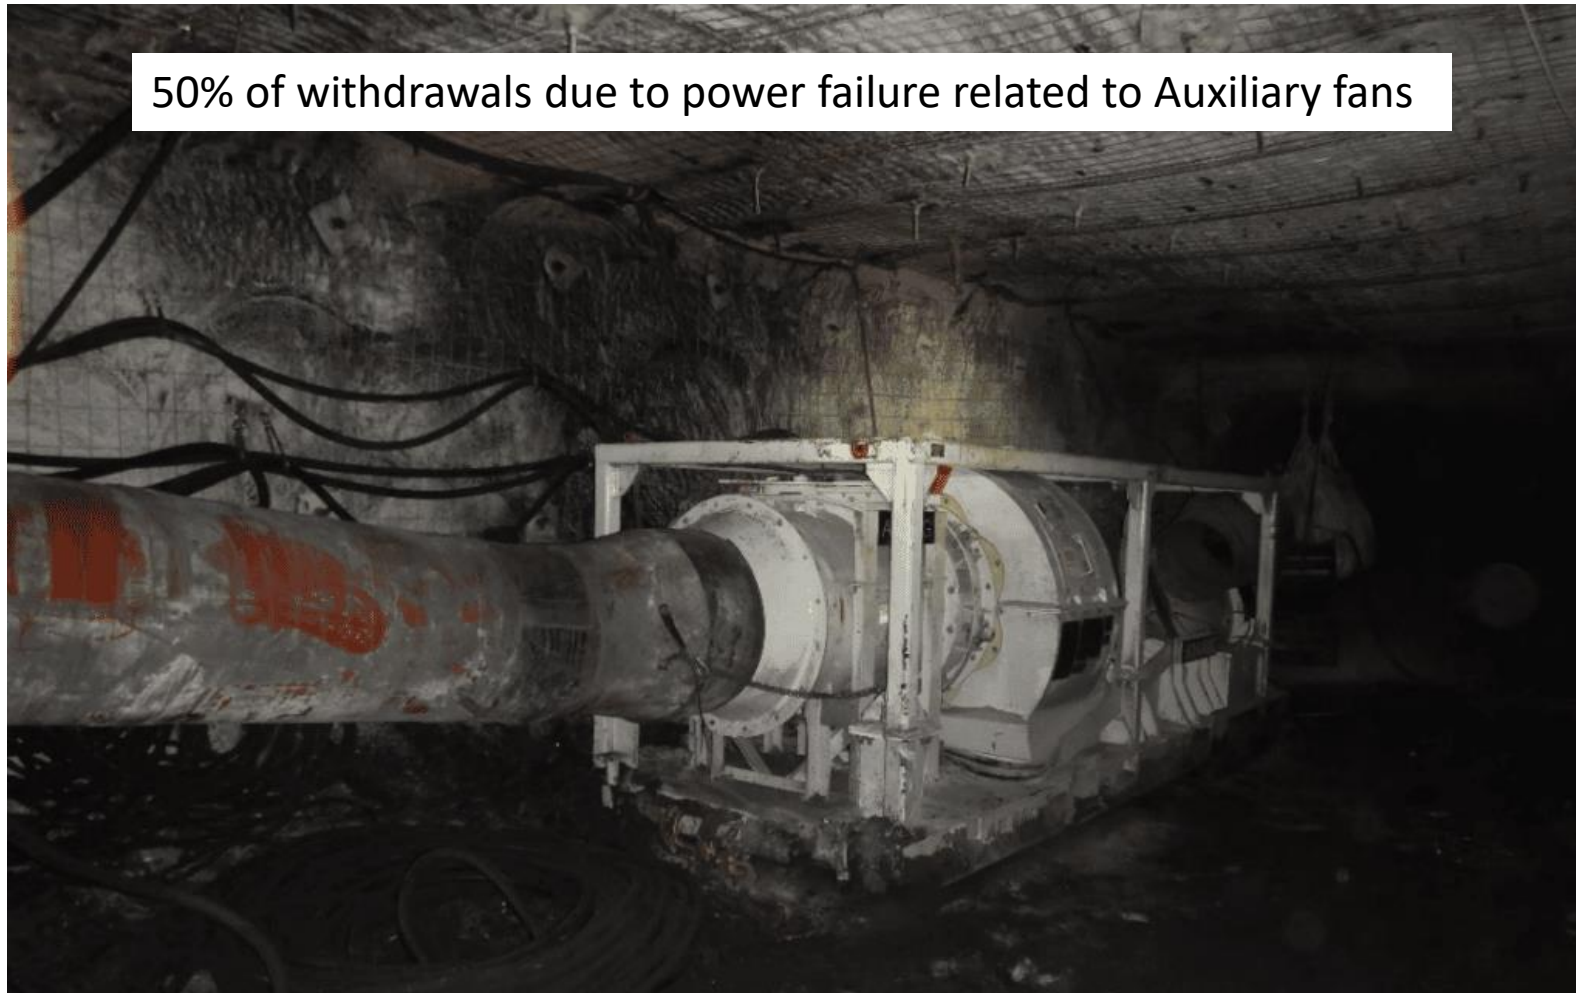
8. Unplanned withdrawal from part of an underground mine

In addition, one of these withdrawals was the result of a communication outage and a further three were the result of excessive dust in a work area.

- One observation in the Brady report was that we accept a normalisation of behaviour. With a large portion of these events there is an acceptance to reset power trips and / or aux fans multiple times over several days and weeks without investigating the root cause.
- There needs to be a point where this isn't acceptable.
- Determining root cause and resolving it allows for less interruption to the operation and more confidence in the systems in place.
- With respect to withdrawals for dust, is consideration given to CMWs working in-bye and potential exposure to dust from certain tasks conducted out-bye such as stone dusting, removal of structure and shotcreting.
