# Incident periodical

High Potential Incidents summary

Queensland Mineral Mines & Quarries Inspectorate

April 2020

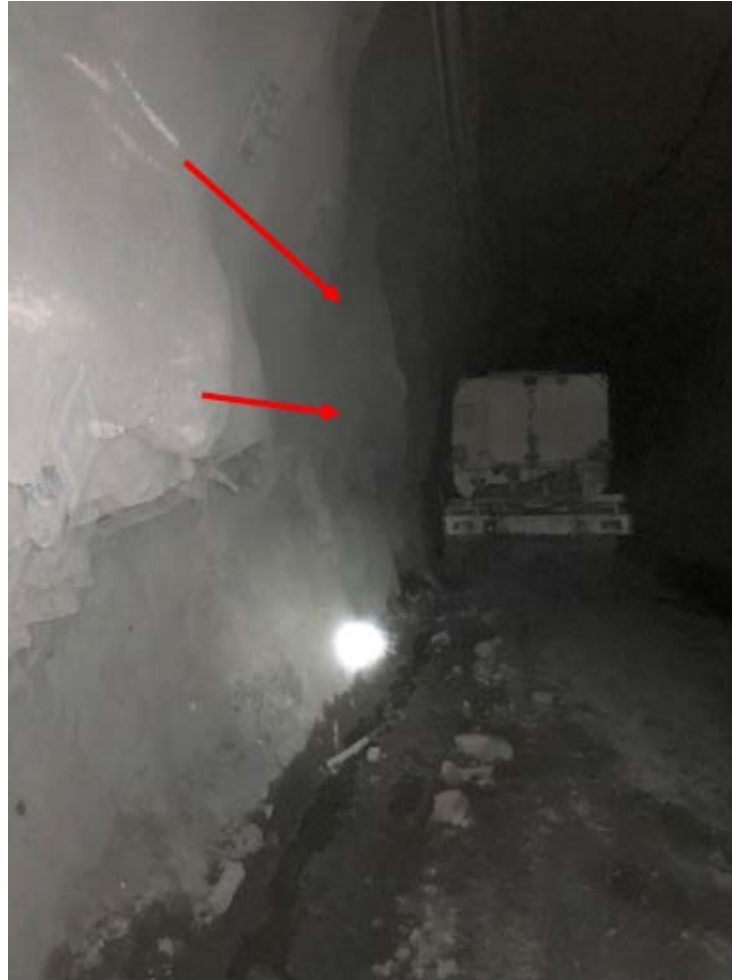
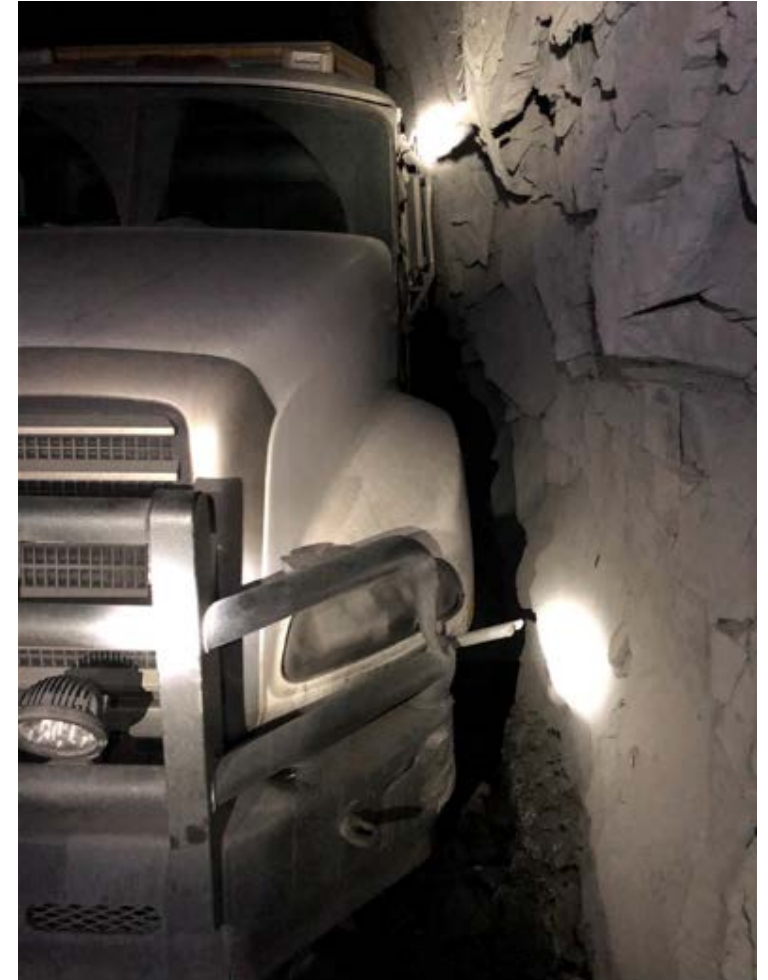
After losing braking, an operator has steered a water truck into the wall of an underground decline, causing minor injuries to the operator and damage to the truck.

The truck was then steered into the wall, coming to a stop.

The SIBS braking system fitted to the truck was not activated during the incident.

- Service brake failed a stall test at required rpm following recovery
- Electric retarder was non-functional due to burnt out control components
- The parking brake was not designed to bring a loaded truck to a stop
- The truck was being operated in a gear inappropriate for travelling down the decline
- The truck's pre-start calls for testing of the braking systems as per OEM requirements, but no procedures for testing or pass/fail criteria were available in the truck

- Ensure appropriate information is available to workers for them to determine the condition of equipment before it is operated. [Administrative]
- Assess and keep a record that workers can demonstrate the testing of critical safety systems on mobile equipment (e.g. braking and steering systems). [Administrative]
- Ensure there are clear-cut definitions of safe and unsafe conditions for mobile equipment and workers are assessed and a record kept that they can demonstrate when a piece of equipment should be stood down. [Administrative]
- Review all contractor supplied plant to ensure it is maintained and repaired as per OEM requirements and correct technical information is available for workers carrying out repairs and maintenance. [Administrative]

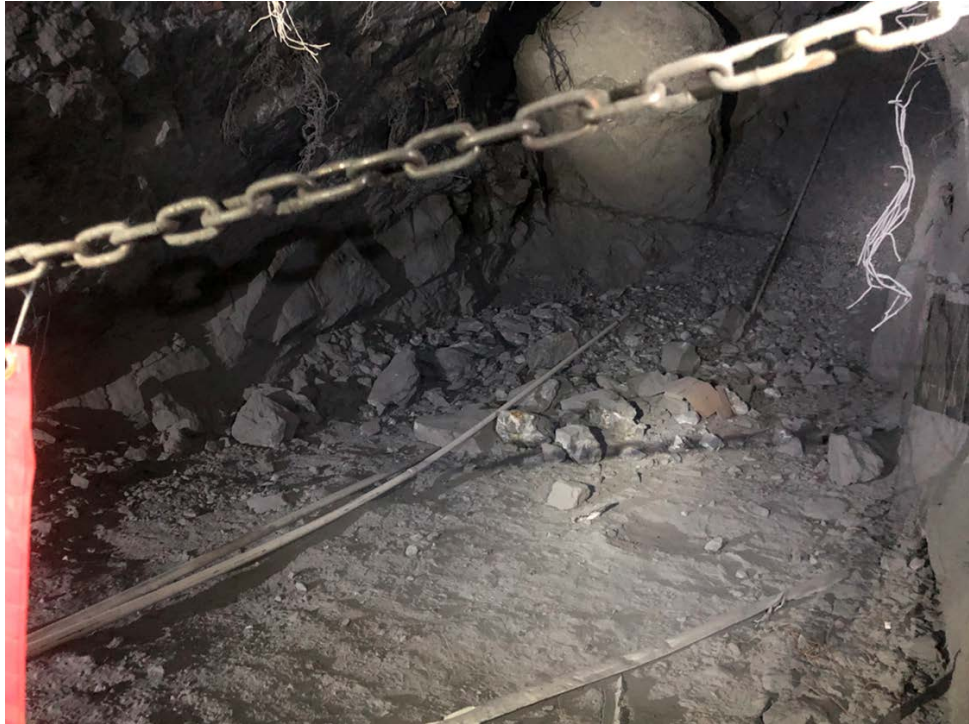
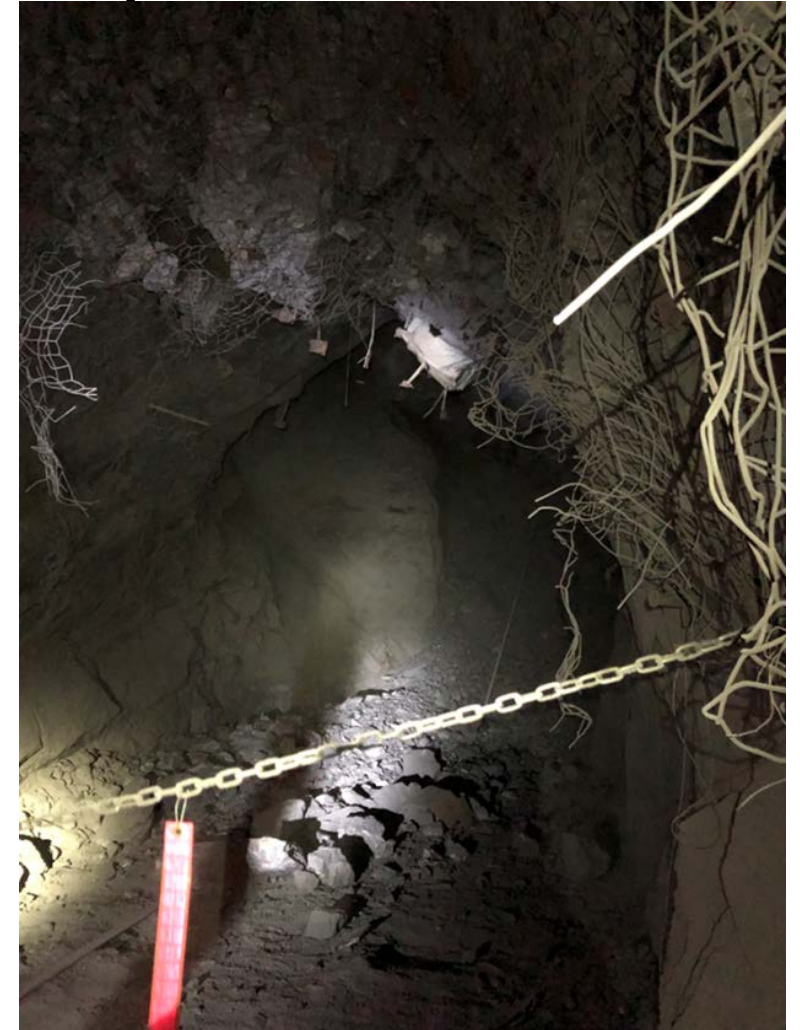
While two persons were preparing to bomb oversize rock in a stope draw point they were struck by a rock fall of approx. 50kg that fell from the back approximately five metres back from the brow. Both workers were treated in hospital.

- The ground support had been damaged by previous firings and was no longer effective
- The ground had not been scaled of broken material
- The usual oversize blast bay was full.
- Neither the persons undertaking the bombing or the supervisor had recognised the deteriorated ground conditions and controls when undertaking the pre task risk assessment and while undertaking the task.
- The task flow chart did not trigger the need to have ground control checked following repeated blasting.

- Ensure scaling practices are thorough and remove loose rocks
  - Ground conditions inspected and re-scaled as part of a re-entry procedure [Administrative]
  - An inspection by an experienced and competent supervisor should be undertaken before persons work in close proximity to open brows [Administrative]
- Use mechanical scaling where necessary [Substitution]
- Damaged ground support must be re-established to ground support management plan standards prior to re-entry [Engineering]

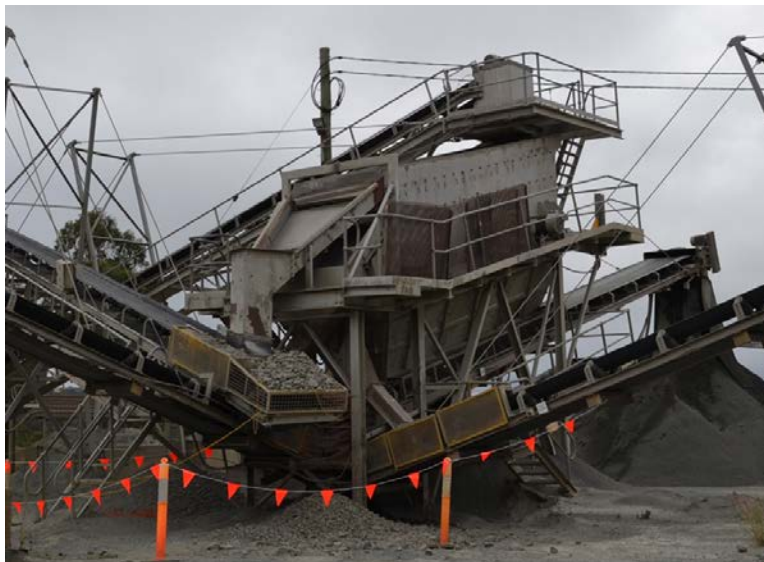
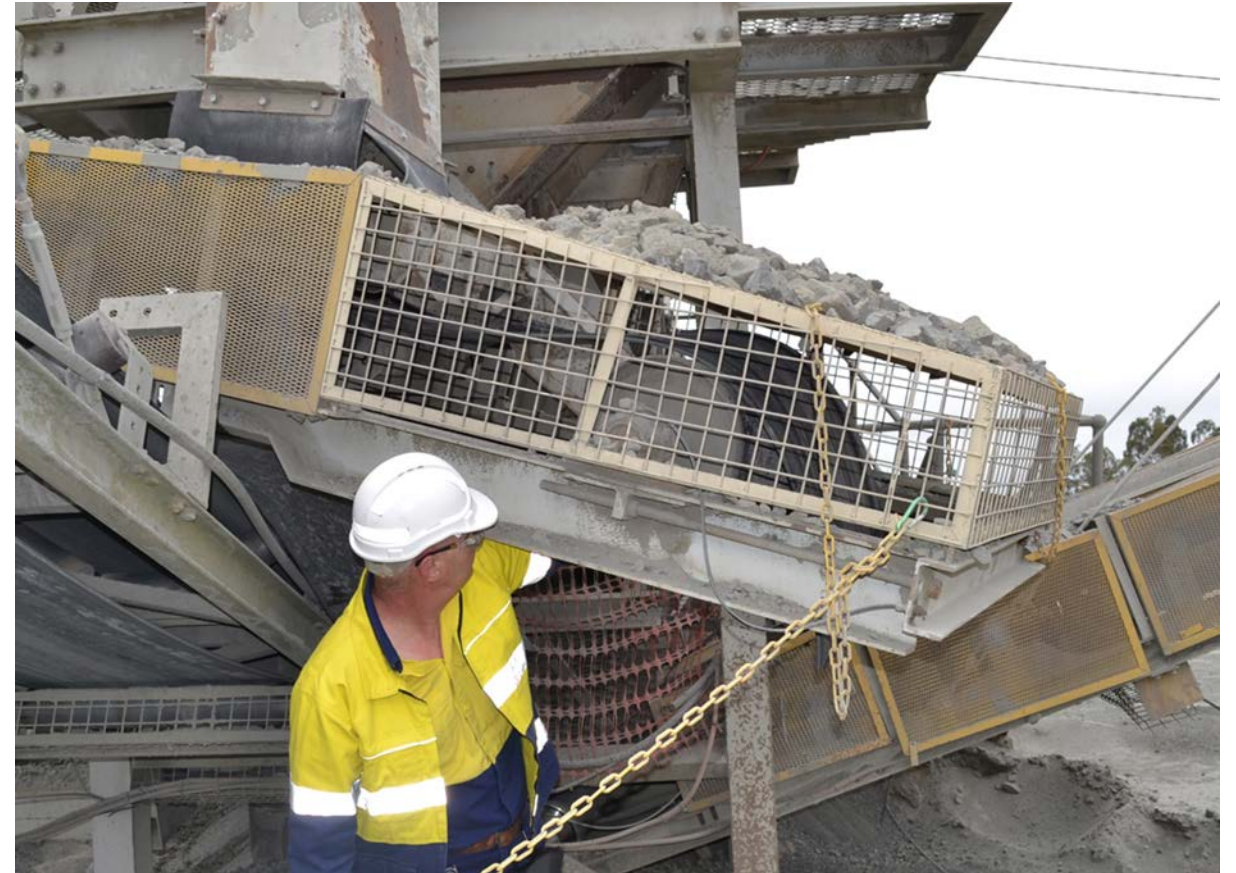
A worker had their arm entangled in the tail drum of a conveyor while attempting to clear spillage from the return side of a belt.

The conveyor had been stopped to allow the blocked chute and spillage to be removed.

A worker was seriously injured at a quarry when his left arm became entangled in the rotating tail drum of a conveyor belt. Prior to the accident, the conveyor had been stopped to enable clearing of rock spillage from the tail drum area. The injured worker was attempting to clear rock from the nip point where the return side of the belt meets the tail drum, when the conveyor was briefly energised (jogged) by another worker from the plant switchboard located some distance away. The conveyor belt was cut in order to free the injured worker.

- The incident is currently under investigation.
- Preliminary findings indicate that the plant was not isolated and that the conveyor was inadequately guarded.

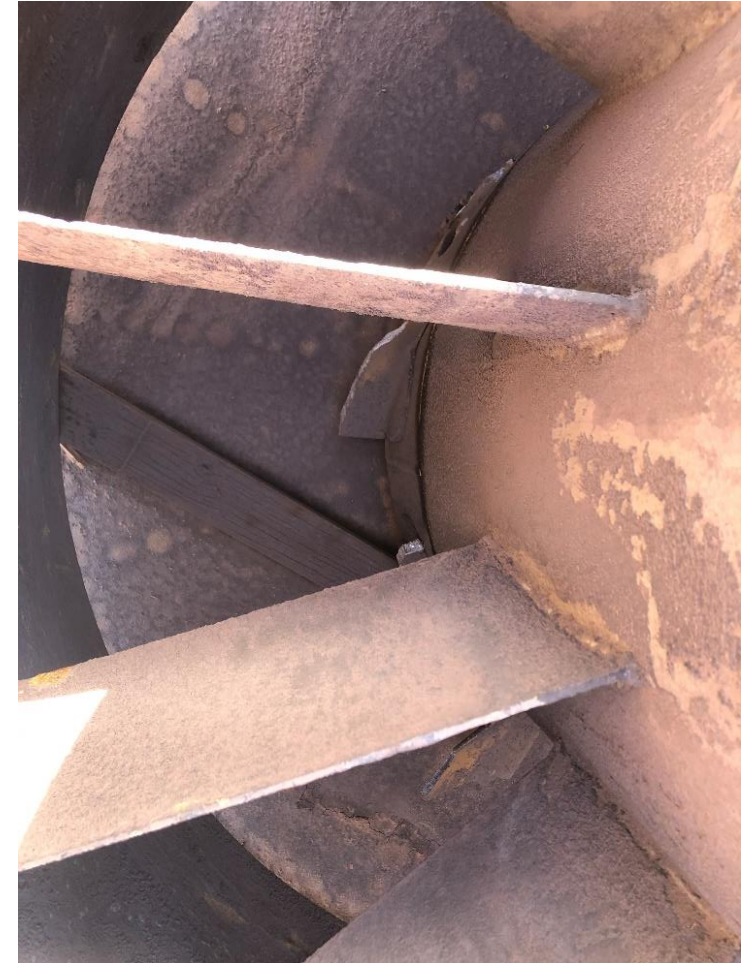
On 31 July 2020, a failure in the primary fan destroyed all fan blades and left palm-sized fragments within a 15 metre radius of the installation.

The fan cowling and evasé were not damaged by the disintegration of the fan components; the fragments were ejected out of the top of the evasé.

- SSE should:
  - Reduce pitch of fans from 54 to 43 degrees. [Engineering]
  - Establish mechanical maintenance strategy as per OEM documentation [Administration]
  - Conduct detailed mechanical inspections of all fans onsite [Administration]

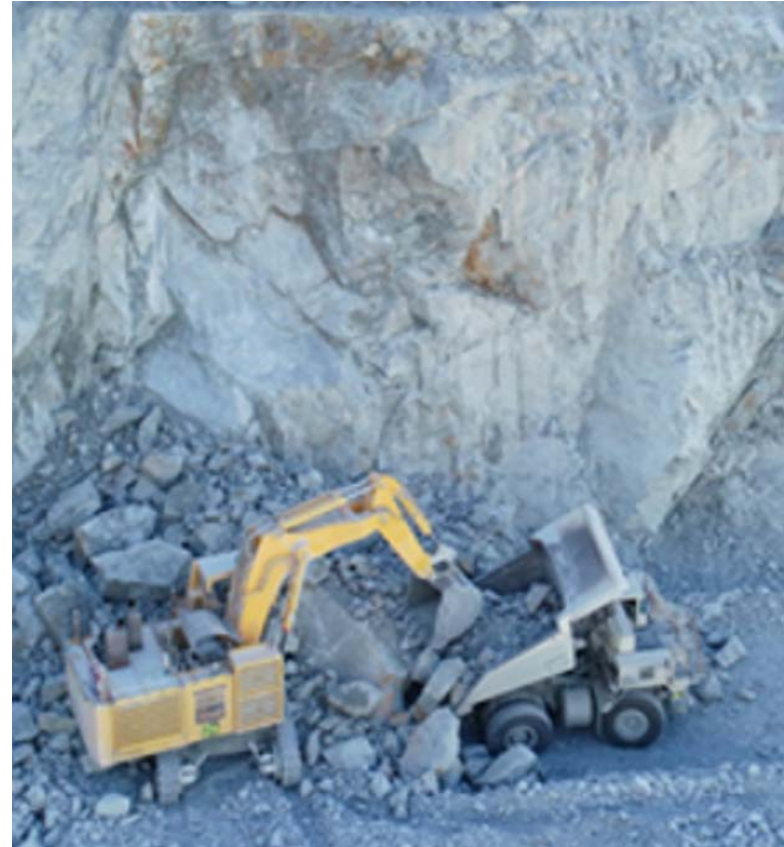
On 30 August 2020, an excavator operator had scaled a face and was loading the resultant material into a truck when approximately 1000 tonne of ground fell and partially buried the excavator and the truck.

Displacement was identified in the area a few days earlier by a radar scanner

The excavator operator has inadvertently removed the key-block that triggered the rockfall.

- Presplit blasting
- The degradation of the effectiveness of the crest pins
- Water ingress

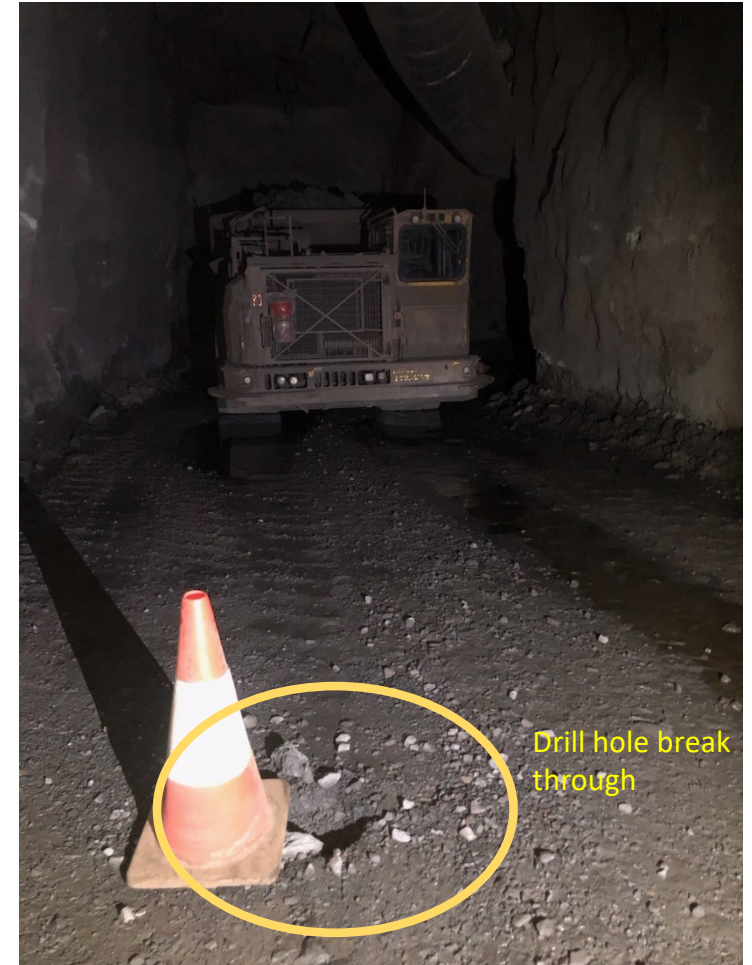
On 26 August 2020 a production uphole was being drilled from one level to an upper level. A truck operator was about to move off when he saw a drill rod break through into the drive 7 metres ahead of his planned travel route.

Mine Technical Services issued a drill plan showing the whole drill pattern, which included breaking through to the upper level. Later the plan was marked up intending to show that only the wall fan holes **G, H and I** were to be drilled.

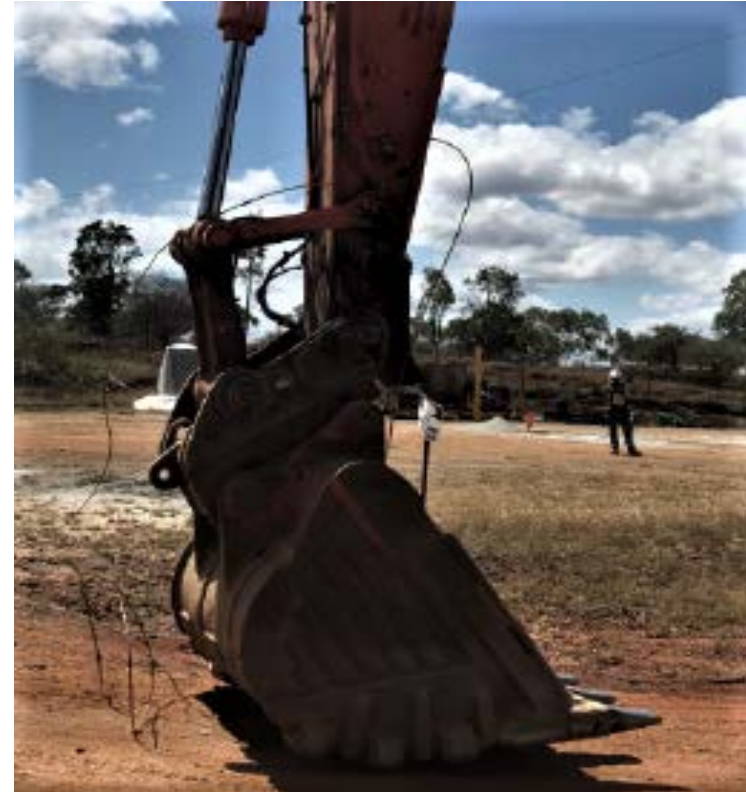
On 7 September 2020, an Excavator was travelling towards the exploration core shed area when it struck and severed the 11 kV overhead power line (OHL). The operator knew to stay in the cab which had been part of his training. The electrician also advised the operator to stay in the cab until Ergon confirmed that the power was isolated.

Conductor entangled around excavator boom

Use the recently issued Safety Bulletin # 188 Mobile Plant Contacting Energised Overhead Powerlines to assist with the identification of the hazards associated with your OHLs and implementing the most effective preventative and mitigating controls. The link is <https://www.dnrme.qld.gov.au/business/mining/safety-and-health/alerts-and-bulletins/mines-safety/mobile-plant-contacting-energised-overhead-powerlines>

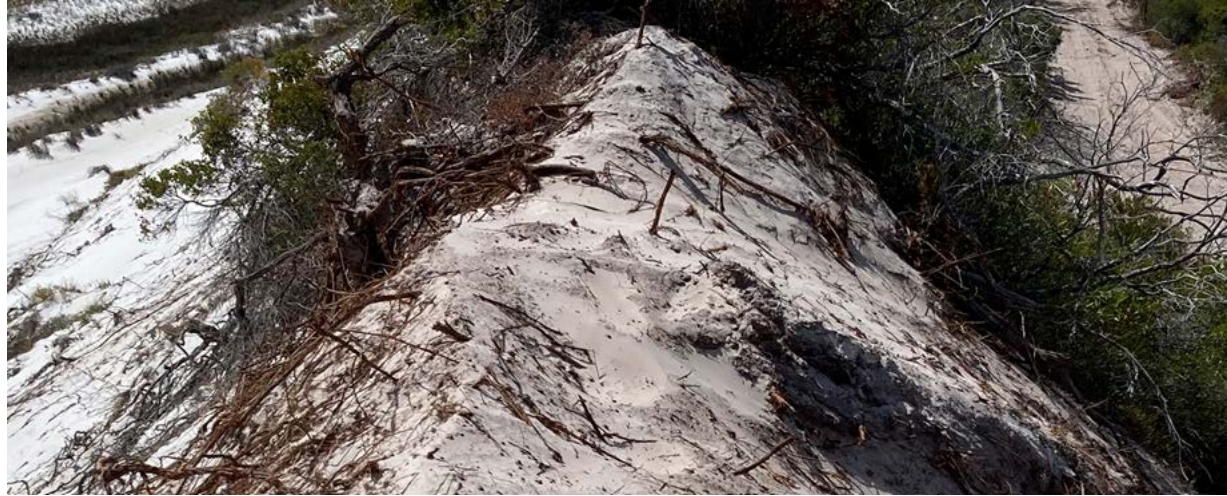
Ridge of sand dune

On 15 September 2020, a dozer operator was creating a track on a the ridge of a sand dune when the dozer slid sideways and veered to the right hand side. The dozer was still stable at this point and only rolled over when the operator tried to reverse back up onto the ridge. The operator was wearing the seat belt and was not injured.

The technique for creating a track is to staddle the ridge and keep the blade height so that sufficient material comes around both ends of the blade to form a window on either side. This will ensure that there is a sound bed for the tracks to run on.

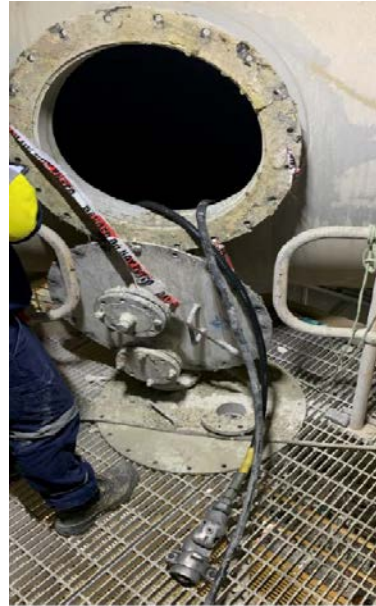
# Water at high pressure strikes worker

On 5 October 2020, a tank cleaning head was being used to clean internal pipework when it was ejected through the open hatch. The worker was struck by the high pressure water at 540 bar (7800 psi) from their knee up to their neck causing:

- Minor abrasions/lacerations and swelling to knee
- Pressure marks on neck area.

Cleaning head

Rotating nozzles

- The ejection of the high pressure cleaning head through the open hatch must be considered as part of the JSA development. [Administration]
- Hatches and other protective barriers must be in place prior to high pressure cleaning tasks. [Separation]
- The mine management structure must provide for a worker to be appointed who has the responsibilities and competencies to oversee contractor tasks. [Administration]
- Original equipment manufacturer, where possible, should be involved in risk assessments to ensure that all hazards have been identified especially when the plant is of a specialist nature. [Administration]

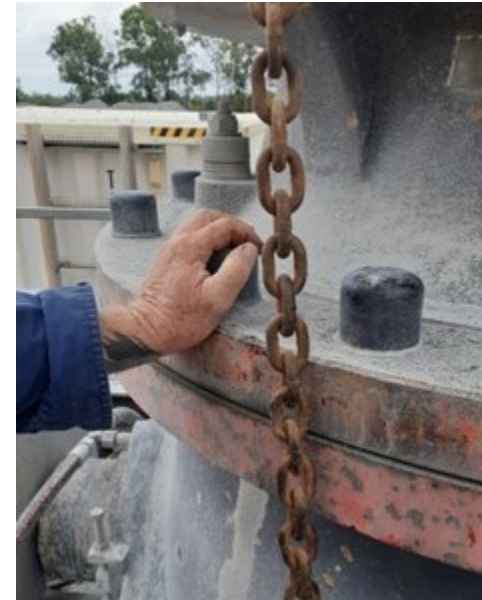
On 20 November 2020, a cone crusher was about to be lifted onto a truck by an excavator in crane mode. As the load was taken up by the four legged chain slings, one of the chain legs trapped the worker's hand against a bolt on the crusher.

The worker received soft tissue injuries to their thumb.

This is a static re-enactment
