# **SIMULATION OF SPRAY PAINTING INCIDENT INSIDE A CONFINED SPACE ON A DRAGLINE: CRITICAL LEARNINGS FOR MULTIPLE INDUSTRIES**

This paper covers the investigation and subsequent re-enactment testing of an incident that occurred while spray painting inside a confined space on a dragline, as conducted by Resource Safety and Health Queensland (RSHQ) to provide further learnings to industry.

While working on a dragline shutdown and performing spray painting activities under a Confined Space Entry Permit, two Coal Mine Workers became unresponsive and were rescued from inside the dragline revolving frame.

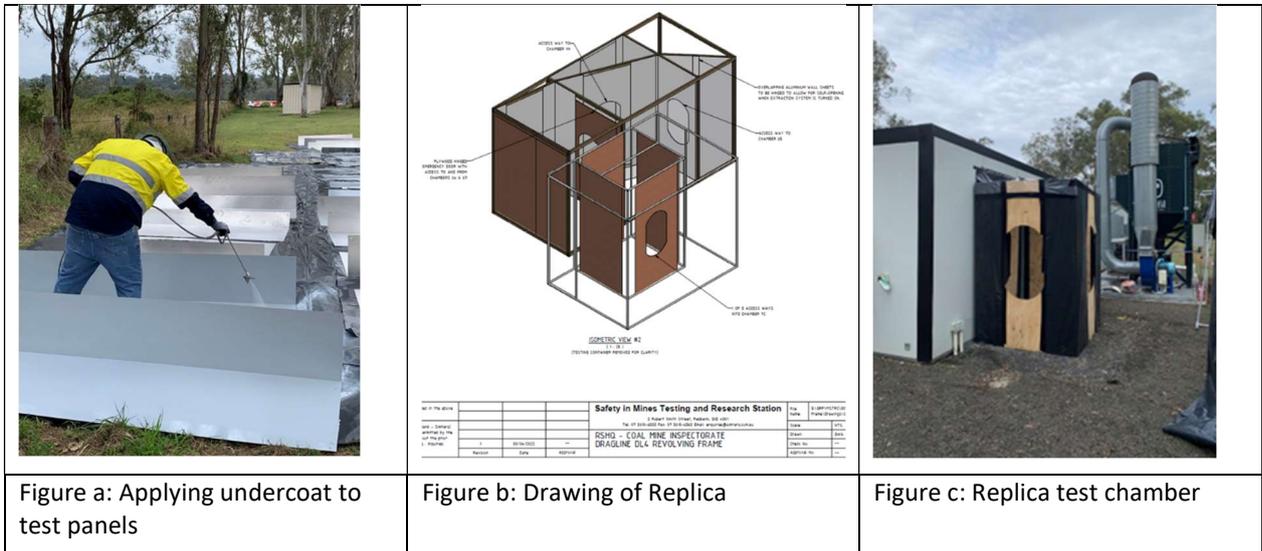
Figure a: Applying undercoat to test panels

Figure b: Drawing of Replica

Figure c: Replica test chamber

Figure d: Drawing of dragline revolving frame showing paint fronts, compartment bays, replica area & sampler locations.

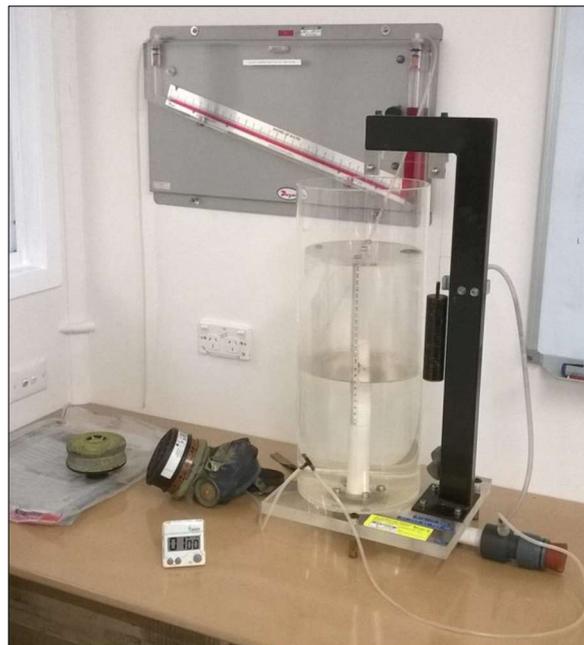
Figure e: Leakage test setup

The two half face respirator and filter assemblies were sealed inside plastic bags and transported to product distributors Safety Equipment Australia (SEA) for inspection and testing for integrity and leakage. Visual inspection was performed to identify faulty, damaged and/or missing components and general maintenance condition. Leakage testing was performed by using a manometer and applying negative pressure to the facepieces with a spirometer bell after the filter inlet and face seal was blocked to prevent inward leakage. Leakage was measured through displacement of the spirometer bell and testing conducted at 20-23°C and 40-60% relative humidity. Leakage testing was repeated following the cleaning and replacement of individual components including valves and valve seats, to trouble shoot and identify the source of any inward leakage detected.
