# Truck Breaches Tip Head Due to Dump Failure

2<sup>nd</sup> December 2025

Hail Creek Open Cut

## Summary - Truck Breaches Tip Head Due to Dump Failure

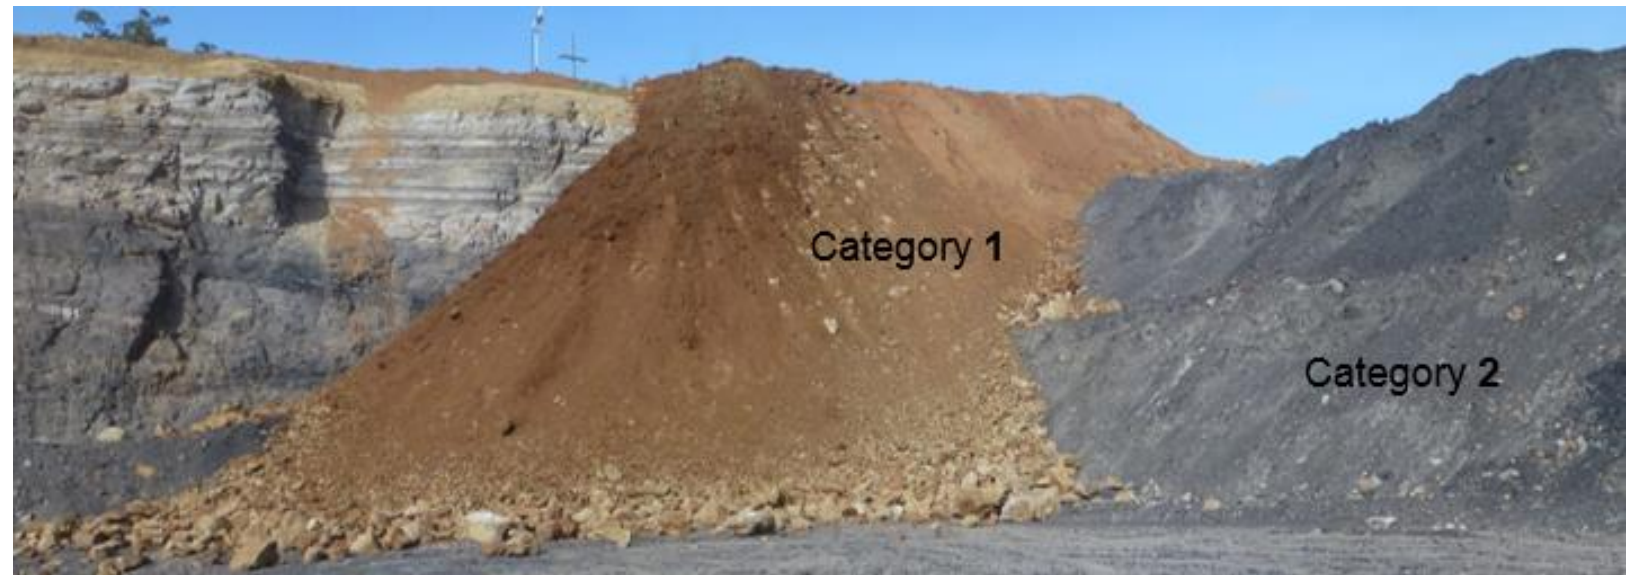
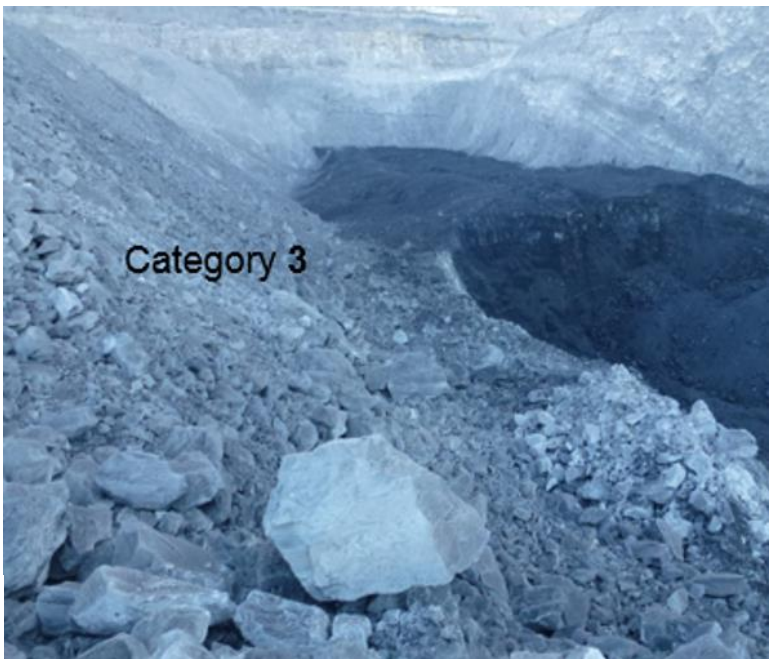
Material Categories

The below photos identifies the dump material categories seen at Hail Creek Mine.
